**Safety Regulation Group**

**Paper 2013/03**

# **Reliability of Damage Detection in Advanced Composite Aircraft Structures**

**Prepared for CAA by:** L Cook  
A Boulic  
D Harris  
P Bellamy  
P E Irving  
**Cranfield University**

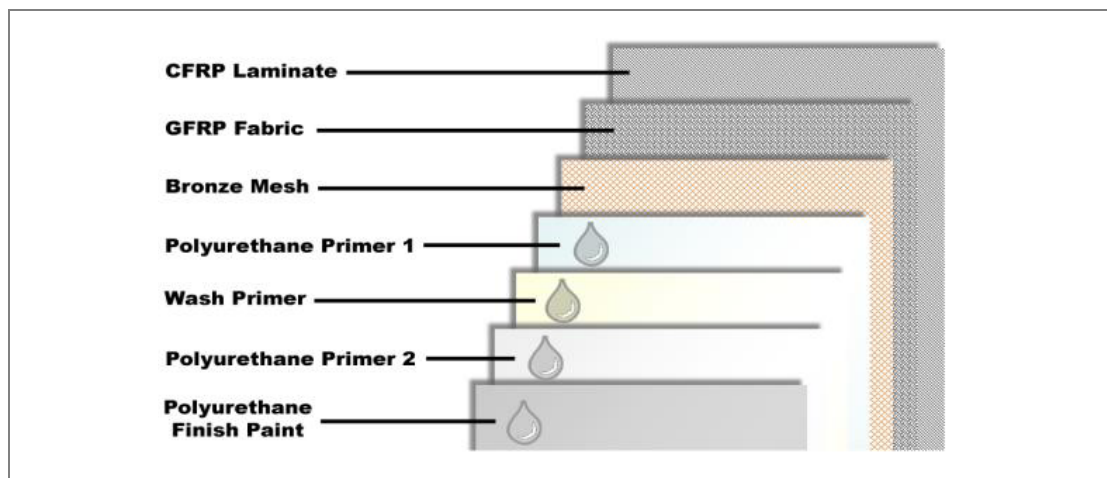
CFRP aircraft structures include metal mesh lightning strike protection and are normally externally painted [2-4]. A typical section through a horizontal stabiliser skin material is shown in Figure 3 [2]. CFRP plies are the innermost layer.

**Figure 3** Material Lay-Up and Paint Coats applied to Horizontal Stabiliser Skin

A thin layer of GFRP fabric separates the bronze mesh and the CFRP to avoid galvanic corrosion between the carbon fibres and the metal mesh.

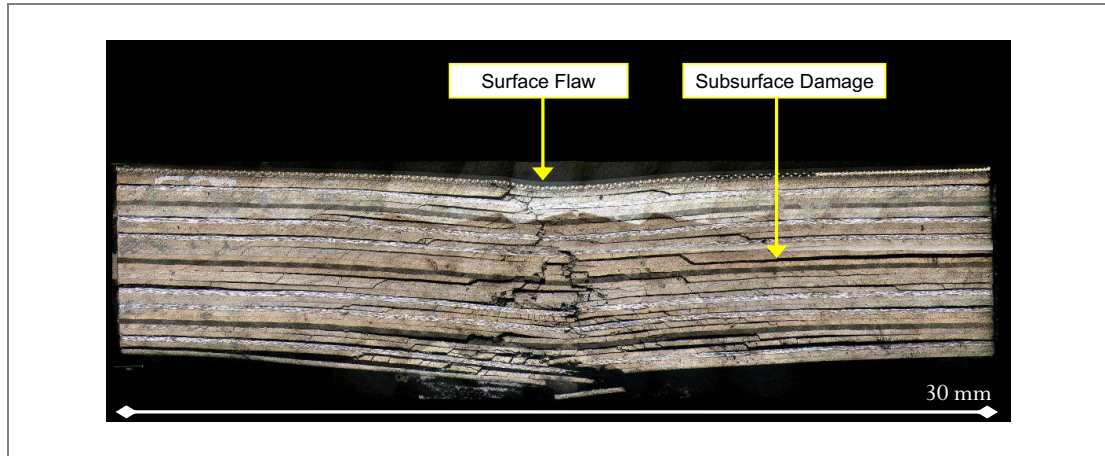
**Figure 4** Cross section through impact damage to a 33 ply, bronze mesh incorporated, painted, CFRP laminate [9]

The subsurface delamination and cracking will be invisible on visual inspection, only the surface flaw being visible. As seen in figure 4, the visible surface flaw due to impact damage can often be significantly smaller in width than the subsurface delamination.

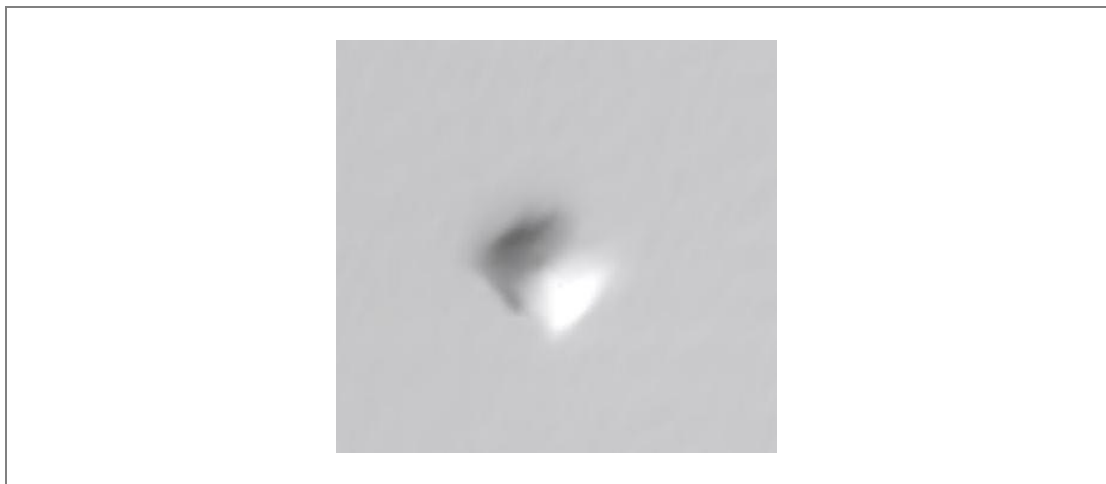
The intensity of shadows (darker areas) and highlights (lighter areas) can vary as a surface changes shape, such variations being referred to as gradients. Humans are able to derive 3D information from 2D gradient (shadow and highlight) cues. These are termed monocular depth cues. Figure 5 provides an example of a 2D image containing shadow and highlight gradients, which the observer can translate into an image of a 3D surface flaw.

**Figure 5** 2D image of a 3D surface flaw

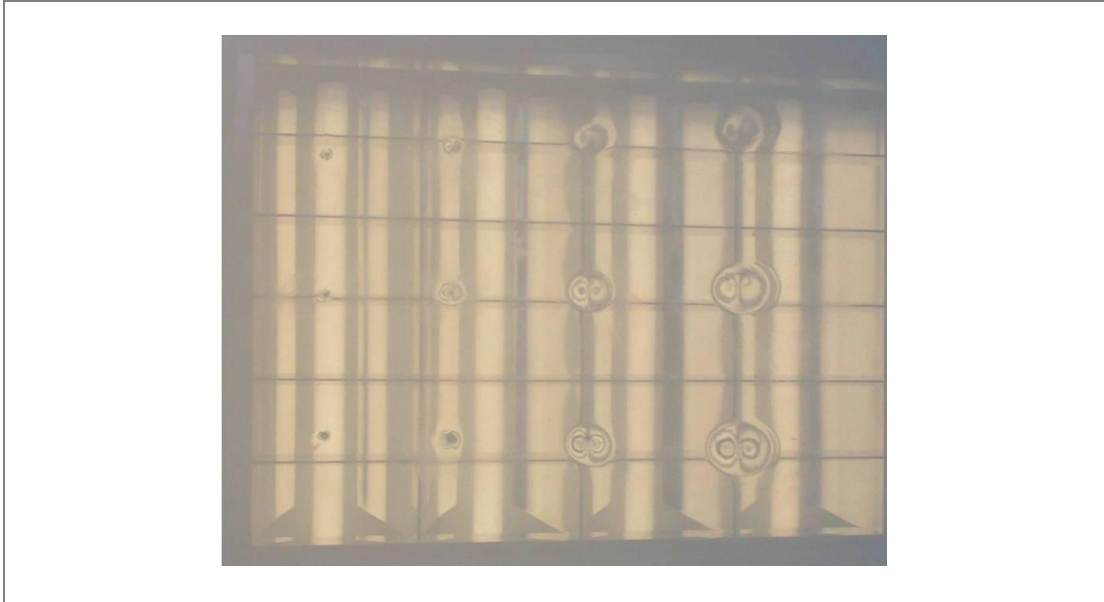
Humans are able to identify distortions in reflections of light, which also provide depth cues to the eye. Figure 6 illustrates the patterns of light reflected by a glossy surface containing several circular, hemi-spherically shaped surface flaws. The flaws are identifiable because they distort the reflection of grid pattern of the lighting luminaire (light fitting reflection housing).

**Figure 6** Surface flaws producing distorted reflections

The reflections seen in Figure 6, and those of people seen on the aircraft in Figure 8, are specular reflections, i.e. they are reflected by the surface of the material. The shape of the surface flaw determines how it distorts these specular reflections – a deep, sharply contoured flaw will produce different distortions to a much wider, less deep, softer contoured flaw. Glossy materials will produce clear, mirror-like undistorted reflections of a light source or object, semi-matt materials will distort the reflections, and matt materials will not reflect a discernable image of the original object.

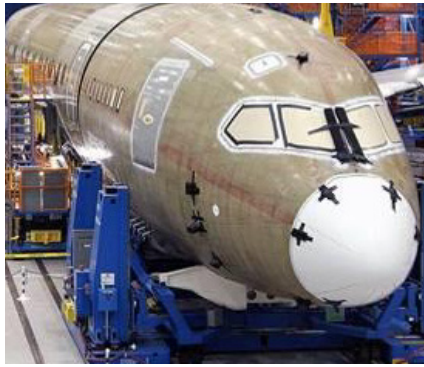
The majority of published literature [e.g. 7,8] on impact damaged composites refers to impact testing of unpainted laminates without a metal mesh. The appearance of the damage created would be seen on an aircraft only if it were to leave the factory without lightning strike mesh or paint, as seen in Figure 7. An aircraft inspector is more likely to be performing visual inspection of a fully finished aircraft, as seen in Figure 8.

**Figure 7** Unfinished structure of Boeing 787 aircraft\*

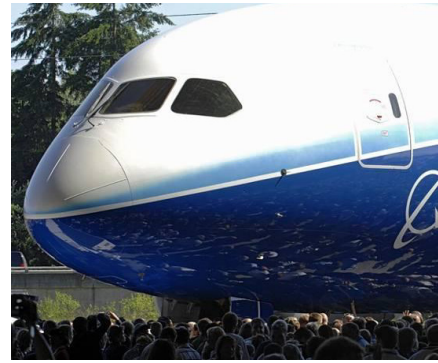
**Figure 8** Fully finished, painted Boeing 787 aircraft\*

A surface flaw produced by impact may have a different shape and appearance on a fully finished aircraft compared with that on an unpainted laminate without a mesh. Furthermore, as seen in Figure 8, in-service aircraft may be painted in a range of different colours. The flaw shape and size, the surface colour, and the surface finish may all affect the visual appearance of a surface flaw. Depth cues provided by a surface flaw on an unpainted laminate without a mesh may have little relevance to those provided by a painted laminate with mesh incorporated,

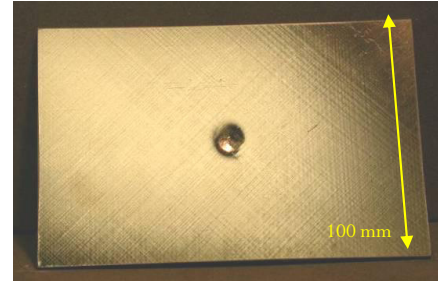
**Figure 11** 20 mm impact at 20 J on 17 ply unpainted produced a deeper, jagged edged surface flaw

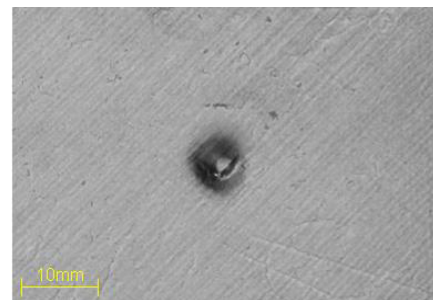
**Figure 13** 15 J, 20 mm impact on 17 ply unpainted laminate produced a less jagged flaw than in Figure 12 that also exhibited surface cracking

The shape of surface flaws produced by impact with a 20 mm hemispherical tup was similar on painted and unpainted laminates. However, on unpainted laminates the impact caused the upper plies to split, with small surface cracks evident, as seen in Figure 13. Cracks were not visible on the painted laminate, shown in Figure 12.

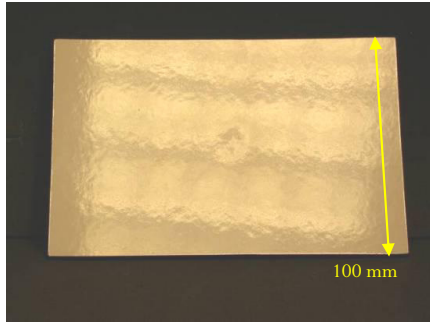
**Figure 18** 15 J, wedge shaped impactor on 17 ply painted laminate produced a small depression in surface

The appearance of surface flaws produced by the wedge shaped impactor on painted laminates (Figure 18), and unpainted laminates (Figure 19), was similar in shape. However, on unpainted laminates, the impact caused the upper plies to split, with small surface cracks becoming evident as seen in Figure 19. Typical visual appearance of surface flaws is of a small, rectangular impression, which at higher impact energies became surrounded by a shallow depression.

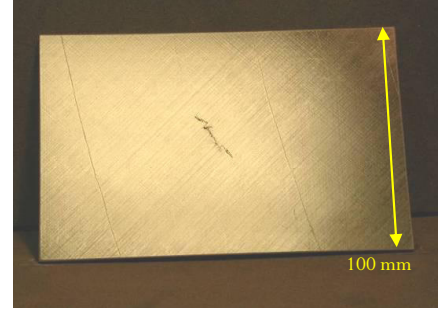
**Figure 19** 15 J, wedge shaped impactor on 17 ply unpainted laminate produced a small depression and surface cracking

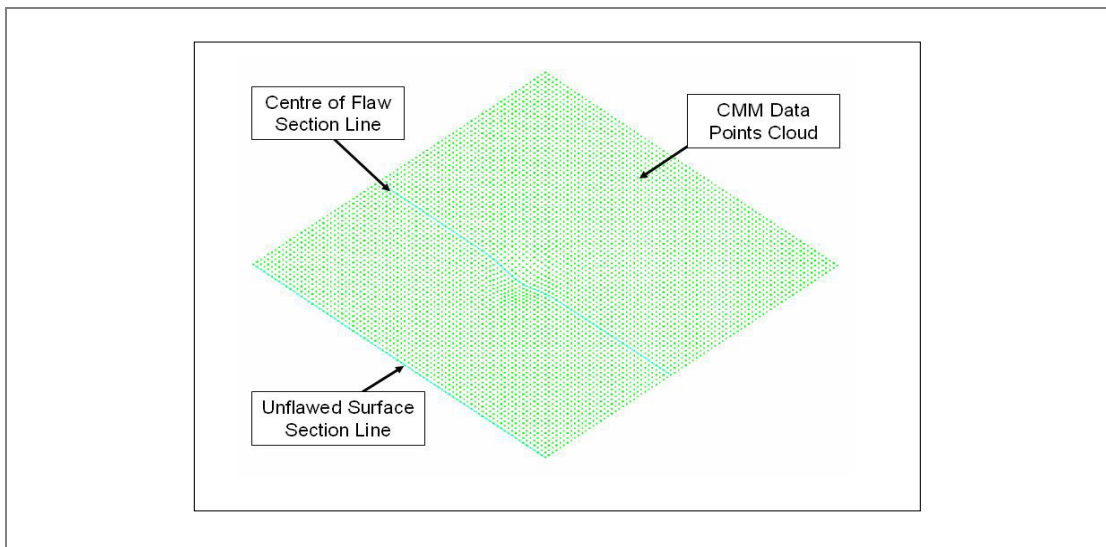
For each of the surface flaws, the series of points representing the profile through the surface flaw centre, and a series of points on the coupon surface close to the flaw area were identified within the CMM point cloud data (see Figure 21) by producing section lines through the points cloud. Once these two sections were isolated within the CMM points cloud, the other section lines were removed leaving only two section lines as seen in Figure 22.

**Figure 21** Section line positions on CMM data points cloud

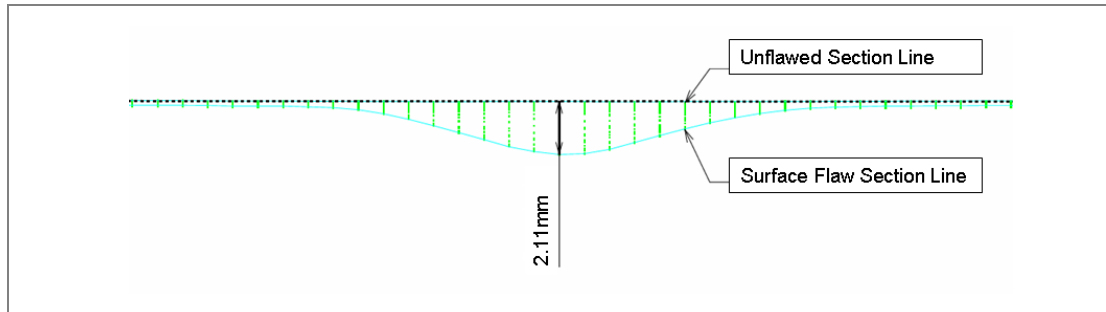
Vertical Z depth measurements were made every 1 mm along the line (Figure 22). The Z depth measurements were taken along a second flat section made through the coupon surface outside of the flaw area. The Z depth measurements were placed into a spreadsheet, as with the depth gauge measurements. This allowed comparisons to be made between the data obtained by the two measurement methods.

**Figure 22** CAD drawing of data obtained from 2.11 mm deep surface flaw using CMM machine, vertical data lines are 1 mm spacing

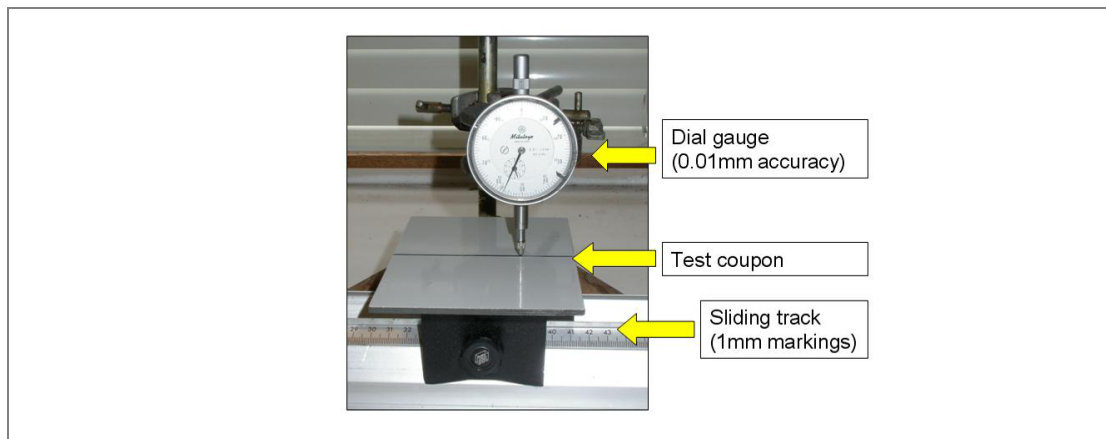
Depth measurements were made across the 100 mm width of the surface of each impact damaged coupon, through the centre of the surface flaw, at 5 mm intervals in undamaged areas and at 1 mm intervals within the flawed area, using a dial gauge (0.01 mm accuracy) and a sliding track (see Figure 23).

**Figure 23** Dial gauge depth measuring setup

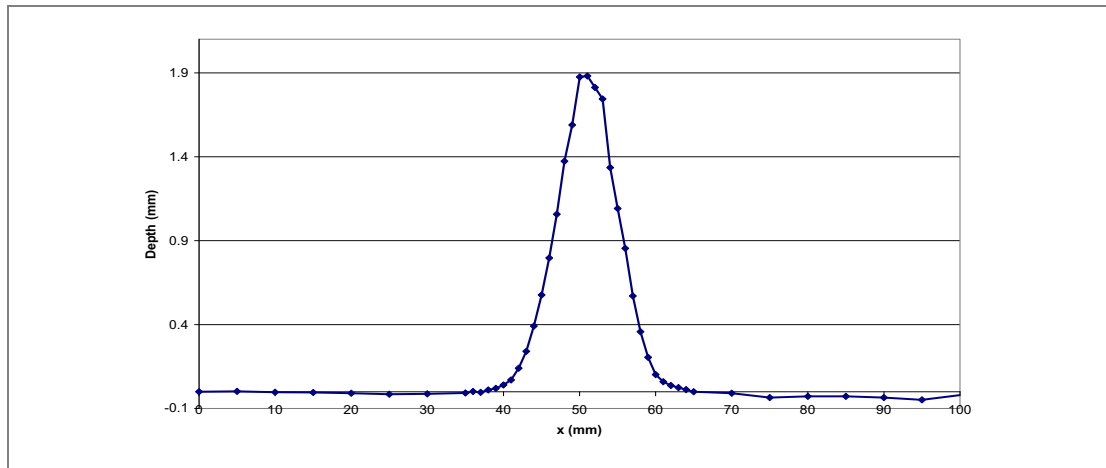
**Figure 24** Example profile of section through surface flaw produced from depth gauge measurements.

Figure 24 illustrates an example of the flaw profile resulting from a 30 J impact with a 20 mm impactor on a 17 ply painted laminate. The maximum flaw depth could be obtained directly from the maximum deflection of the dial gauge. Flaw width was more difficult to measure as the depth profiles exhibited some small change in surface position even at several mm from the approximate edge of the defect. To define the width of the flaw as the point where zero surface deflection occurred would result in a width occupying a much larger portion of the test sample than was evident in the visual appearance of the defect. To obtain a flaw width relevant to the visual appearance the following procedure was followed.

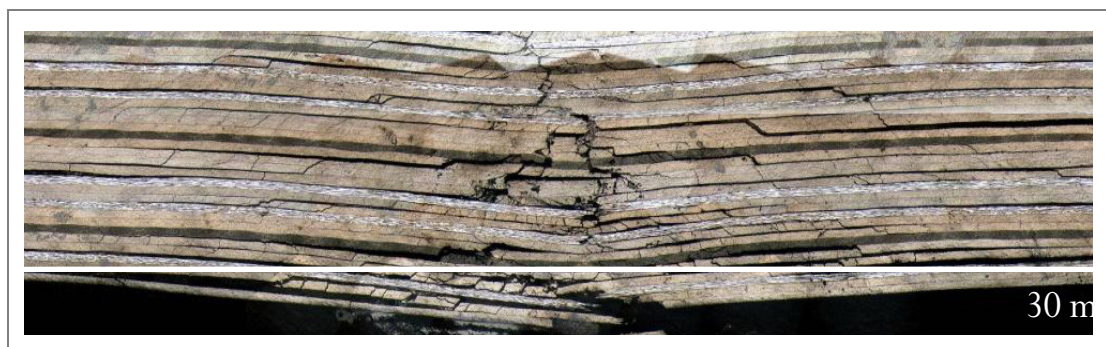
**Figure 25** Section through 50 J, 20 mm impact on 33 ply painted, mesh covered laminate

A microscope fitted with a digital camera was used to take multiple small photograph images of the finished sections. The 3 mm x 3 mm images were then combined into a composite image (example shown in Figure 25) giving a view through the 30 mm section of damaged laminate. From these composite images, it is possible to see the sectional profile of the surface flaw, and the extent of the subsurface damage. Furthermore, it is easy to visualise the severity of the subsurface damage compared to the relatively small size of the surface flaw.

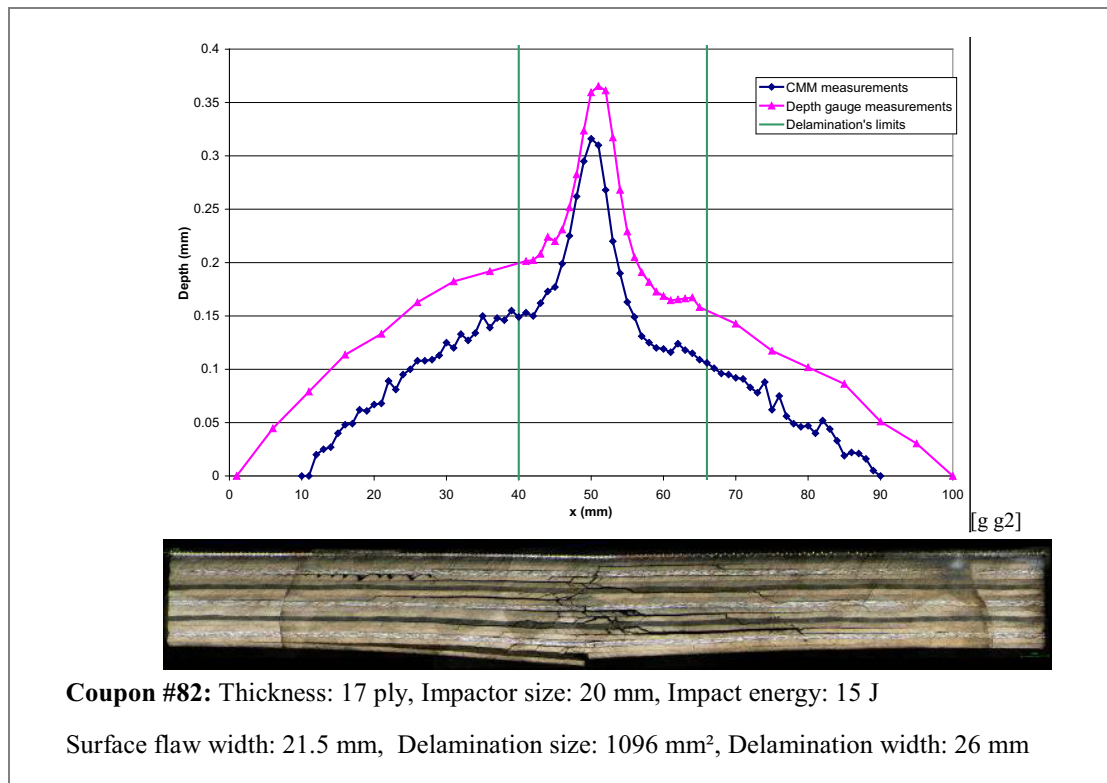
**Figure 27** Section graph, section photograph and measurement data for surface flaw on Coupon #82

The results of the C-scan, depth gauge and CMM work for the set of 12 surface flaws [9], were combined into graphs, to show the surface flaw sectional profile and subsurface damage width for each flaw. Examples are given in Figures 26–29. Where a surface flaw was too small for width measurement, no value is given.

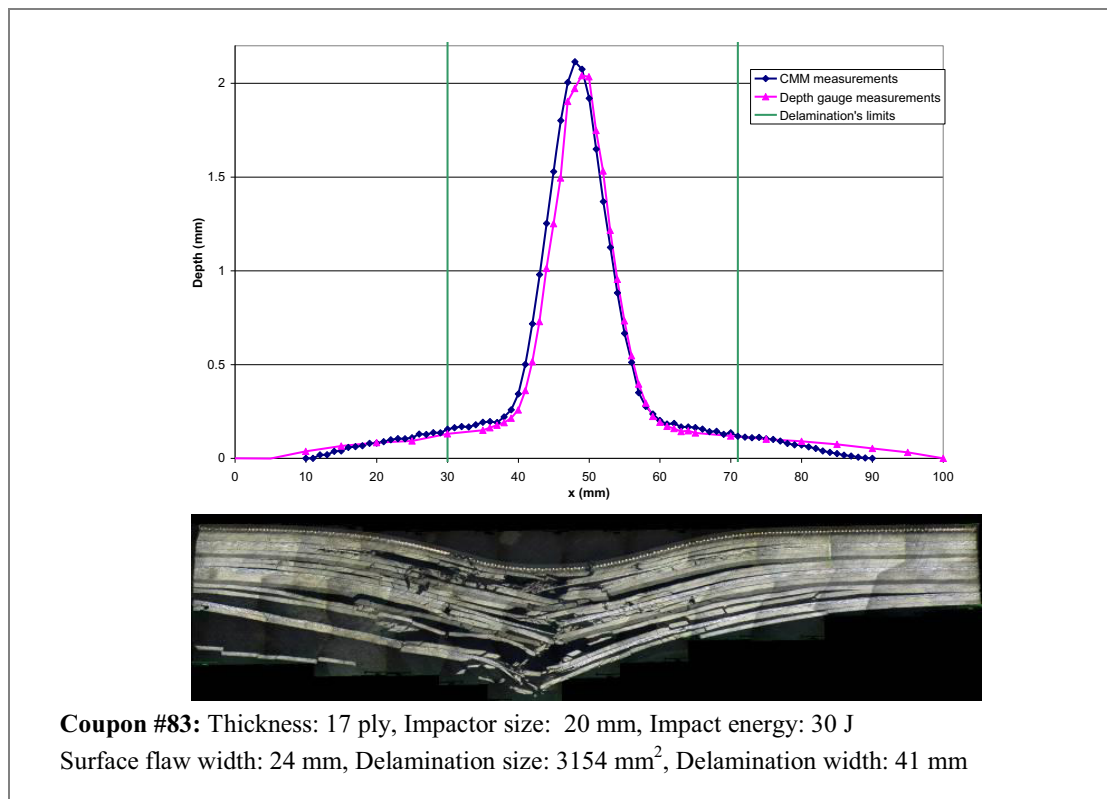
**Figure 28** Section graph, section photograph and measurement data for surface flaw on Coupon #83

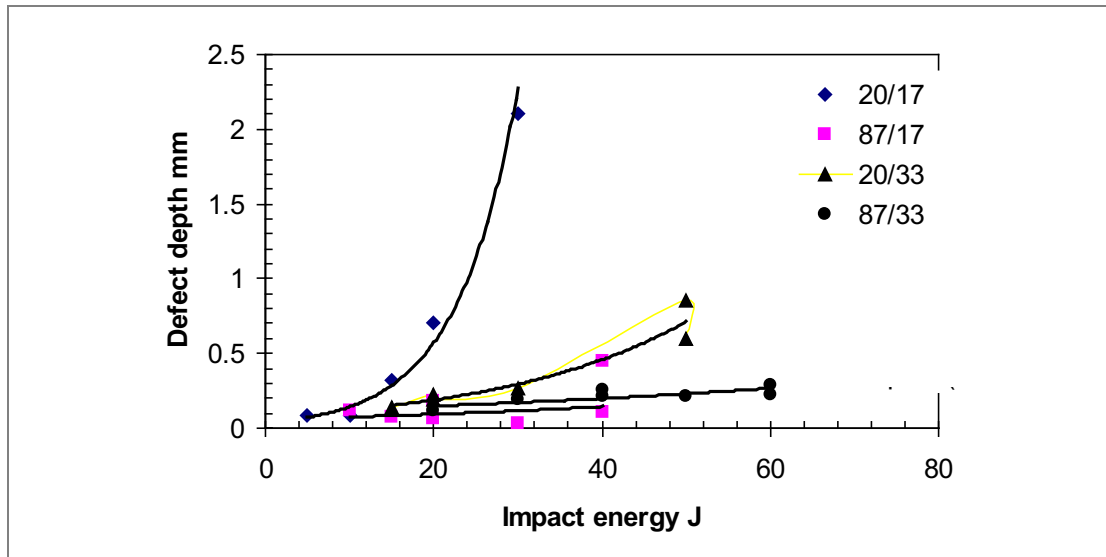
**Figure 30** Plot of impact energy vs. flaw depth for the 4 laminate and impactor diameter combinations

It can be seen that the relation between impact energy and flaw depth can be represented as 4 families of points, each representing one of the 4 variants. Each curve characterises the relation between impact energy and flaw depth for the particular combination of laminate thickness (17 or 33 ply) and impactor diameter (20 or 87 mm). There are similar relations between impact energy and flaw width, but as can be seen in Figure 31 the relation is much more approximate with considerable scatter in data points. This increased scatter in width is almost certainly a consequence of the difficulties in measuring and defining defect width. There is no definite boundary to the edge of the defect and the defect surface gradually merges with the undamaged part of the laminate.

From the data in Table 2, it is possible to observe that for higher energy levels (>20J) the delamination area measured on the C scan can be significantly larger than the flaw area calculated from  $(width/2)^2$ . The results for coupon 69 and 86 both illustrate this to good effect. The delamination width for coupon 69 is almost 3 times greater than the flaw width, and over 4 times greater for coupon 86. The data illustrate that lower energy impact damage can produce a 21.5 mm wide flaw (#82) that has less subsurface damage beneath than a 22.5 mm wide flaw (#86), due to the use of a differently shaped impact object. Furthermore, the flaw on coupon 68 is less wide than the flaw on coupon 66 (33 mm vs. 60 mm), yet coupon 68 received a lower energy impact and has similar delamination size to coupon 66. This illustrates that flaw width can depend on the shape and size of the impacting object. The relation between impact energy, defect depth and defect width for the four variants of impactor diameter (20 mm /87 mm) and two thicknesses of laminate (17 ply/ 33 ply) are shown in Figures 30 and 31.

Because of the difficulties of creating a selection of defects of reproducible geometry via impacts on composite laminates, it was decided to machine into facsimile samples a series of defects representative of size and geometry of the 4 families in Figures 30 and 31 above. The advantages of doing this are firstly that specific shapes and sizes can be accurately reproduced many times if necessary in samples of different colour and surface finish. Secondly noting that the defects in Figures 30 and 31 fall into 4 families, if the relation between impact energy and defect depth is known for each family, defects of size intermediate between impact data points can be created, independently of having performed an impact test under those conditions. This facility allows the visual inspection trials to be performed with selections of defect size optimised for each trial.

Figures 36 and 37 can be compared with Figures 30 and 31; both showing the relation between impact energy and flaw depth and width (radius = width/2 for Figure 36). The difference between them is that Figures 30 and 31 use directly measured width and depth data, whereas 36 and 37 show depth and radius derived from geometric variables fitted to the original flaw profile measurements. There are close similarities in the two sets for the depth measurements. In the case of the width (radius) measurements, there is significantly less scatter in the case of derived radius values than for the direct width measurements. This difference can be explained by the curve fitting process giving a more consistent representation of flaw width than was the case for direct measurement which as already noted was subject to significant measurement errors.

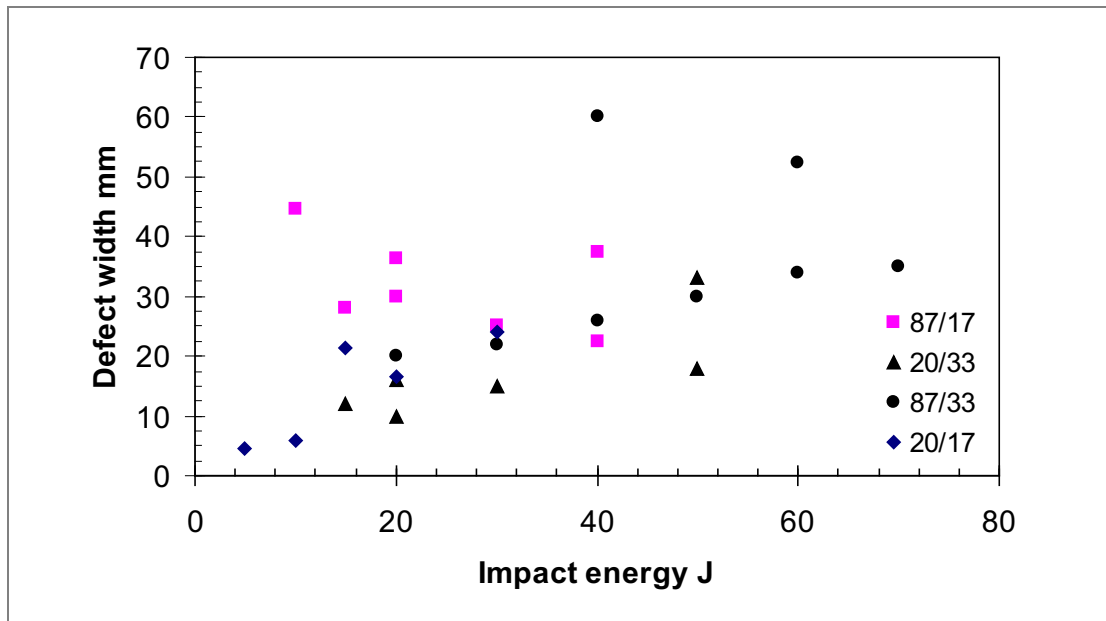
**Figure 31** Plot of impact energy vs. flaw width for the 4 laminate / impactor combinations

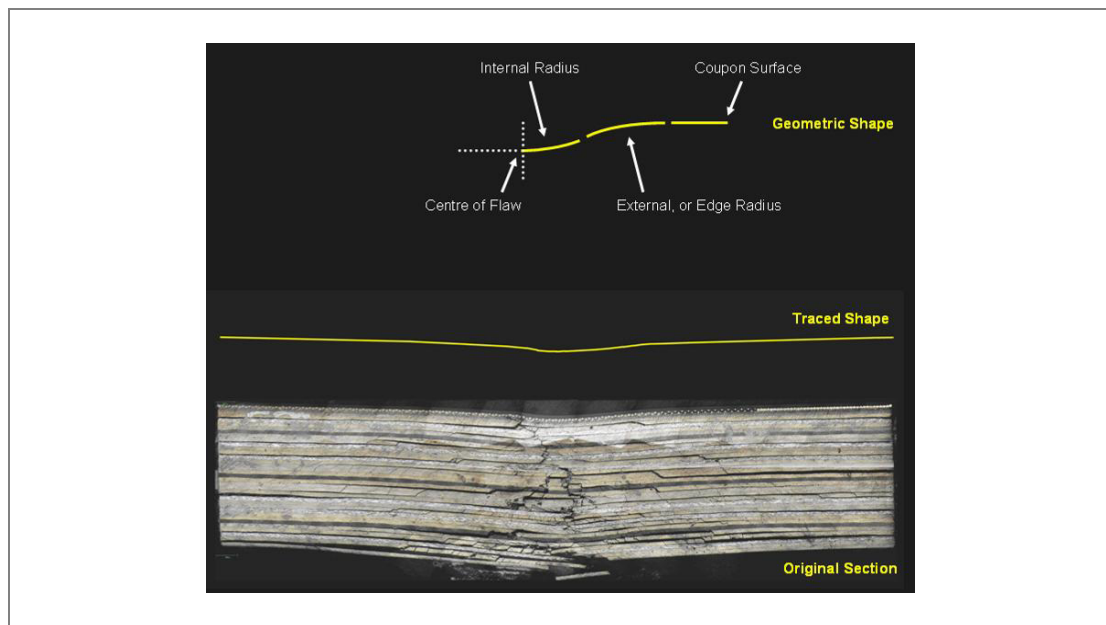
The flaw shapes in Figures 32 and 33 show a section through the surface flaw on an impact damaged coupon. Above the section photograph, a line is shown, which is a direct trace of the surface flaw. It was possible to draw the traced flaw shape using geometric, or parametric lines Figure 34 illustrates the way in which section lines through a surface flaw were constructed using geometric variables to define the section shape. These parameters were used to characterise the sectional profile of each surface flaw.

**Figure 32** 20 mm/50 J Surface flaw on a 33 ply coupon

The section lines through the CMM points data were created as splines, and were non-parametric, i.e. they have no geometric features such as radii within them. New geometric lines, as described in Figures 32 and 33 were overlaid to match the shape of the non-parametric surface flaw section lines. The geometric variables of the lines were adjusted until the geometric line fitted as best as possible to the original CMM points data (see Figure 35). From these fitted lines, it was possible to derive geometric variable values describing the original shape.

The two options discussed above concern the production of a multi-variable POD model, which would give visual inspection reliability as a function of surface flaw depth and width. However, each of the flaw geometry variables described in Figure 32 has the potential to affect visual inspection reliability by altering the level of shadow, shine and specular reflection distortion produced by the surface flaw. In order to develop a truly multi-variable model of visual inspection reliability, it is conceivable that a series of experiments in which a range of different flaw sizes, where only a single geometric variable is adjusted may be required.

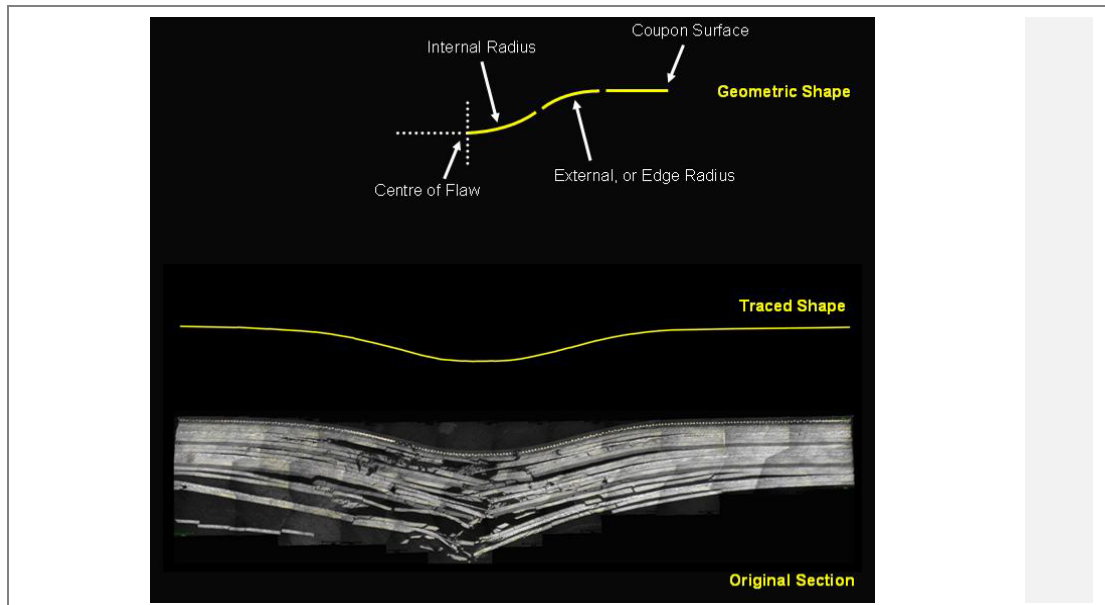
**Figure 33** 20 mm/ 30 J Surface flaw on a 17 ply Coupon

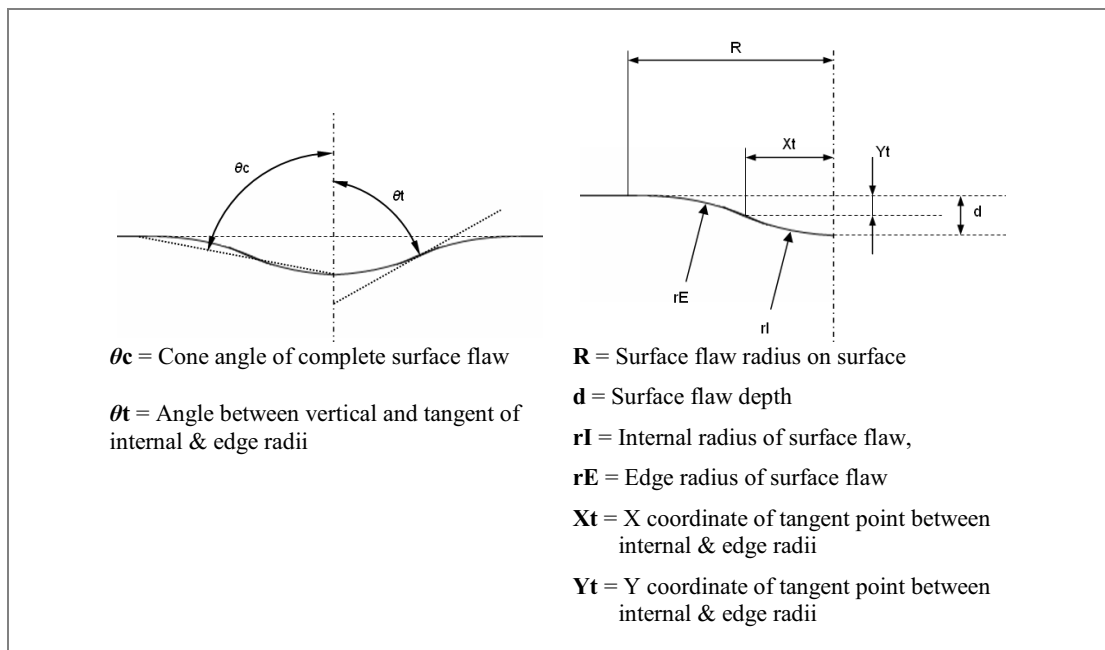
**Figure 34** Geometric variables used to reconstruct a surface flaw section

The sectional profile of surface flaws was recreated in a CATIA CAD system, by overlaying geometric lines, constructed using the variables in Figure 34, onto the CMM points data of the surface flaws.

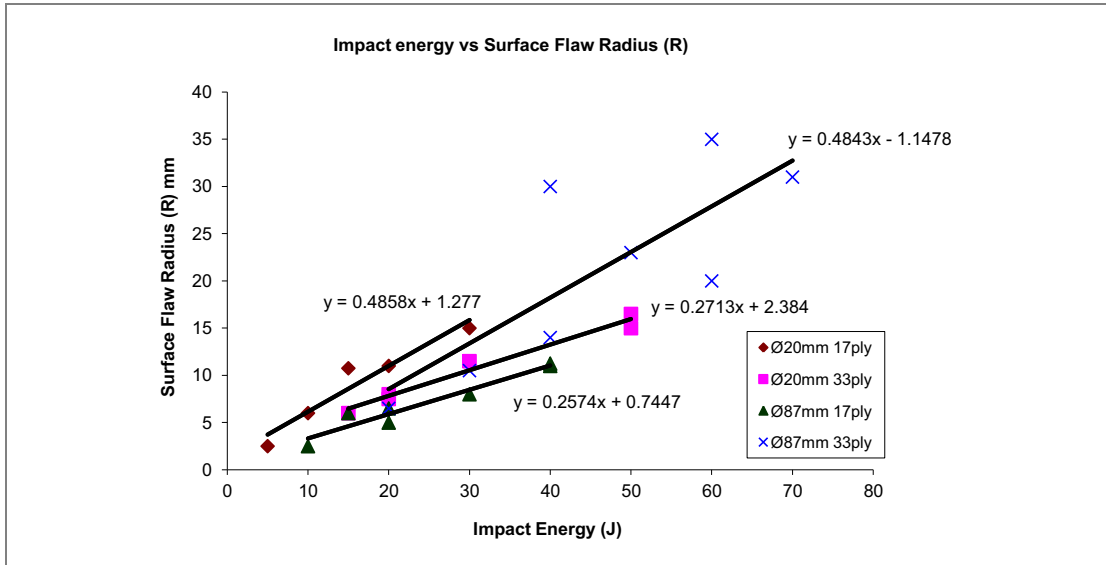
**Figure 36** Plot of impact energy vs. surface flaw radius with lines of best fit

The data in Table 3 were plotted so as to identify relationships between the geometric variables for each combination of ply thickness and impact diameter. Best-fit lines were constructed to the data points. Graphs describing flaw width vs. impact energy, depth vs. energy, width vs.  $Xt$  value, and depth vs.  $Yt$  value are shown in Figures 36 to 39.

Table 4 gives the equations of the lines obtained by the best fit-line method from Figures 36–39. Also given is the energy range for which the relationship remains valid. All the relationships are only valid for impacts greater than 4J; impacts below this

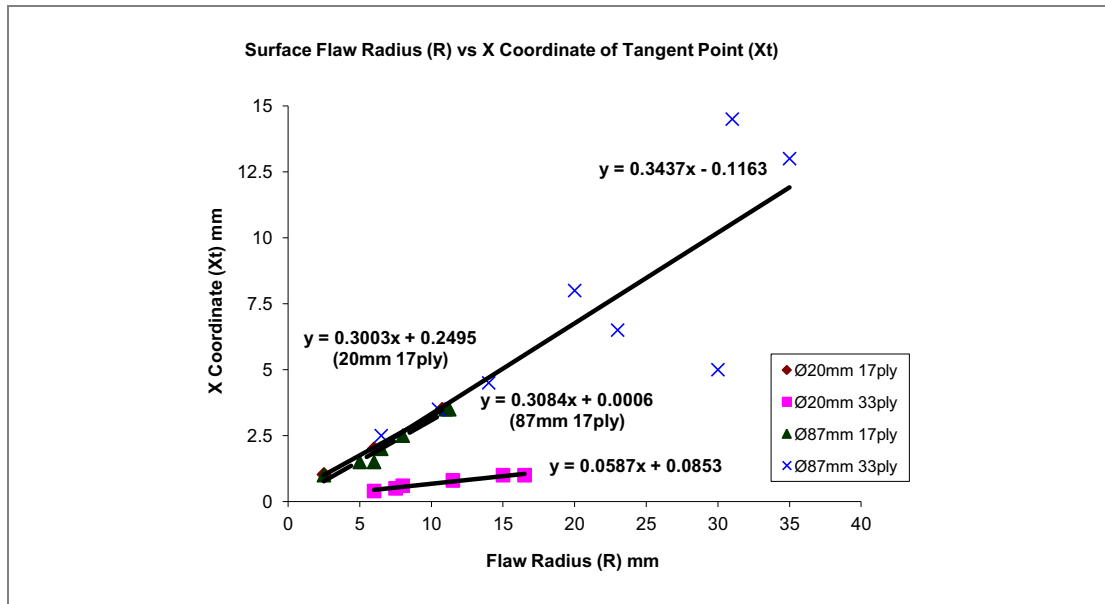
**Figure 38** Plot of surface flaw radius vs. Xt with lines of best fit

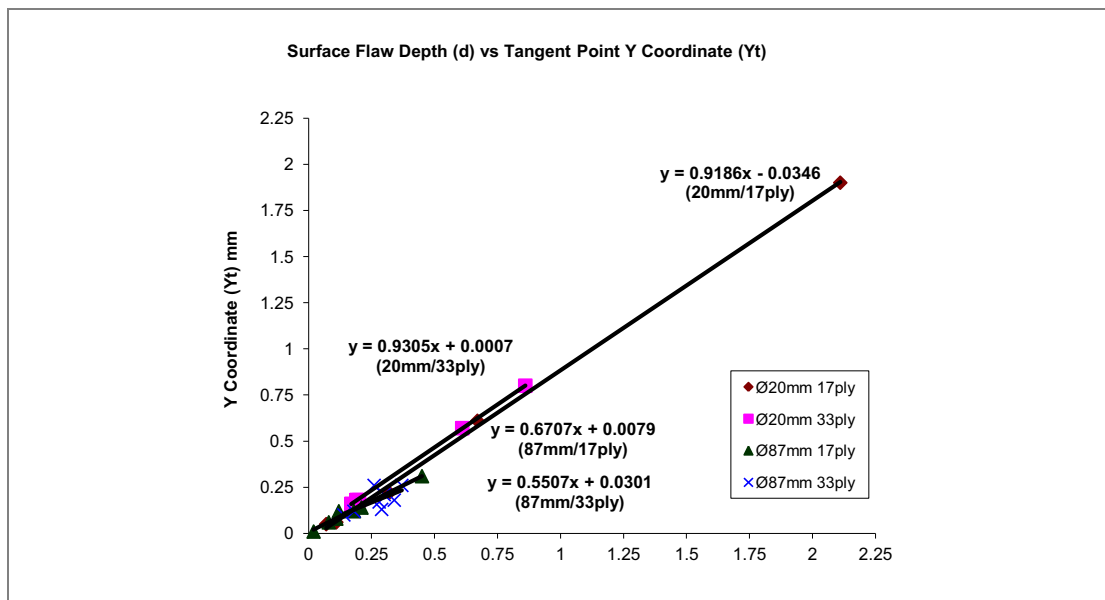
**Figure 39** Plot of surface flaw depth vs. Yt with lines of best fit

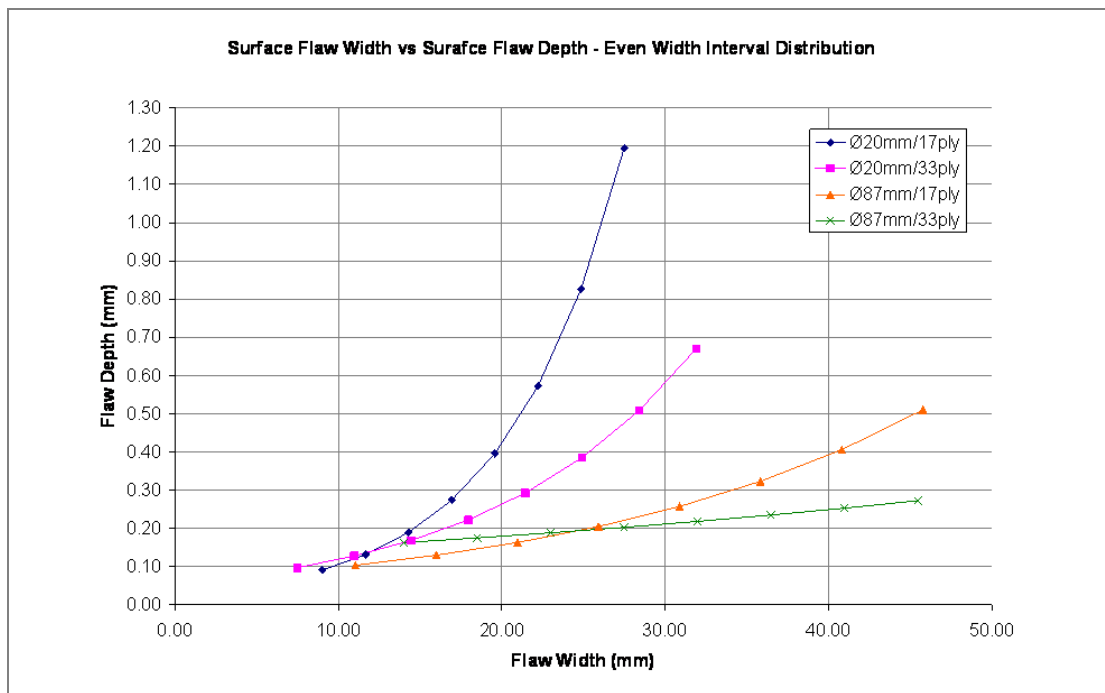
Using the widths in Table 5 and the relationships in Table 4 to calculate flaw depth, a graph of flaw width vs. flaw depth can be produced, as seen in Figure 40. When using an even width interval, there are 9 flaws greater than 30 mm wide, and 6 flaws that are deeper than 0.6 mm.

**Figure 40** Graph of flaw widths vs. flaw depths with even spacing between flaw widths

Using the same method as for the graph in Figure 40, the plot of flaw width vs. flaw depth seen in Figure 41 was produced using the flaw widths from Table 6. On this graph, it can be seen that with the new distribution, there are now only 4 flaws wider than 30 mm and there is only one flaw greater than 0.6 mm deep.

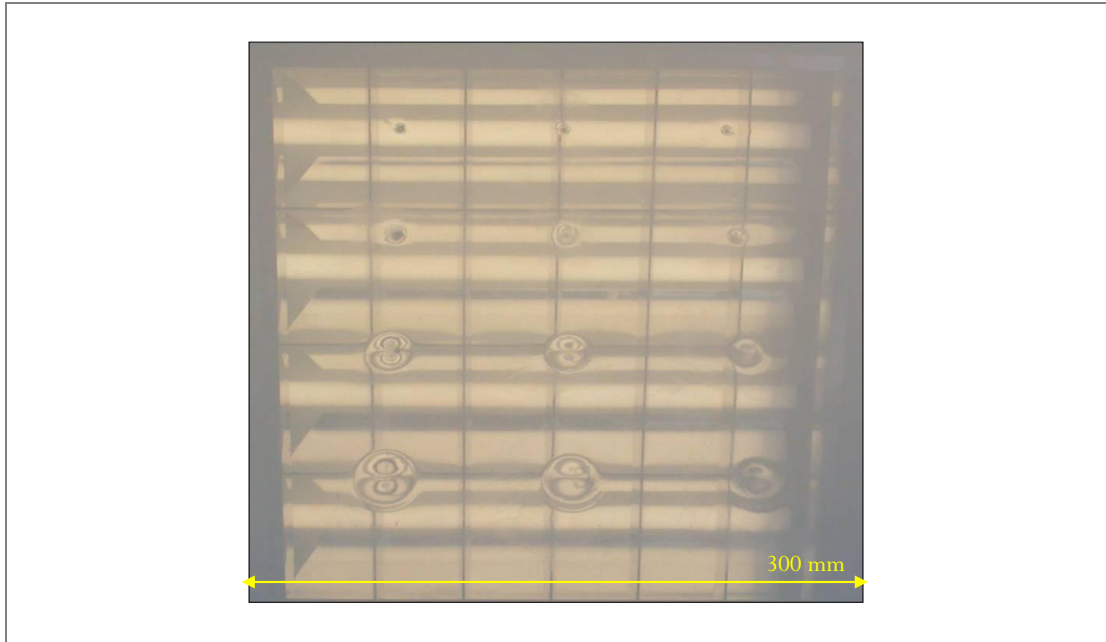
After NC machining the surface flaw into 3 mm thick Plexiglas panels, the flaw area was polished to return the flaw site to its original surface finish. Figure 44 illustrates a test piece that contains 12 surface flaws produced in this way, and can be compared with Figure 45 which shows a photograph of an actual impact damage surface flaw on a painted/mesh laminate.

**Figure 44** Test piece containing Surface flaws

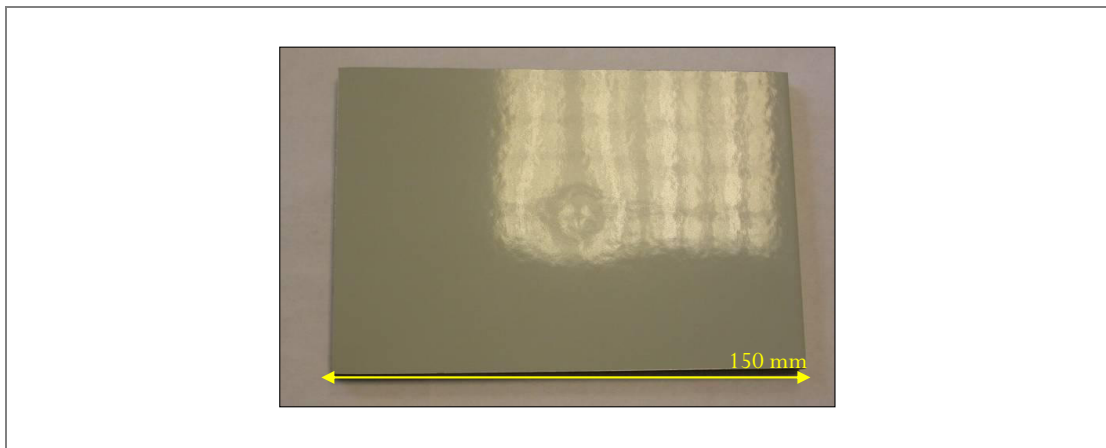
**Figure 45** Impact damage surface flaw on a painted/ bronze mesh CFRP laminate

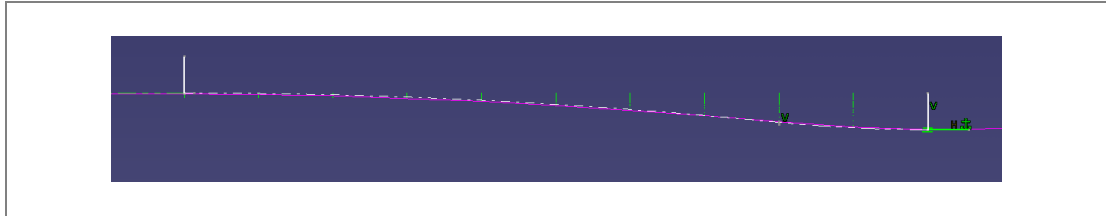
Five selected flaws on each colour of specimen underwent CMM measurement to check for conformity to the original specification. An example of a comparison between the CMM data, and the original flaw specification can be seen in Figure 46. The CMM data taken from the machined flaw run are barely distinguishable from the specified geometry.

**Figure 46** CMM data (pink solid line) and specified geometry (white dashed line) of 22.2 mm/ 0.57 mm deep NC machined surface flaw

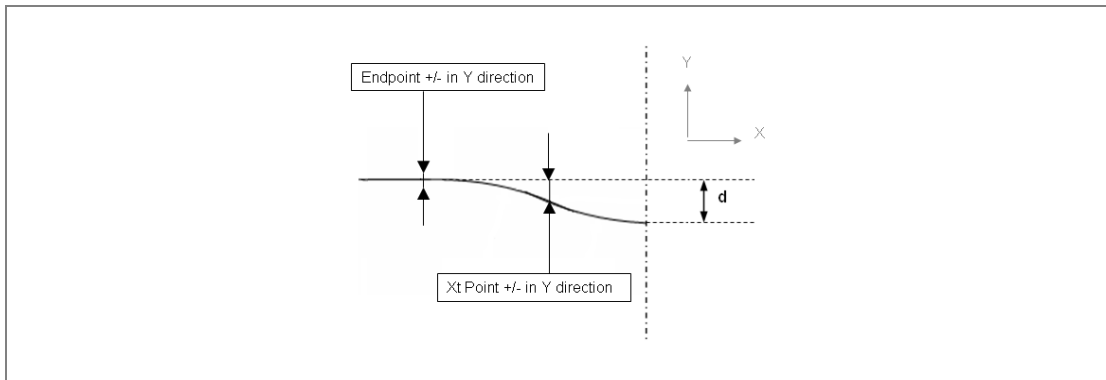
Three Y-Axis measurements of the CMM data were made using CATIA at the endpoint, the Xt point, and the centre point of the flaw, as shown in Figure 47. Table 9 details the findings. One can see in Table 9 that there was maximum average discrepancy across the different coloured panels of 15% on flaw #9 between the specified flaw depth, and the actual flaw depth (as obtained by subtracting the endpoint measurement from the total specified depth). However, the other flaws measured had an average depth discrepancy of less than 5%. The average discrepancy between the actual and specified depth at the Xt point was less than 10% for all surface flaws measured. The surface flaws were deemed to be within an acceptable tolerance of the original size specifications, and the overall shapes conformed to the design specification.

**Figure 47** Checking points for CMM data vs. original specification

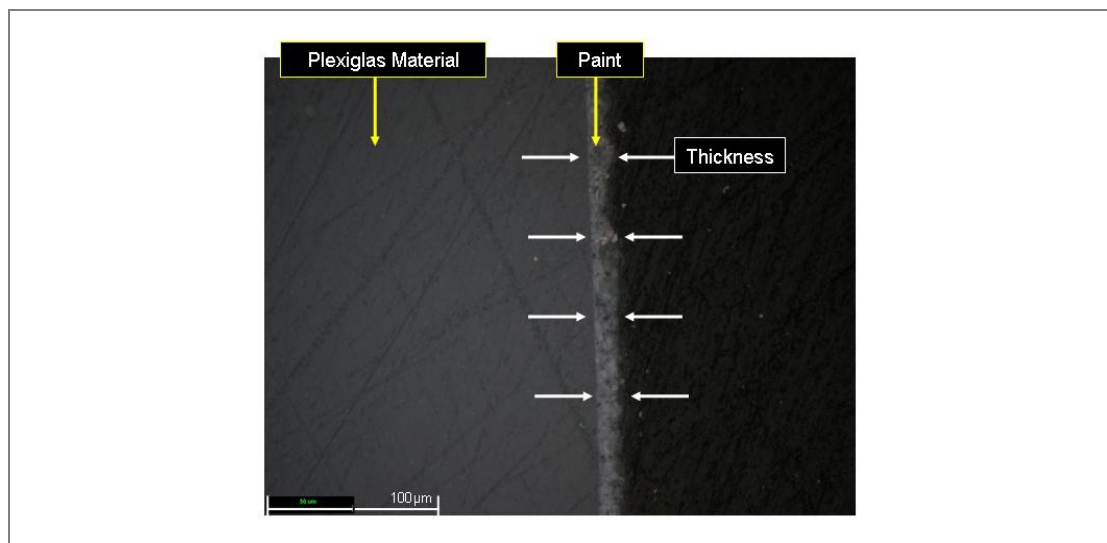
For the matt specimens, the thickness of the paint was measured. This was accomplished by metallographic sectioning of samples of a painted Plexiglas test piece. Figure 48 details the image obtained using a microscope. The measurement of the paint thickness was made using the microscope image processing software. The thickness was measured in several different places, and was found to be consistently within 12µm to 20µm, and therefore the defect geometry was not significantly influenced by the matt coating.

**Figure 48** Section of painted Plexiglas material used for thickness measurements

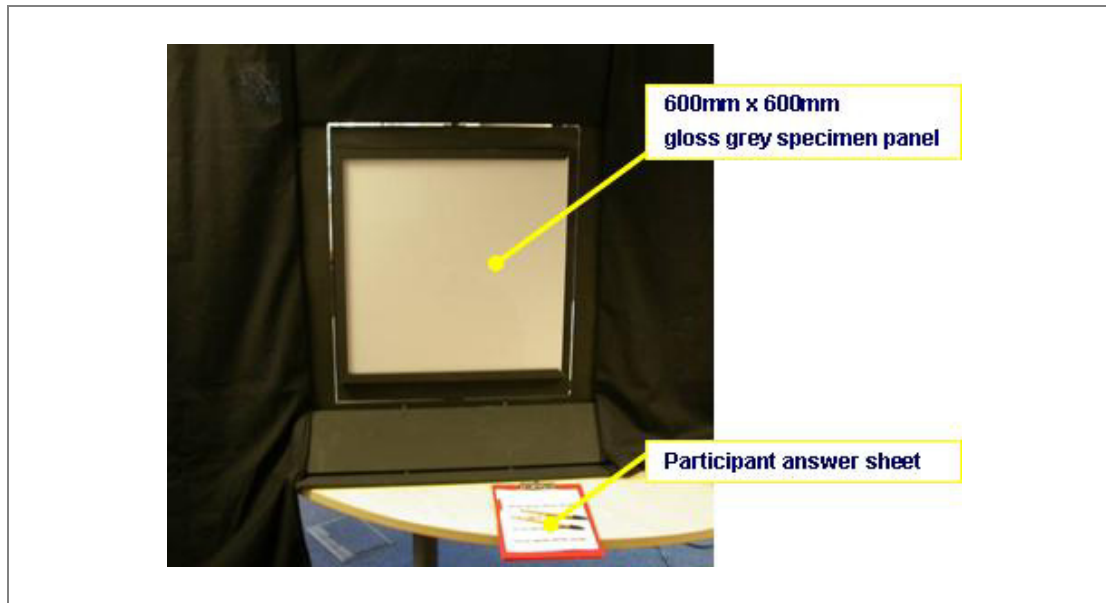
A pivoted display stand was used to display the specimens to the participants (see Figures 49 and 51). The design of the stand allowed the participants to inspect the panel, after which the operators swung the panel round and replaced it with the next specimen, without the participants seeing the changeover.

**Figure 49** Specimen display stand for visual inspection trials

Figures 49 and 50 show the inspection trials experiment as it was set up in the meeting room. The display stand was table mounted, and curtains attached to it in order to provide a screen behind which the personnel performed the panel changeover. A small, detachable display curtain hid the panels from view whilst they were swung into the inspection position.

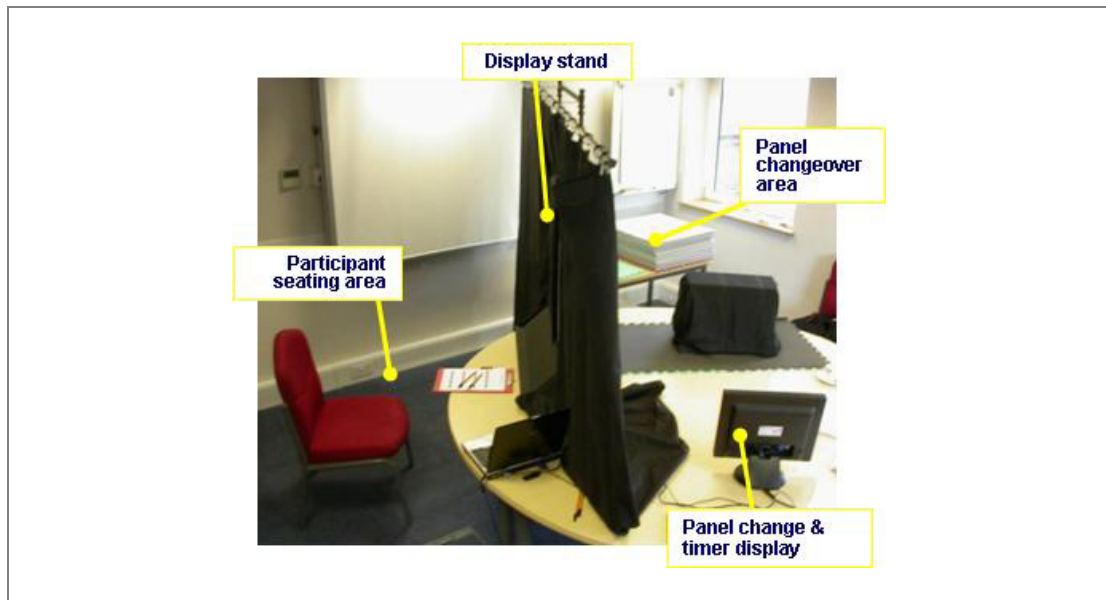
**Figure 50** Specimen display stand setup in meeting room

For the inspection trials with matt finish specimens, only 16 unflawed specimens were available. In order to display the 48 required unflawed specimens, the set of 16 unflawed specimens were displayed cyclically. The specimen sequence was displayed on the panel change screen (see Figure 50) for these trials, and the flawed and unflawed specimens were kept in separate piles. The changeover operator chose the correct flawed specimen, or an unflawed specimen, as instructed by the panel change screen. Prior to the first trial with a matt finish specimen set, the flawed specimens were stacked in the correct order in which the display screen would request their display for inspection. Upon removing a flawed specimen from the display stand, operator 2 restacked the flawed panels in the reverse order ready for the next trial, in which the display sequence reversed, as described for the gloss specimens. Two different timing presentations were used, one for forwards order trials and one for reverse order trials.
