**Safety Regulation Group**

**Paper 2013/03**

# **Reliability of Damage Detection in Advanced Composite Aircraft Structures**

**Prepared for CAA by:** L Cook  
A Boulic  
D Harris  
P Bellamy  
P E Irving  
**Cranfield University**

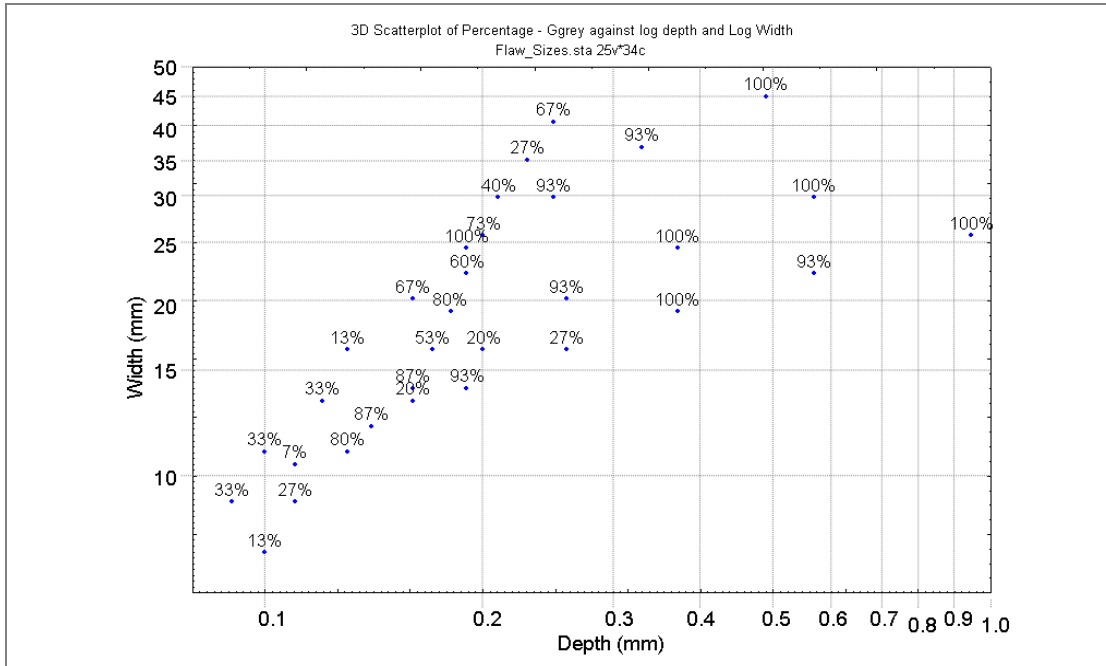
**Figure 59** Scatter plot of % of participants detecting each flaw vs. flaw depth and width for gloss grey specimens

A second method of presenting the results was to use Statistica statistical data analysis software [46] to produce scatter graphs, with the percentage of participants detecting each flaw plotted against the corresponding flaw depth and flaw width of each flaw (see Figures 59–64). A natural log scale is used for the X and Y-axis, allowing greater separation of individual data points at smaller values of width and depth. The scatter plots allowed the detection percentage for each flaw to be compared in terms of depth and width against the other flaws in the specimen set. For example, in Figure 59 it can be seen that on the gloss grey specimens, there is no clear correlation between flaw width and detection %. However, all flaws greater than 0.3 mm deep were detected by more than 90% of participants. On gloss grey specimens, there were instances of greater than 90% detection when flaws were below 0.3 mm. On gloss blue specimens, however, there were no instances of greater than 90% detection when flaw depth was below 0.3 mm.

The scatter plots were also useful for comparing the detectability of individual flaws across the range of surface colours and finishes. For example, it can be seen that the detection of the 44.7 mm/ 0.49 mm deep flaw varied between 69% on gloss blue specimens and 100% on gloss grey specimens.

All of the plots in Figures 59–64 have a number of similar features, differing in detail with changes in sample colour and surface finish. At small values of depth and width percent detections are low and approach zero. The lower limit of the data is at flaws of 0.1 mm depth and 10 mm width. The upper limit of data is at dents approaching 1 mm deep and 30-40 mm wide. Detections approached 100% for these large flaws. The extent of the region of 90-100% detections changed depending on the colour and

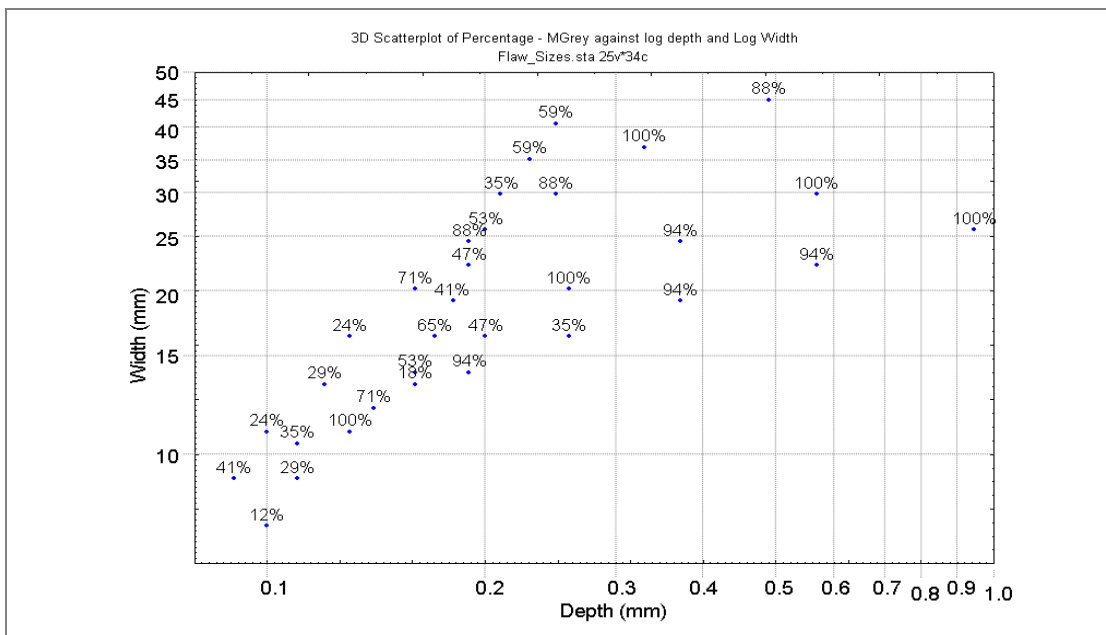
**Figure 60** Scatter plot of % of participants detecting each flaw vs. flaw depth and width for matt grey specimens

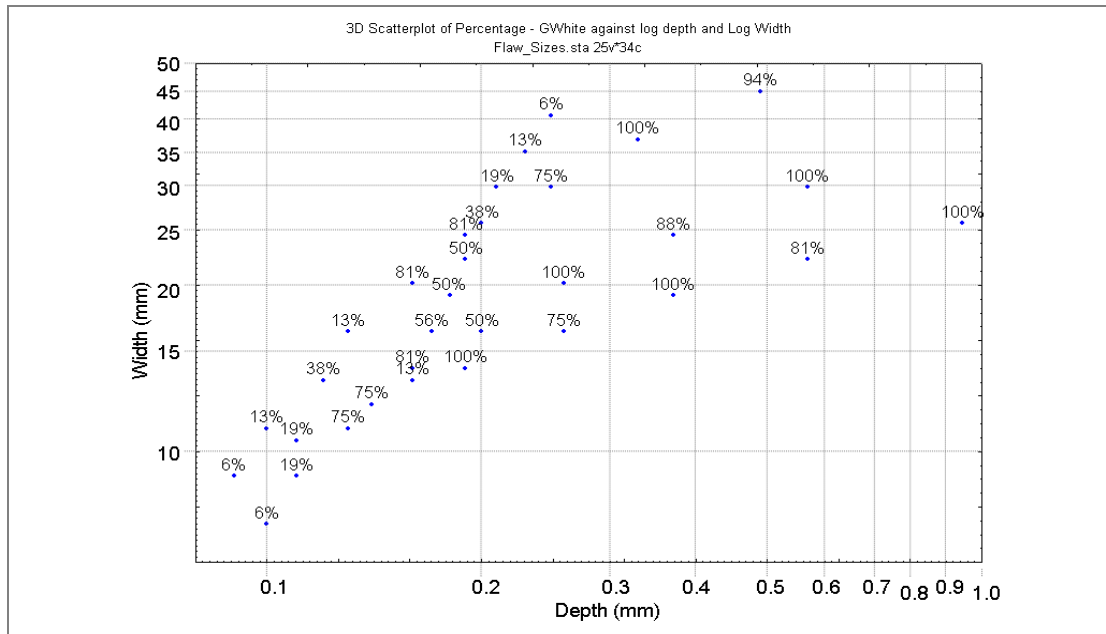
**Figure 61** Scatter plot of % of participants detecting each flaw vs. flaw depth and width for gloss white specimens

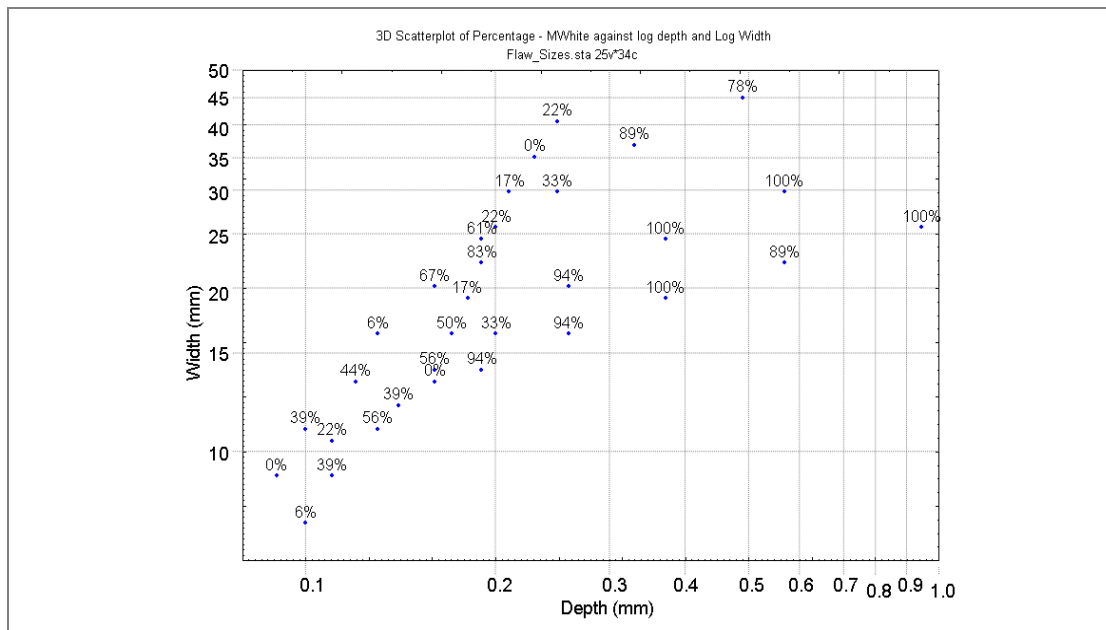
**Figure 62** Scatter plot of % of participants detecting each flaw vs. flaw depth and width for matt white specimens

When viewing the scatter plots, it became apparent that the levels of detection percentage appeared to form bands, or contours, of constant detectability. In order to explore the possibility of detectability bands further, the wafer plot function of Statistica was used to fit the scatter plots with contours representing percentage levels of detection. The wafer plots are shown in Figures 65–70. The wafer plots also use a natural log scale on the X and Y-axis. The contours on the wafer plots are best fit lines of constant detection percentage, and allowed changes in detection rates due to colour or finish to be easily identified. Furthermore, the effects of flaw width and depth on detection rates were easily visualised on the wafer plots.

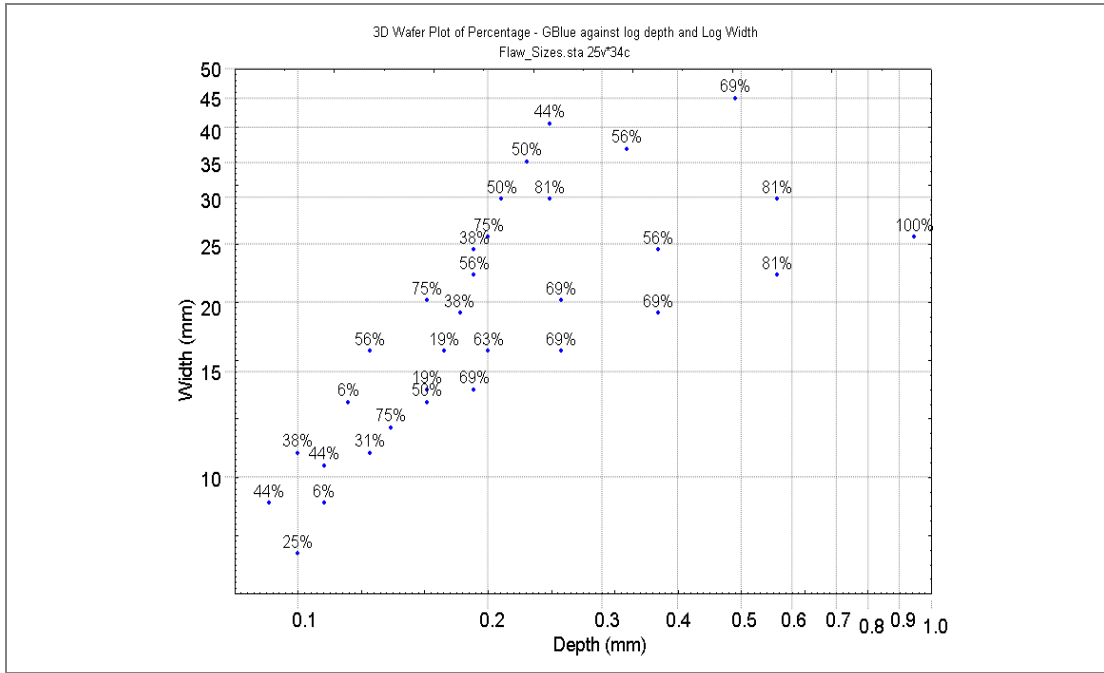
**Figure 63** Scatter plot of % of participants detecting each flaw vs. flaw depth and width for gloss blue specimens

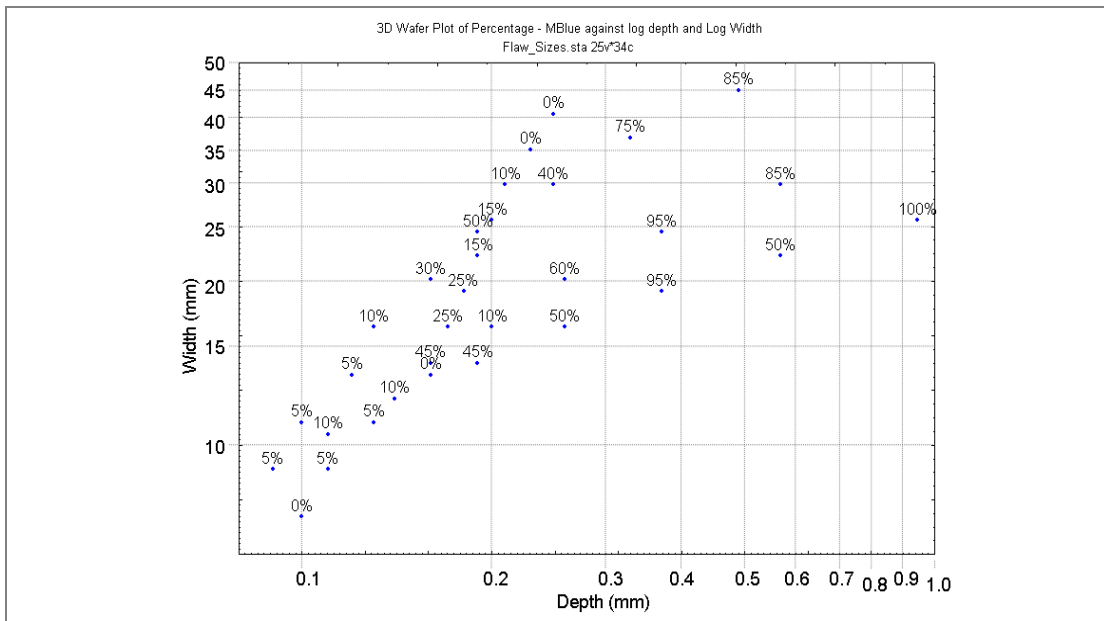
**Figure 64** Scatter plot of % of participants detecting each flaw vs. flaw depth and width for matt blue specimens

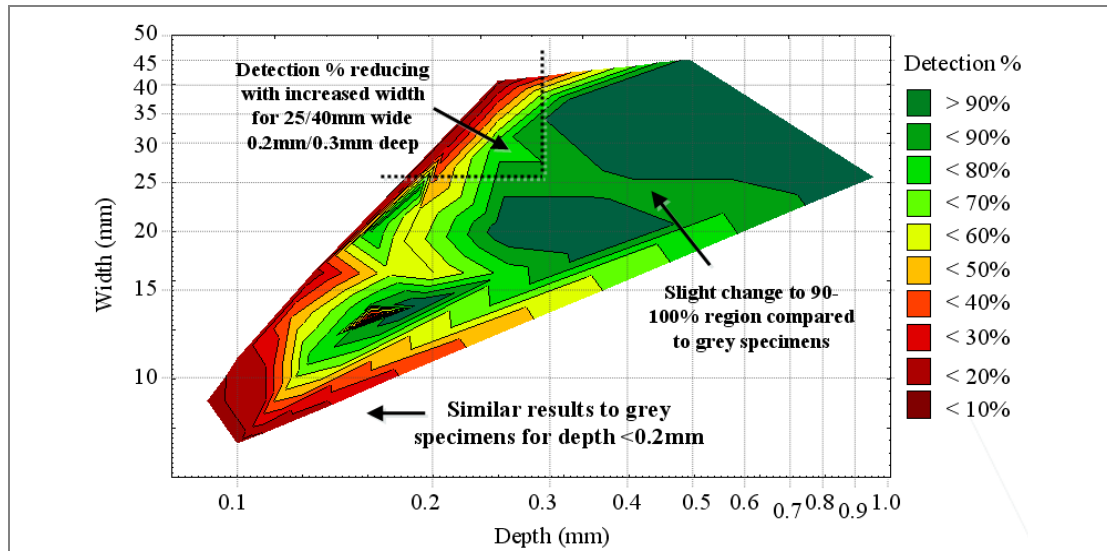
In Figure 67, the wafer plot of the gloss white specimens illustrates that there are some differences compared to the results with grey specimens. The large area of 90-100% detection has changed shape slightly. For flaws between 0.2 mm - 0.3 mm deep, and >25 mm wide, the detection percentage reduces as width increases. However, for flaws below 0.2 mm deep, there is little difference to the detection contours compared to the gloss and matt grey results. This implies that there are slight differences in detection rates on gloss white specimens compared to gloss and matt grey specimens.

**Figure 67** Wafer plot of gloss white results with comments

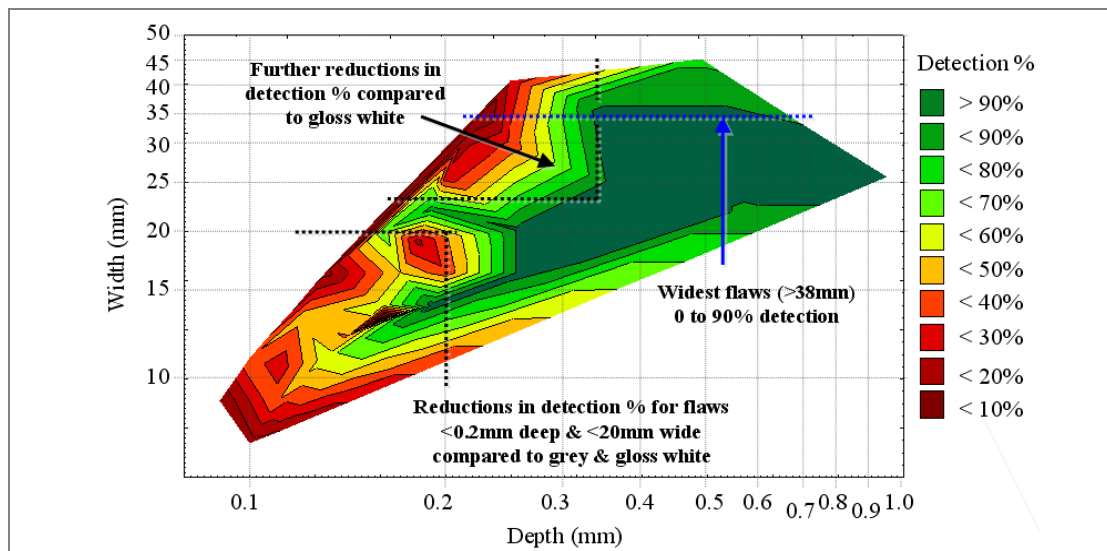
In Figure 68, which shows the results from matt white specimens, there are notable differences to the contour shapes found in the gloss white results. The large area of >90% detection has changed shape, and no longer includes flaws wider than 38 mm. The detection of flaws >38 mm wide now varies from <10% to >90% depending on flaw depth. For the flaws between 0.2 mm and 0.3 mm deep and >25 mm wide, there is greater variation in detection rates compared to the same region on the gloss white results. Detection of flaws <0.2 mm deep and <20 mm wide saw reduced rates on the matt white specimens compared to the gloss grey and white, and matt grey specimens. The results seen in Figure 68 imply that the matt finish altered detection rates on the white specimens.

**Figure 68** Wafer plot of matt white results with comments

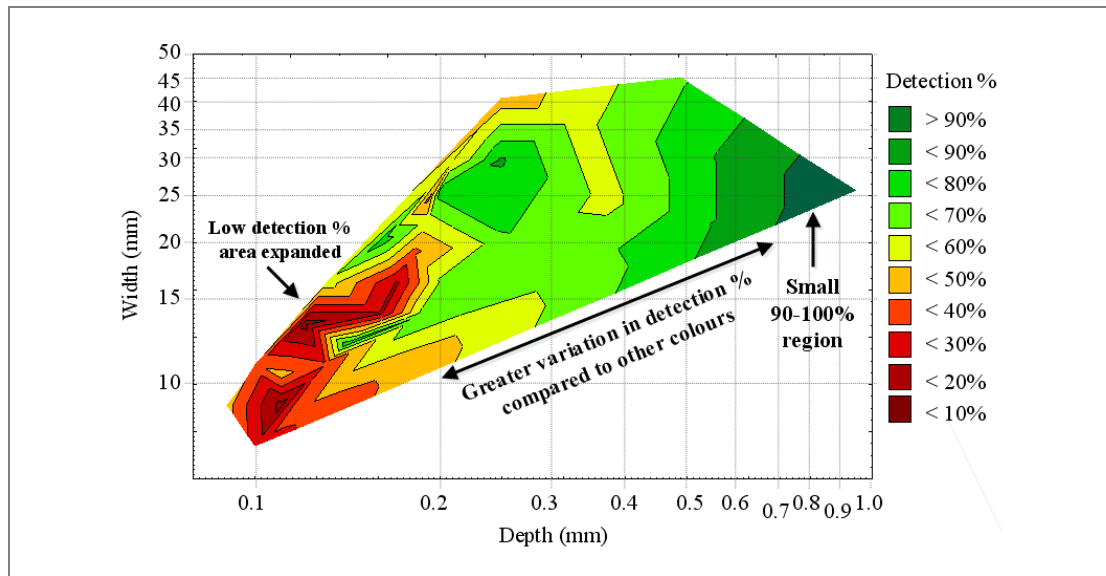
Figure 69 shows the results obtained from the gloss blue specimens. In this plot, it can be seen that there is a significantly different shape to the detection contours compared to the results from grey and white specimens. The lower limit of the region of >90% detection has shifted to 0.7 mm deep compared to that of the grey and white results (0.25 mm deep). The detection contours for flaws >0.2 mm vary less with flaw width than on the other plots (fig 69-72 and 73). For the gloss blue specimens, detection varies mostly with flaw depth. The area of low detection percentage (<30%) covers a larger width and depth range on the gloss blue results compared to the grey and white results. From the plot in Figure 69, it can be seen that different detection results are obtained from gloss blue specimens than from grey and white specimens.

**Figure 69** Wafer plot of gloss blue results with comments

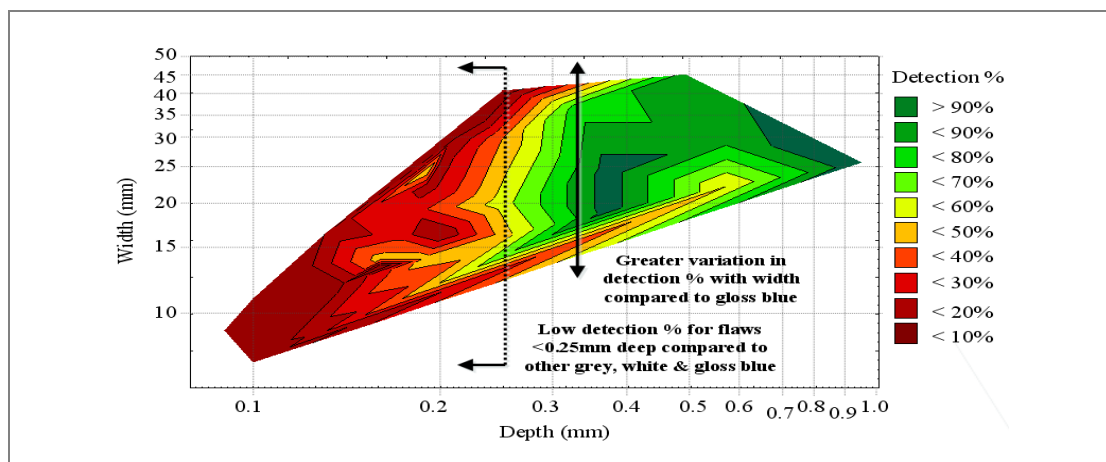
Figure 70 illustrates the results from the matt blue specimens. It can be seen in Figure 70 that there is greater variation in detection percentage with width than on gloss blue specimens. It can also be seen that detection of flaws with <0.3 mm depth is reduced to below 50%. The results seen in Figure 70 imply that a matt blue finish gives different detection results to a gloss blue finish.

**Figure 70** Wafer plot of matt blue results with comments

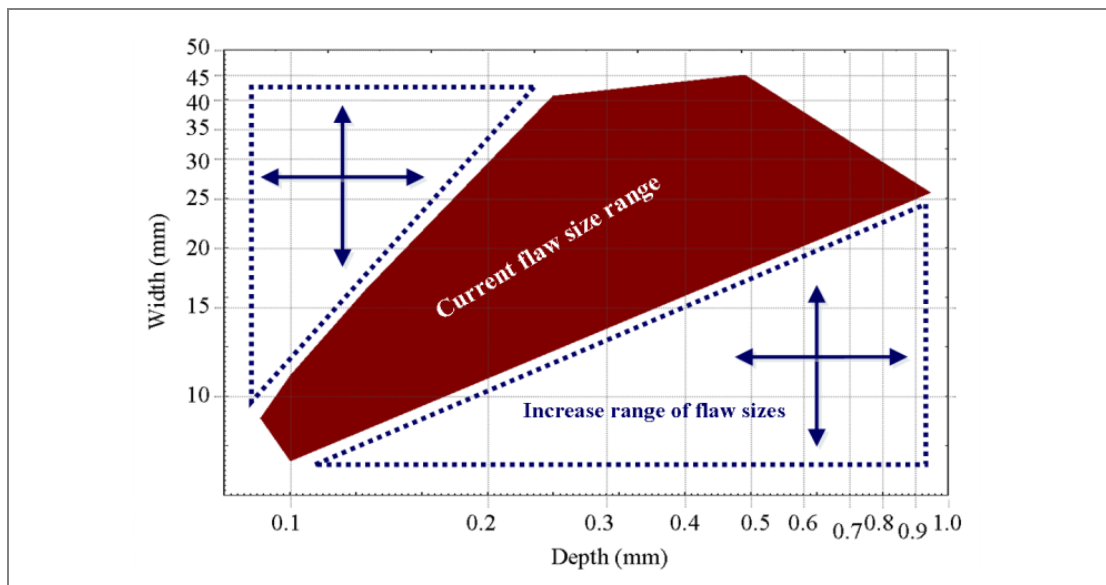
The flaws used in this study represented impact damage that occurred due to impacts from a 20 mm and 87 mm hemi-spherical object on a 17 ply and 33 ply painted, mesh incorporated laminate. As seen in Figure 71, this results in a flaw size and shape range that occupies only a selection of possible flaw depths and widths. Flaw sizes outside of this range could conceivably be produced by impact objects of different sizes, or on different laminate thicknesses to those used in this study. Future work should include an extension to the range of geometries studied so that the additional areas shown in Figure 69 are included.

**Figure 71** Illustration of flaw size range used in study, and possible additional range of flaw geometries which could be studied

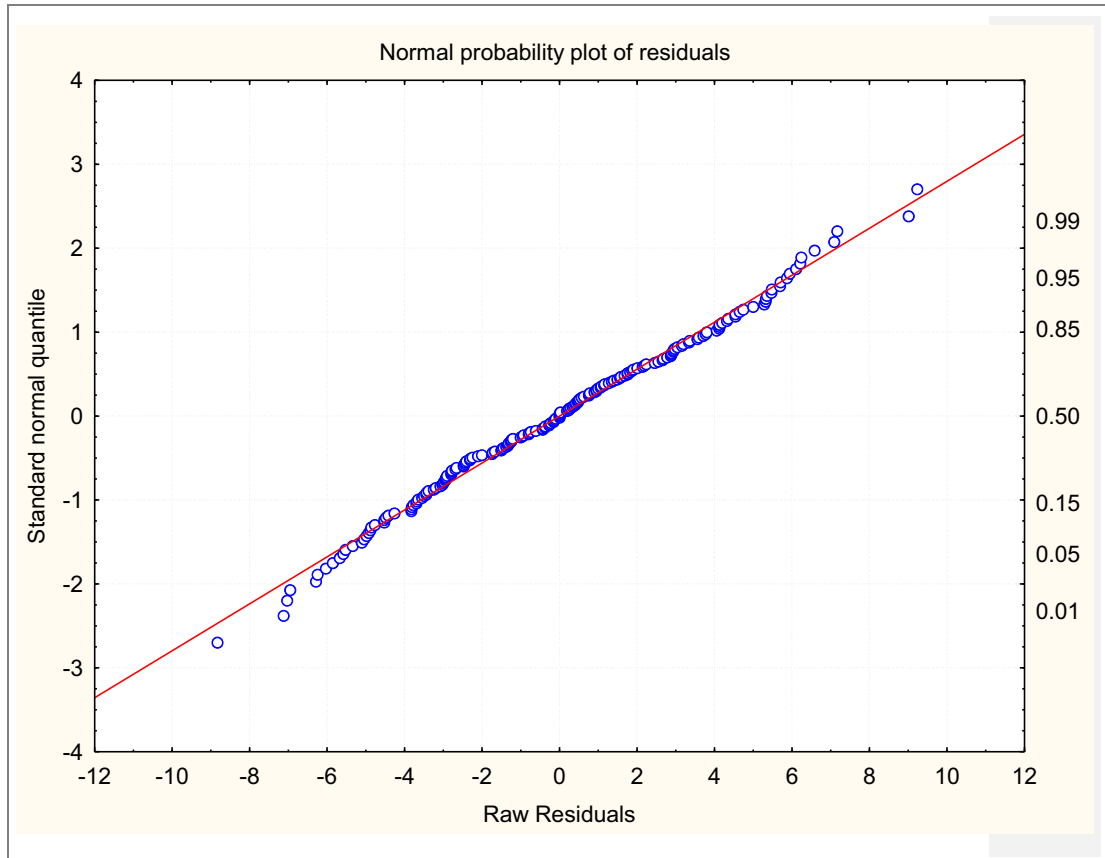
**Figure 72** Plot of standard normal quantile vs residuals for all the inspection data contained in Appendix 3, showing a close adherence to a normal distribution

Blue, Grey), panel surface finish (Gloss or Matt), impactor diameter (20 mm or 87 mm) and laminate thickness (17 ply or 33 ply). All interactions between these categorical descriptors were included. Some of the parameters will not be independent variables in that the flaw width and depth will depend on the ply thickness and the impactor diameter. Table 13 shows the significant effects identified. This is equivalent to an analysis of variance table but as a non-linear model is being fitted to the data, the same exact techniques to estimate the effects cannot be used using maximum likelihood estimation. A significant p value ( $p < 0.05$ ) indicates that there is a significant effect of the parameter in question. Figure 72 shows that the fit of the data to the model is reasonable as the residuals follow a normal distribution. This is indicated by the close adherence of the data to a straight line as shown in Figure 72.

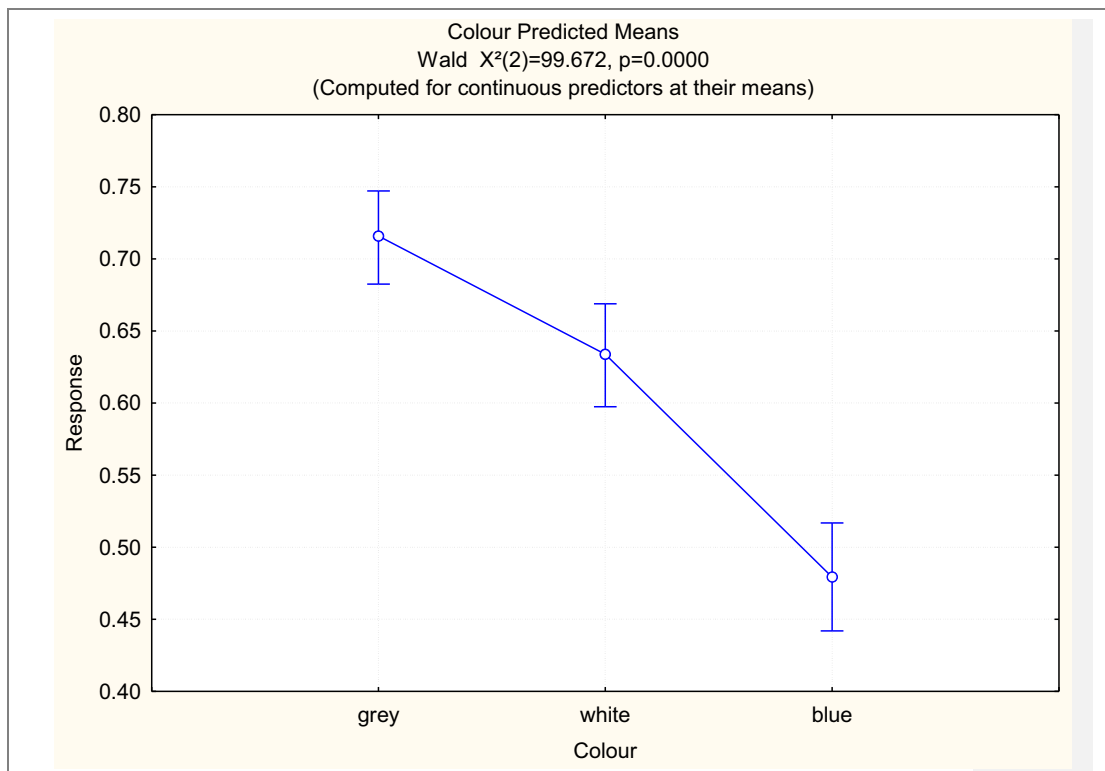
Figure 73 shows that detection probability is greatest in grey samples and is reduced almost by half in the blue ones. White samples have intermediate values.

**Figure 73** Effect of sample colour on probability of defect detection; both surface finishes combined; mean width and depth defect sizes.

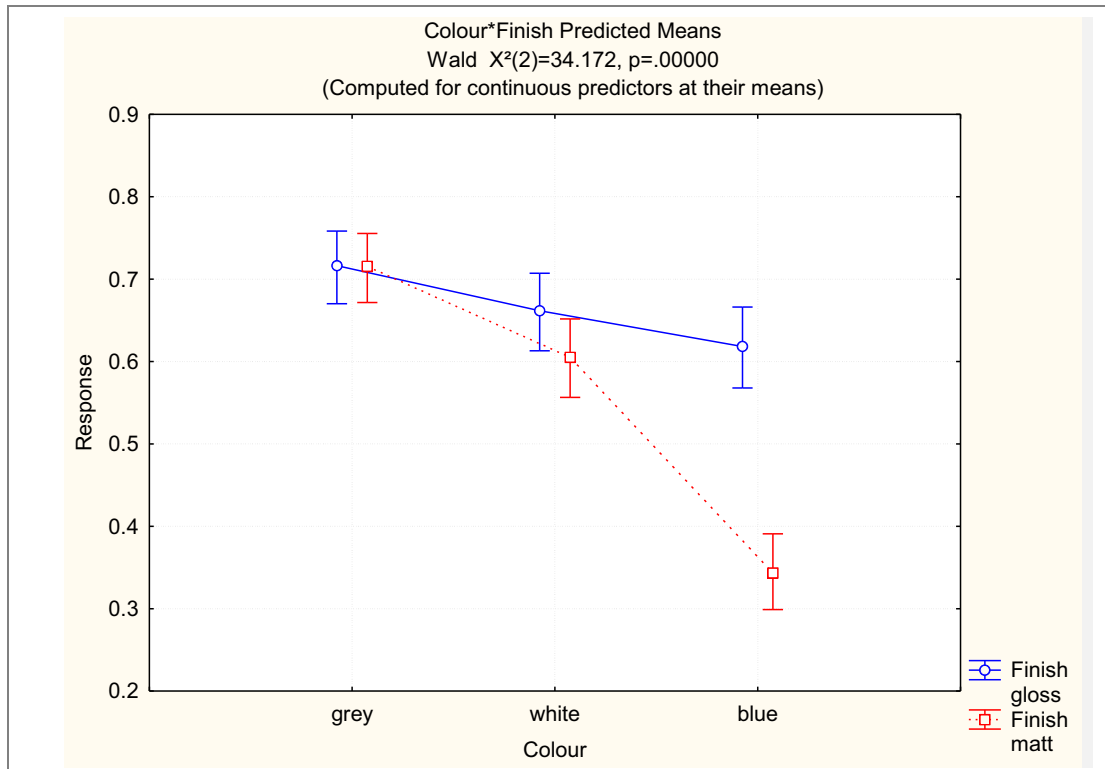
Figure 75 shows the effects of colour and surface finish with their effects considered separately. In this more detailed representation it can be seen that for grey samples there is no significant effect of surface finish, a slight effect for the white- still not statistically significant, and a major effect of surface finish for the blue samples. In the blue samples a matt surface finish reduces the detection probability by a factor of 2. there is still some small effect of colour on detection probability in the gloss surfaces, with blue once again having the lowest probability of detection. All these effects are considered at the mean values of defect depth and width.

**Figure 75** Effects of sample colour and surface finish on probability of defect detection; colour and surface finish separated; flaw width and depth at mean values

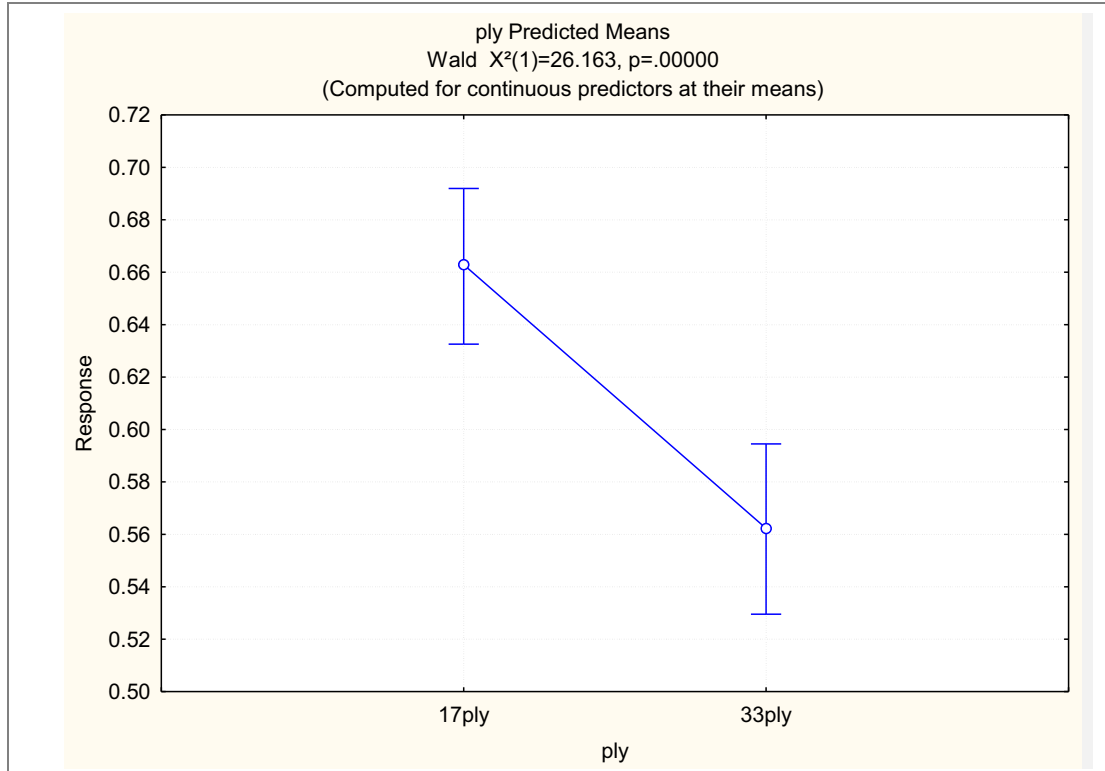
There is a significant effect of ply thickness as Figure 76 shows. However ply thickness will influence defect shape particularly defect width as Figure 41 demonstrates. Hence this effect is a manifestation of the effect of defect width on detection probability.

**Figure 76** Effect of impact sample thickness on detection probability; all colours and surface finishes combined; mean values of defect depth and width

Graphs are shown only for those effects that were significant in Table 13. They are easy to interpret except perhaps for the two interaction effects. Colour\*finish is looking at how the differences in probability of detection between the two surface finishes varies across the 3 colours – so Figure 76 shows that there is a significant difference in the detection probability of the two finishes only in the blue colour. This difference (in the blue) is enough to give a significant difference in finish for the all colours plot (Figure 73). This shows how important it is to include interaction effects in statistical analysis. The other interaction that was significant was colour\* impactor diameter mm – in this case the effect of impactor diameter was not significant on its own. This interaction has been plotted in two ways (Figures 77 and 78) to help interpretation – it can be seen that there is no significant difference in the probability of detection between grey and white when surface flaws are formed by 20 mm impactors but there is a difference for 87 mm diameter impactors.

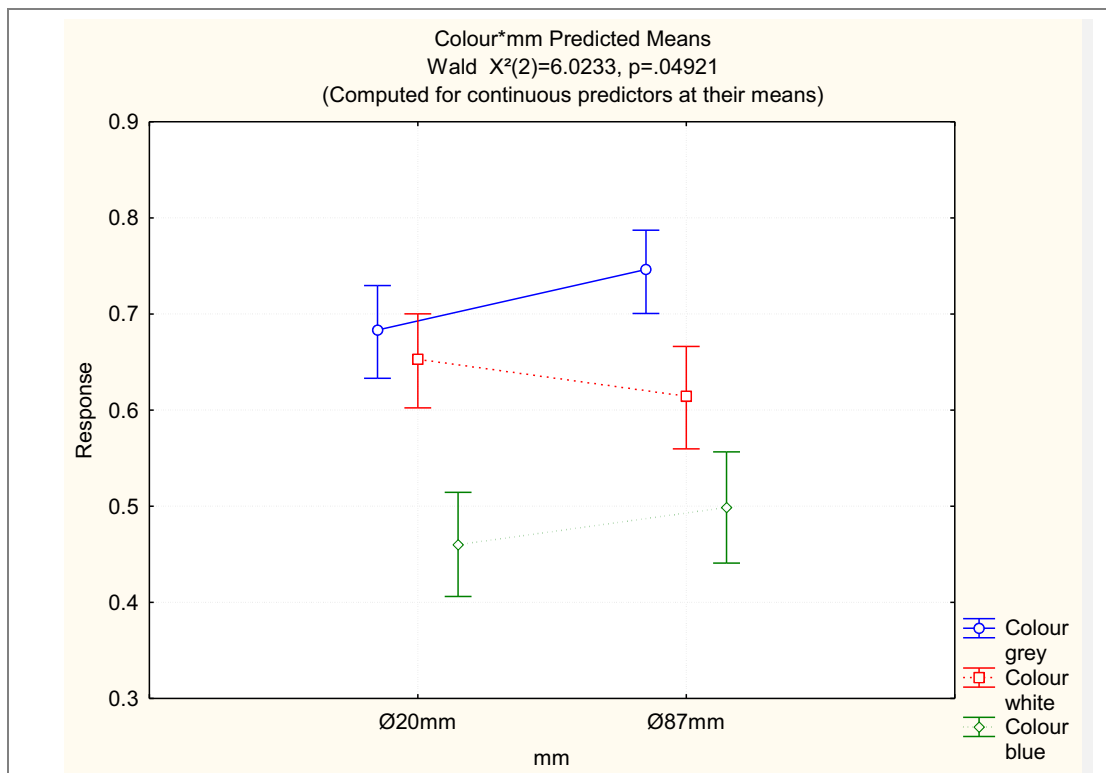
**Figure 78** Effect of impactor diameter on inspection reliability in different colour samples

Figures 77 and 78 show the combined and separate effects of colour and impactor diameter on probability of detection. As for the ply thickness, impactor diameter will affect the defect profile, 87 mm diameter impactors producing wider defects for a given depth as Figure 41 indicates. Figure 77 and 78 show that colour is more dominant than impactor diameter, and that sometimes probabilities of detection are increased with increasing diameter, and on other occasions they are decreased.

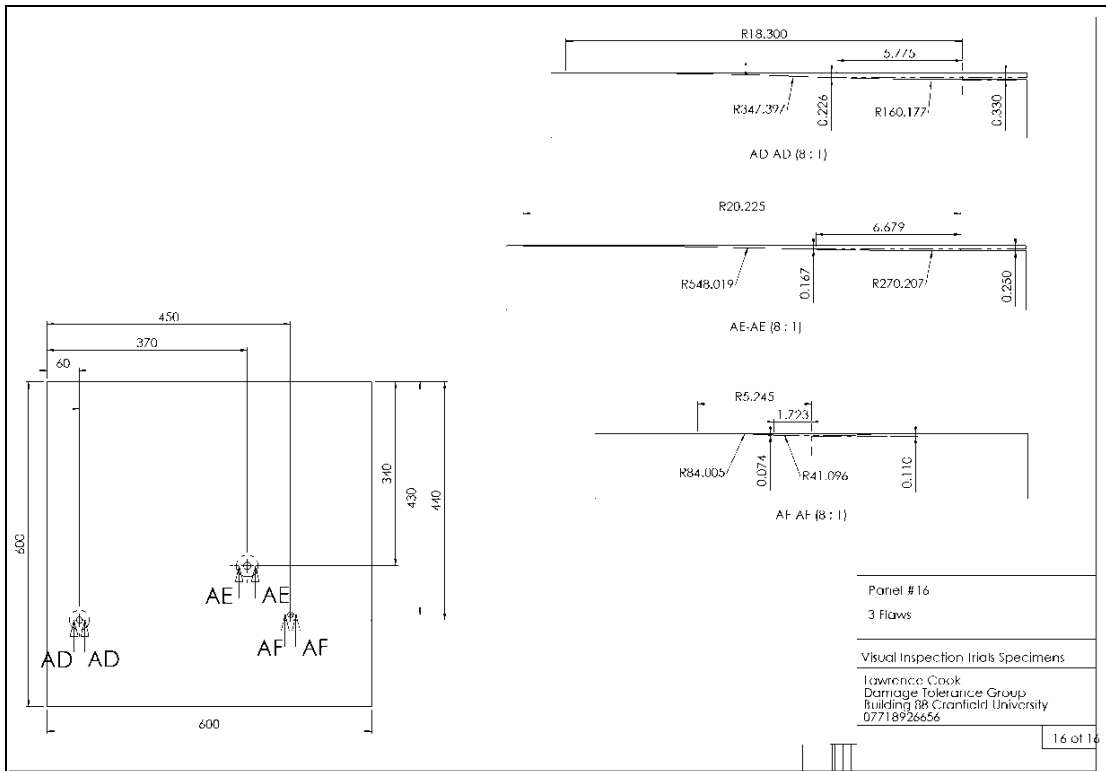
### Characterisation of impact damage surface flaws
