DESIGN AND EVALUATION OF A FOAM-FILLED HAT-STIFFENED PANEL CONCEPT FOR AIRCRAFT PRIMARY STRUCTURAL APPLICATIONS

Damodar R. Ambur
NASA Langley Research Center
Hampton, VA 23665-5225

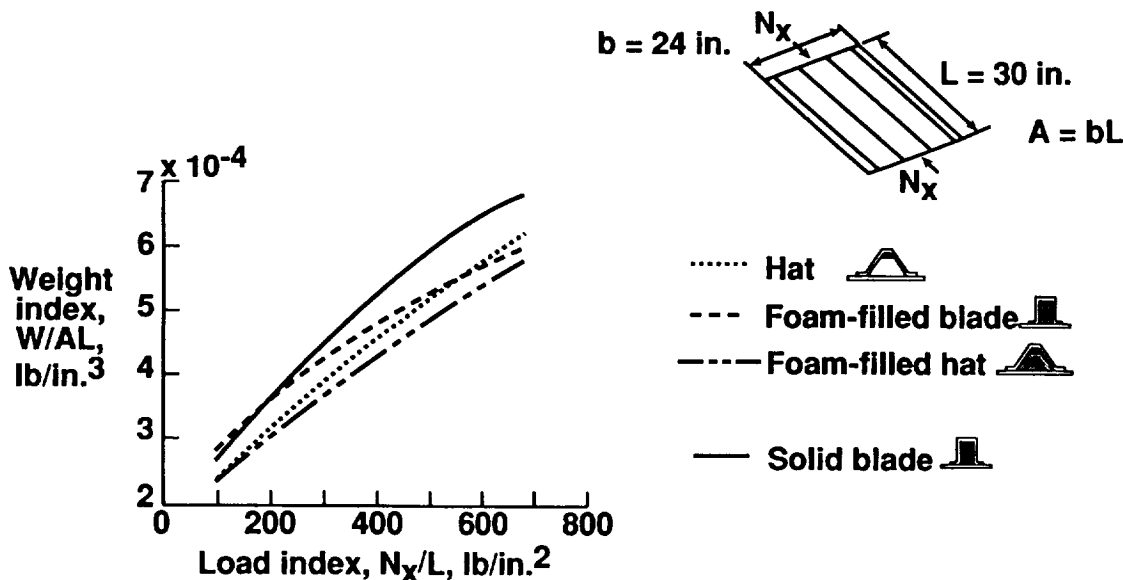
Figure 2. Structural efficiency of foam-filled stiffener panel concepts.

A design study was performed to compare the structural efficiency of the foam-filled structural concepts with the simpler, efficient, and more widely used hat-stiffener concept. The results presented in Figure 2 correspond to a 30-inch-long and 24-inch-wide panel with four stiffeners across the width. The unidirectional tape material used in this study is the Hercules Inc. AS4/3502 graphite-epoxy system with Rohacell WF-71 foam as the core material. This four-stiffener configuration is structurally the most efficient for load cases above 6,000 lb/in. and has also been adapted for lower load cases in this study. A constrained optimization for minimum weight was performed using the Panel Analysis and Sizing COde (Ref. 3) and the results for a range of axial loads from 3,000 to 20,000 lb/in. are presented herein. Results for solid-blade stiffened panel are also included in this figure for reference.

The results show that the foam-filled hat-stiffened panel is lighter than the conventional hat-stiffened panel by about 6.5 percent at 6,000 lb/in. and by about 10 percent at 20,000 lb/in. The foam-filled blade-stiffened panel appears to perform better than the hat-stiffened panel above 16,000 lb/in. The foam-filled hat-stiffener panel is lighter by about 20 percent when compared to the solid-blade concept. Hence, If the foam-filled hat-stiffened concept is used in stiffened structures, a substantial weight savings is possible over the entire load range considered. A foam-filled hat-stiffener panel design for 3,000 lb/in., which corresponds to a fuselage structure, has been chosen for further evaluation.

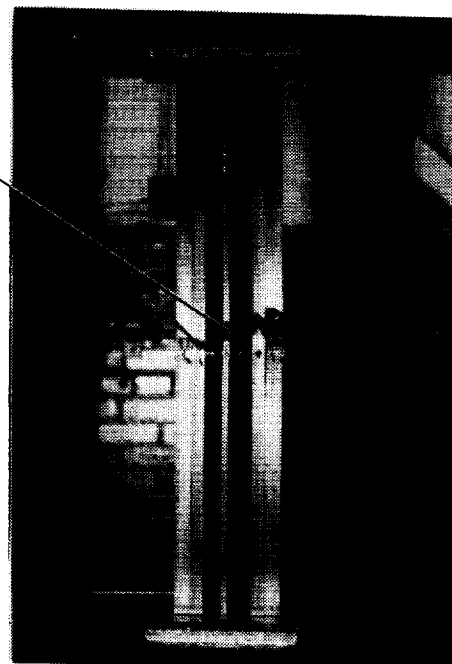
**Out-of-plane deflection
Contour at failure**

**Dropped
weight
impact at
20 ft-lb**

Failure mode

Figure 5. Failure mode of element specimen subjected to dropped-weight impact.

The location of impact is at mid-length of the specimen as shown in Figure 5. An impact energy level of 20 ft-lb was chosen as an upper bound for impact. As the specimen was loaded with the damage resulting from this impact, the specimen skin buckled at approximately 33,500 lb and the final failure of the specimen occurred at 35,552 lb. The failure mode was very similar to the element specimen without impact damage. This result suggests that the imposed damage scenario of 20 ft-lb on the stiffener cap does not result in any reduction in residual strength.

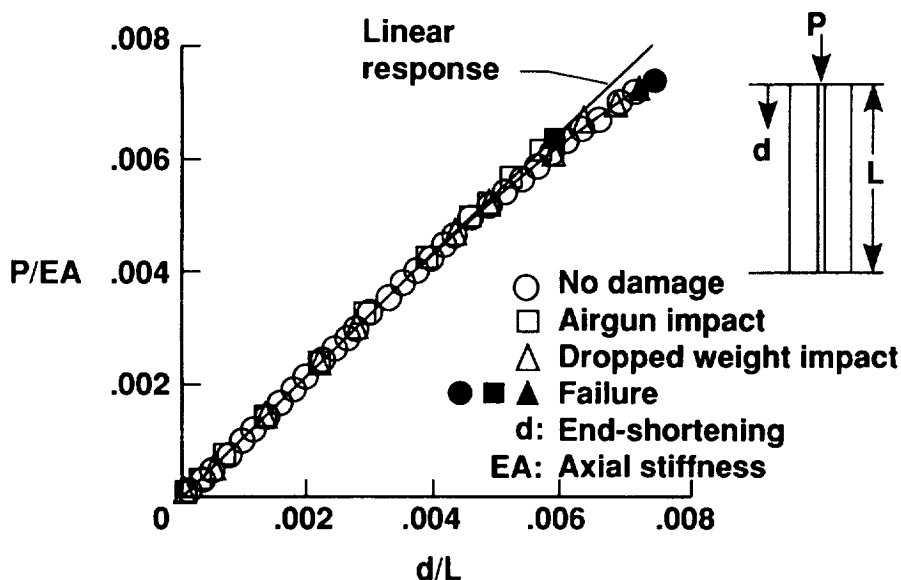
Figure 7. Summary of load versus end-shortening results for element test specimens.

The end-shortening results for the element test specimens are summarized in Figure 7. In this figure, end-shortening results are normalized by the overall length of the specimen and then plotted against the total applied load normalized by the axial stiffness of the specimen. Thus, the numbers along the axes represent global axial strains. The open circles, squares, and triangles represent data for specimens without damage, with airgun impact damage, and with dropped-weight impact damage, respectively. The solid symbols represent the corresponding failure events. All specimens exhibit nonlinear behavior beyond approximately 33,000 lb, which is the load at which skin buckling occurred. The specimens without damage and dropped-weight impact damage failed at an axial strain of 7,500 μ in./in. while the specimen with airgun impact damage at the skin-stiffener flange interface location failed at 6,000 μ in./in.

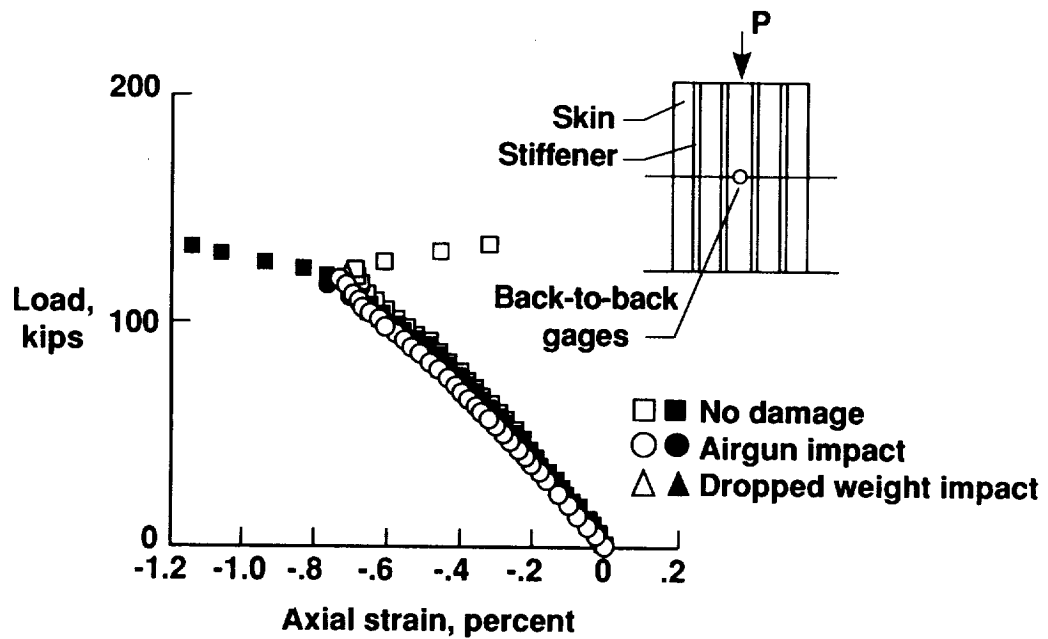
Figure 13. Strain results for panel test specimens at a skin location.

The strain results in the skin at mid-length for the panel test specimens are presented in Figure 13. The specimens behaved well and exhibited consistent response in all cases. In the case of the undamaged panel, the skin buckles at approximately 125,000 lb as indicated by the strain reversal in one of the back-to-back gages. The out-of-plane displacement contours obtained from moire interferometry confirmed local skin buckling in the mid-bay of the panel at this load value. The strain levels in the skin of the damaged specimens corresponding to the failure event are approximately 7,000 μ in./in.

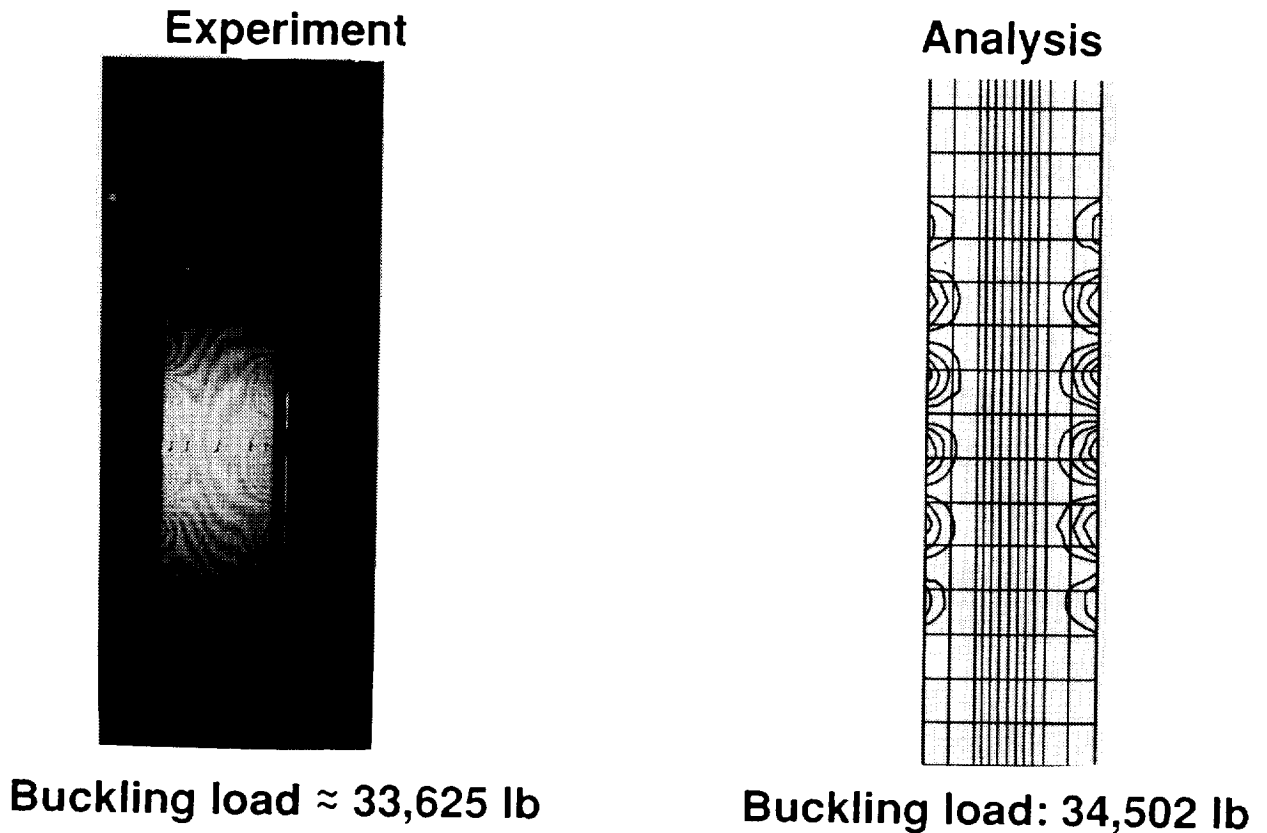
Figure 15. Element test specimen buckling response.

Experimental buckling response of the element test specimen is compared with the finite element analysis result in Figure 15. From moire interferometry and strain results it appears that the element specimen skin buckled into a six half-wave pattern at approximately 33,625 lb. The analysis predicts this first buckling mode at 34,502 lb with the same number of half-waves.

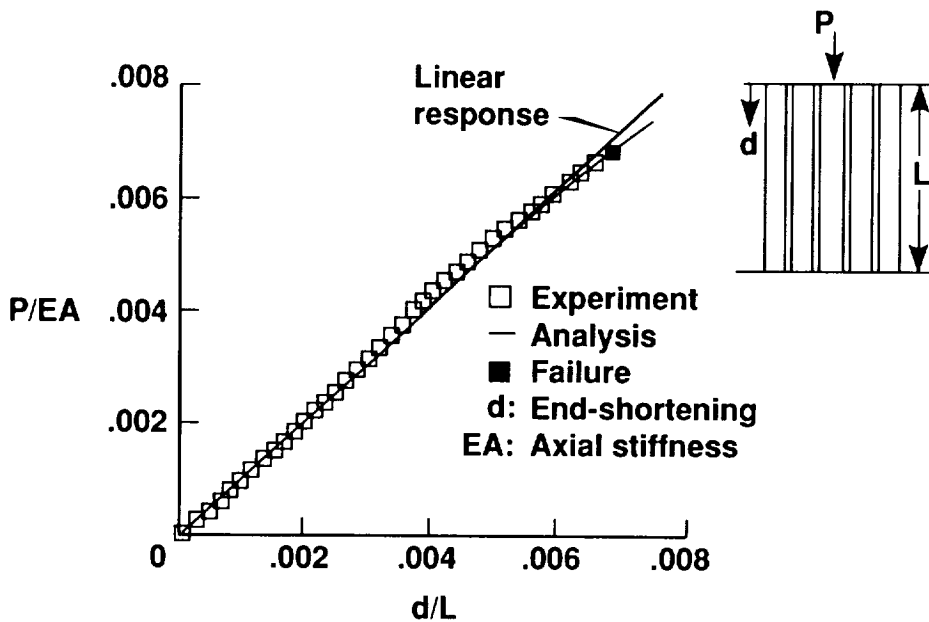
Figure 16. Correlation of panel specimen end-shortening results.

Nonlinear analysis of the panel specimen was performed using the DIAL finite element code and the end-shortening results are compared with experimental results in Figure 16. The finite element model was generated using shear deformable plate elements resulting in a 16,500 degree-of-freedom model when appropriate boundary conditions were imposed. The analytical results are represented in the figure by a solid line and the experimental results are represented by open squares with the filled square representing the failure event. The specimen nonlinear response compares well with the analytical results.
