AERONAUTICAL RESEARCH COUNCIL

Some Work on Tension Pads for Structural Tests

Technical Note No. Structures 172

ROYAL AIRCRAFT ESTABLISHMENT

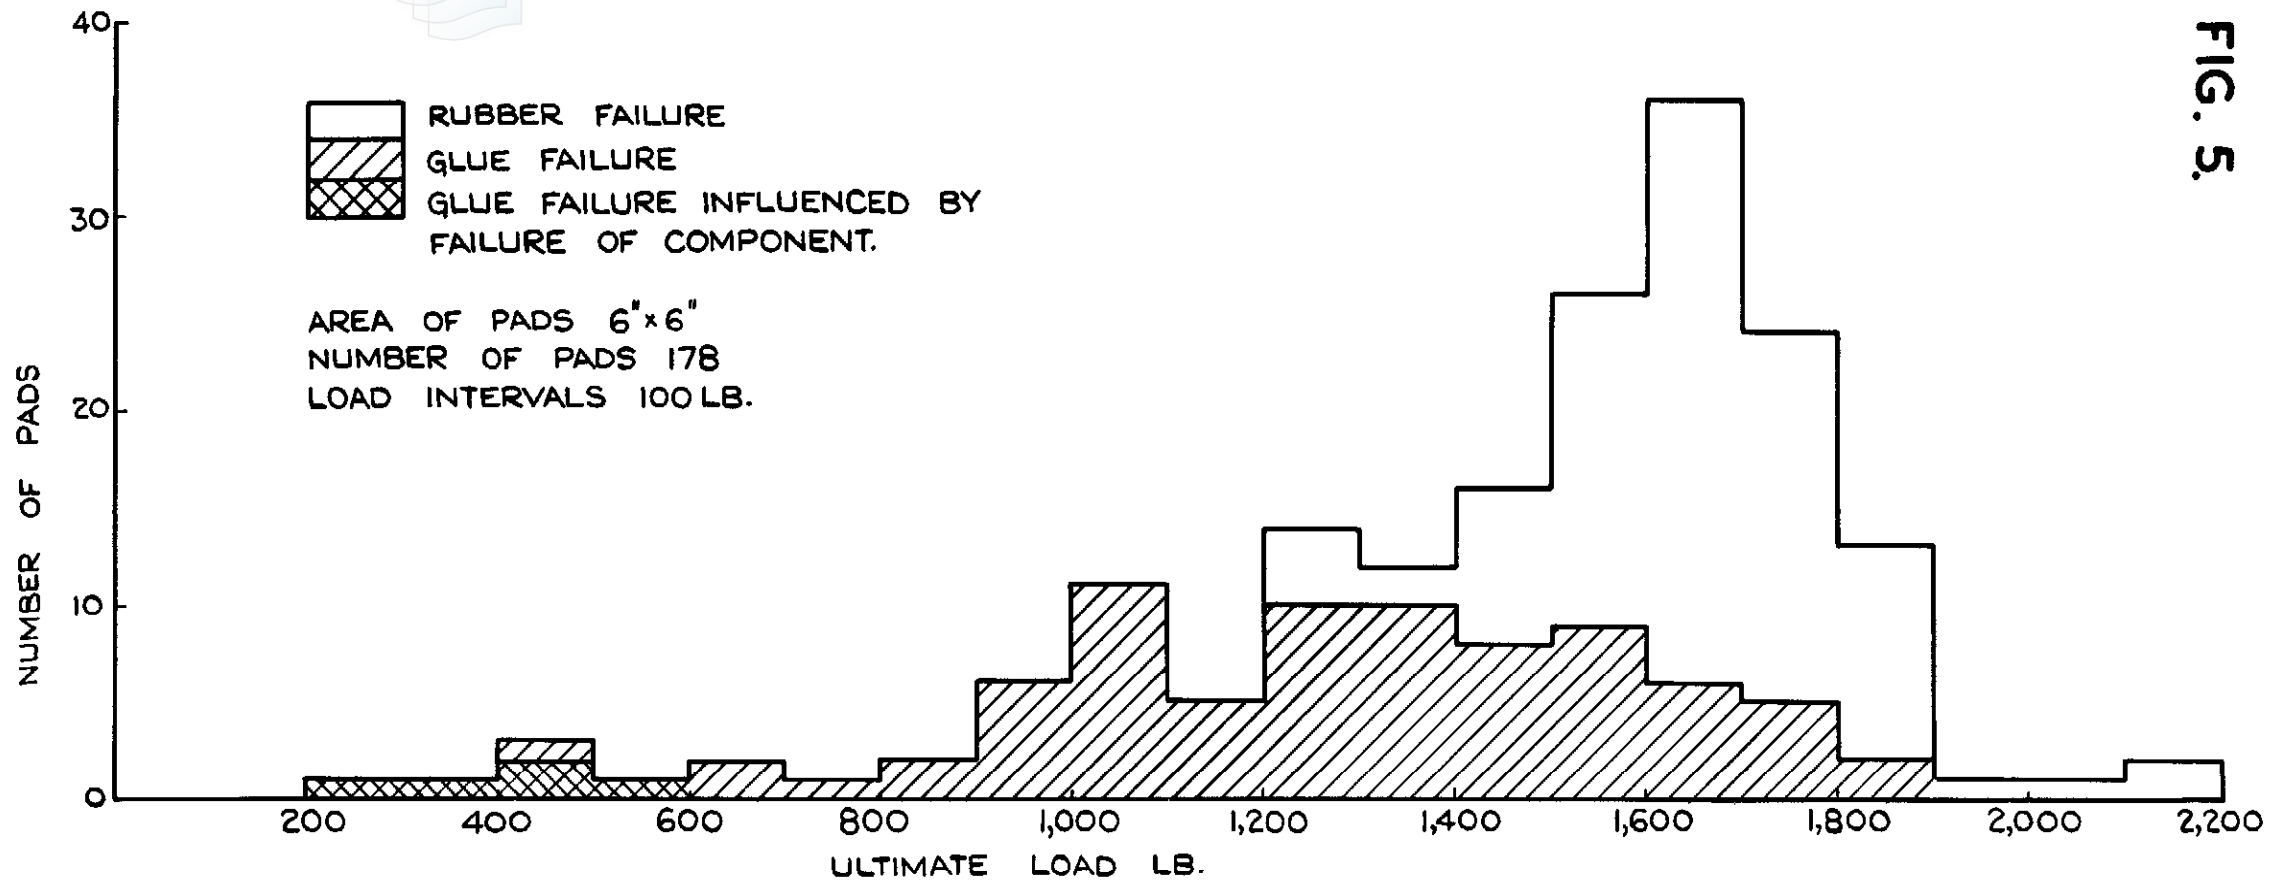
FIG. 5. HISTOGRAM OF FAILING LOADS OF PADS PULLED FROM COMPONENTS AFTER TEST.

After the structural tests and after being glued to the specimens for about 8 months the ultimate strength of each pad on the tail-unit components was determined. Fig. 5 gives the results in the form of a histogram. Five pads indicated by cross hatching were adjacent to the crease in the skin which was formed by the compressive failure of the tailplane. It is thought that their strengths were lowered as a consequence; it is reasonable to ignore their low values and to conclude that the majority of the pads had a post-test strength greater than 30 p.s.i. but one or two pads had a post-test strength of little more than 10 p.s.i.
