October 2012

This document has been prepared by Beca Consultants Pty Ltd (Beca) for the Department of Defence and shall remain the property of the Department of Defence.

This Manual has been prepared solely for the purpose of providing internal guidance to Defence personnel. Any use by non-Defence personnel is unauthorised. No responsibility will be taken by the Commonwealth of Australia or the advisers assisting in the preparation of this Manual, for any such use, including any purported reliance on the guidance provided by this Manual. This Manual is not intended to be a substitute for specialist advice, and unless expressly agreed in writing by the Commonwealth of Australia, nothing in this Manual will alter or affect the respective rights, obligations and liabilities of the parties under any contract.

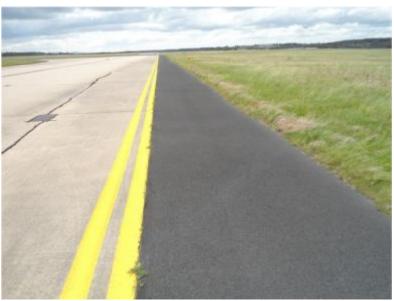
Asphalt Surfaced Taxiway Shoulder

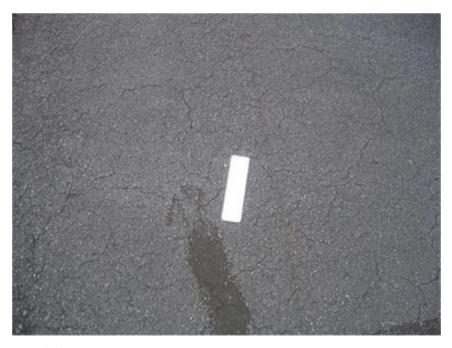
# 4.2.1 Age Cracking

Age cracking is characterised by short and tight (and sometimes interconnected) cracks forming a block pattern and extending over the full pavement.

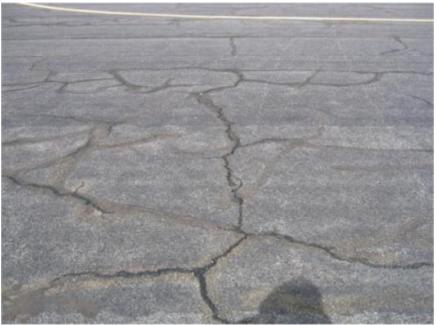
### 4.2.2 Block Cracking

Block cracking is characterised by interconnected cracks forming a block pattern, approximately rectangular in shape. It commonly extends over the full pavement. The blocks generally range in size from 0.25m by 0.25m to 3m by 3m. Joints or cracks in underlying pavement layers may reflect through the surface layer. These may appear as regular rectangular blocks in the case of concrete pavements that have been overlaid with asphalt, and irregular blocks in the case of cement treated base courses that have been overlaid with asphalt. Block cracking usually occurs over a large portion of pavement area, but sometimes will occur only in non-trafficked areas.

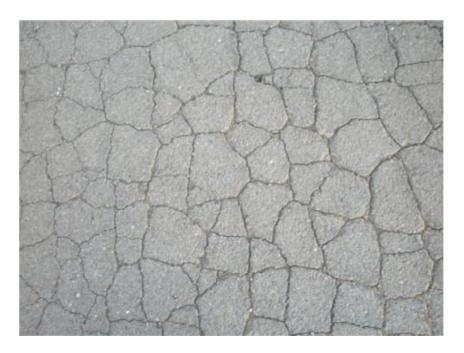
# 4.2.3 Crocodile Cracking

Crocodile cracking is characterised by interconnected cracks forming a series of small, approximately straight-sided polygons. These cracks are caused by fatigue failure of the asphalt surface under repeated traffic loading, and hence, are likely to be found within wheel paths and other frequently trafficked areas. The cracking initiates at the bottom of the asphalt surface (or stabilised base) where tensile stresses and strains are highest under a wheel load. The cracks propagate to the surface initially as a series of parallel cracks. After repeated traffic loading the cracks connect, forming many-sided, sharp angled pieces or cells that are generally less than 150mm across, but may range up to 300mm. The defect is characterised as crazing when the cracks are hair line and the polygons are smaller than crocodile cracking.

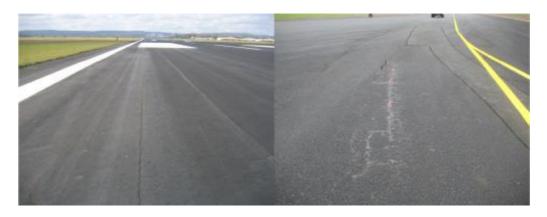
# 4.2.4 Longitudinal Cracking

Longitudinal cracks generally run parallel to the pavement centreline or in the direction of traffic. Longitudinal cracks may occur mid paving lane or commonly on construction (lane) joints. If the cracks are load induced they will only occur in aircraft wheel paths and will be characterised by their close spacing and generally parallel orientation with limited branching. Some staining about the longitudinal joint may be evident.

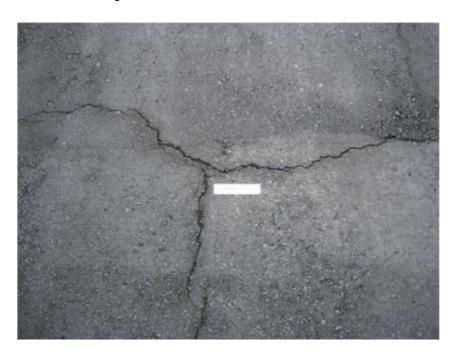
# 4.2.5 Random Cracking

Random cracks may be either isolated (singular) or a series of cracks that are generally irregular, unconnected and vary in direction.

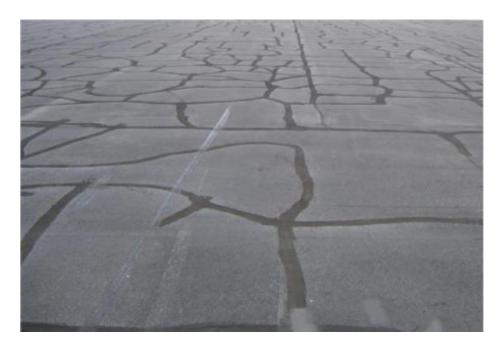
# 4.2.6 Reflection Cracking

Reflection cracks are caused by movement at joints or cracks in the underlying concrete slab, cement stabilised layer or previous asphalt surface.

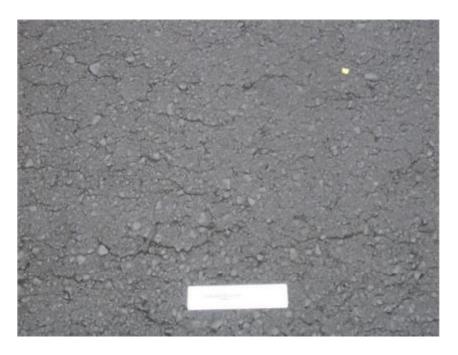
# 4.2.7 Roller Cracking

Roller cracks are characterised by a pattern of fine, parallel, transverse cracks (generally perpendicular to the direction of paving) formed during spreading and/or steel wheel rolling of asphalt. Most common in thin layers, tender asphalt mixes and when the asphalt being laid is excessively hot or cold.

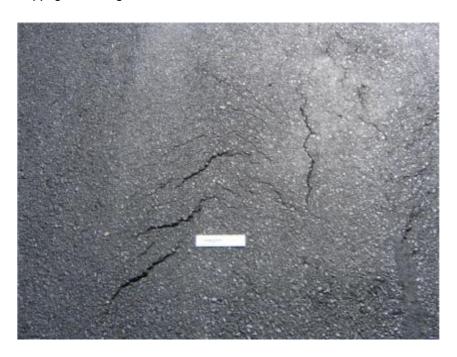
# 4.2.8 Slippage Cracking

Slippage cracks are half-moon or crescent shaped cracks, commonly associated with the slippage and deformation of the wearing course under horizontal wheel loads (braking and/or turning of aircraft). Cracks occur in a closely spaced parallel group, confined within the slipped asphalt layer. Also refer to Section 4.4.3 – Heaving and Shoving.

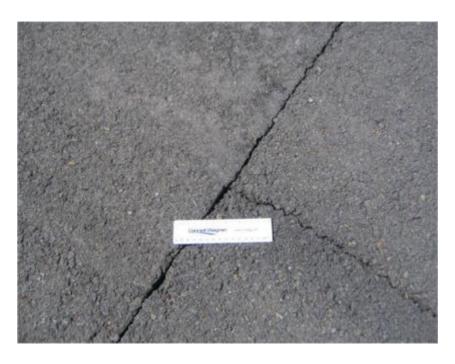
# 4.2.9 Transverse Cracking

Transverse cracks generally running perpendicular to the pavement centreline and the direction of traffic (or direction of paving). Transverse cracks normally occur in isolation and are unconnected with limited branching.

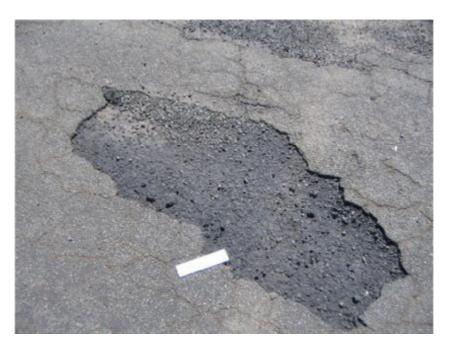
#### 4.3.1 Delamination

Delamination normally involves the loss of discrete and large areas of the asphalt surfacing, and is usually characterised by a clear delineation between the wearing course layer and the underlying layer.

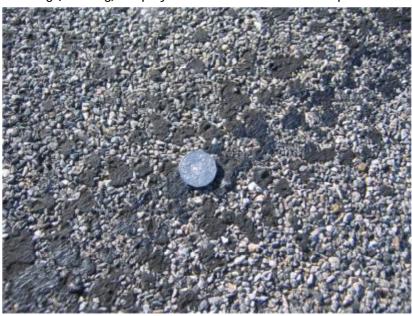
## 4.3.2 Flushing (Bleeding) of Sprayed Seal – can also occur in asphalt surfaces

The pavement surface is considered to be bleeding when excess binder accumulates on the pavement surface. Bleeding is often an advanced form of flushing and both conditions result in a loss of skid resistance. Flushing is the condition when all the surface texture has been lost and the pavement surface is smooth

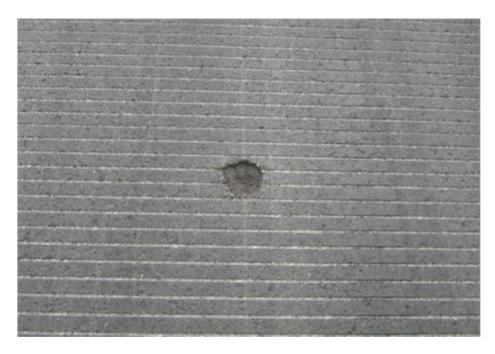
## 4.3.3 Lightning Strike

Lightning strikes are common on airfield pavements. They are characterised by a steep sided or bowl shaped cavity with fretted edges that extends into the pavement wearing surface. Cavities are approximately circular with diameters ranging from 25mm to 150mm and depths up to 30mm to 50mm.

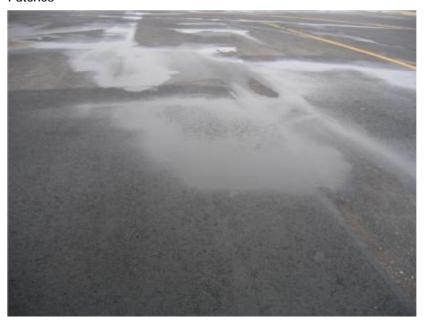
### 4.3.4 Patches

A defective asphalt patch is an area of pavement where the original pavement has been replaced and is exhibiting deterioration. The deterioration may include defects such as those described in Section 4. This may be an indicator of deficient pavement strength or severe underlying layer deterioration. Expedient patches are often small with irregular sides that have made it difficult to achieve compaction and adhesion to the existing surface. Properly reconstructed asphalt patches generally have straight edges allowing placement of new asphalt via paving machine allowing much greater control over asphalt placement and a higher quality patch.

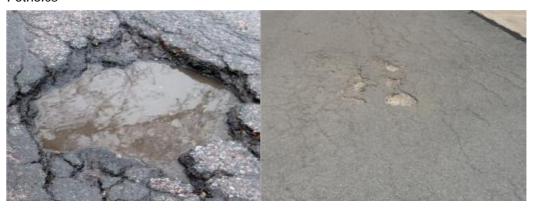
#### 4.3.5 Potholes

Potholes are typically localised steep sided bowl shaped cavities in the pavement surface that extend into the underlying layers. Potholes result from either the loss of asphalt surfacing material and base course erosion as a consequence of traffic and water action or advanced cracking. Potholes generally occur in pavements that are inadequately maintained. It is uncommon for any significant potholes to develop in airfield pavements due to the need to have them repaired for operational reasons.

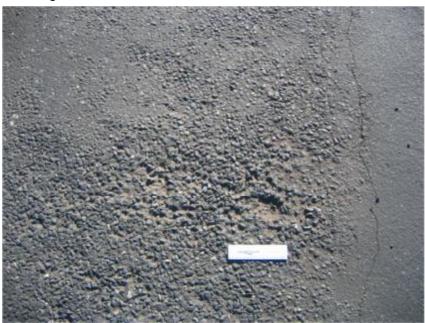
# 4.3.6 Ravelling

Ravelling, which is also commonly referred to as weathering, is the progressive deterioration of the bituminous surfacing (wearing course) caused by the fretting and dislodging of aggregate particles and loss of binder leaving pitted holes and a rough surface.

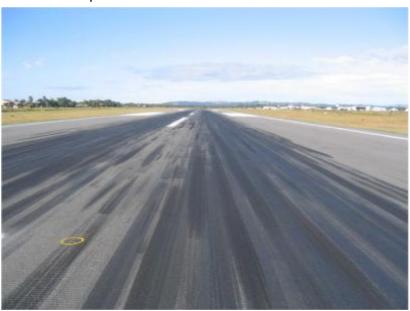
# 4.3.7 Rubber Build Up

Rubber build up results from the deposit of rubber from aircraft tyres, primarily in the runway Touch Down Zone (TDZ) areas. As noted in Section 7.4, the quantity of rubber deposited depends on a number of variables including; ambient temperature, texture of the runway surface, size and number of aircraft tyres per aircraft, tyre pressure, types of braking system, and the number of aircraft movements.

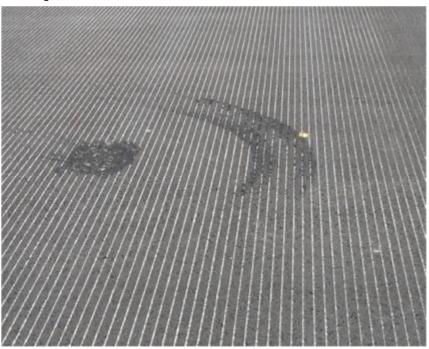
## 4.3.8 Scuffing

Scuffing is mechanical damage or localised marks in the pavement surface.

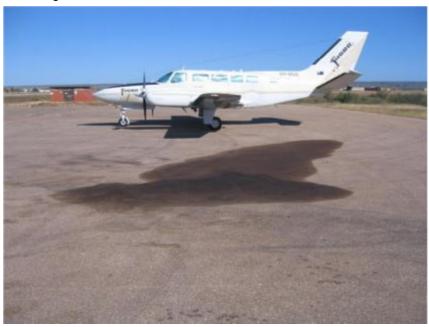
## 4.3.9 Softening of Surface

The contamination of an asphalt or spray sealed surfacing with any hydrocarbon fuel or hydraulic or lubricating oil will soften the bitumen binder and may result in damage or disintegration of the surfacing. Spilt fuel is a fire hazard and as such could endanger aircraft and personnel. All fuel spills must be cleaned up immediately by containment, absorption and/or washing of the pavement.

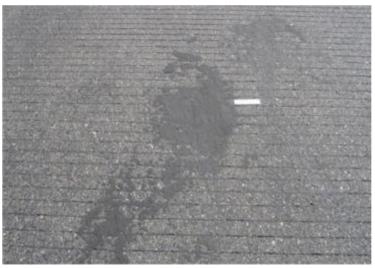
## 4.3.10 Stripping of Asphalt

Stripping is the breakdown of the bitumen-to-aggregate adhesive bond within the asphalt layer. Stripping can be present without any noticeable surface manifestation of the distress if the affected pavement area is not subject to heavy traffic loadings. However, if subjected to heavy traffic it is usually first indicated by localised flushing of the surface or the bleeding of bitumen on the surface in small spots or localised patches. In very heavily trafficked areas, this phenomenon may also be indicated by significant plastic deformation (horizontal crack-free deformation as shown in the photograph), and/or rutting during hot weather, also usually without cracking. Stripping has only been observed to occur to date in asphalt in which conventional bitumen has been used. It is thought that only the conventional bitumen from some refineries, or manufactured by a particular process, is susceptible to stripping. Insufficient knowledge is available to confirm the exact cause of the stripping in asphalt at Australian airports.

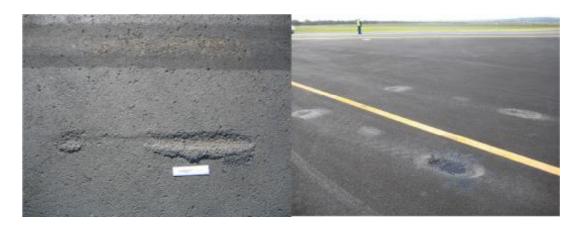
### 4.3.12 Surface Abrasion

Surface abrasion occurs under traffic and is normally restricted to aircraft wheel track areas. In flexible pavements abrasion due to pneumatic tyres is usually not significant; however, abrasion under helicopter skids and/or solid-tyre GSE can be severe and rapid. Indents can be caused by static aircraft loads during high temperature conditions.

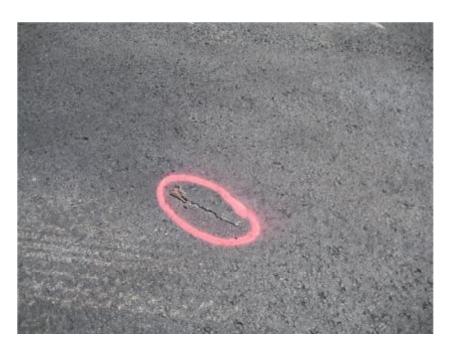
## 4.3.13 Surface Inclusions ("Pock" Marking)

Surface inclusions generally comprise of any foreign matter, material contaminant or concentrated impurity found within the asphalt surfacing that causes a surface defect (normally loss of material).

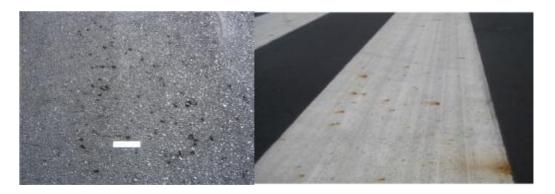
## 4.3.14 Weathered Aggregate

Weathering of unsound coarse aggregate in the surface of asphalt leaves pitted holes and sometimes, rust staining.

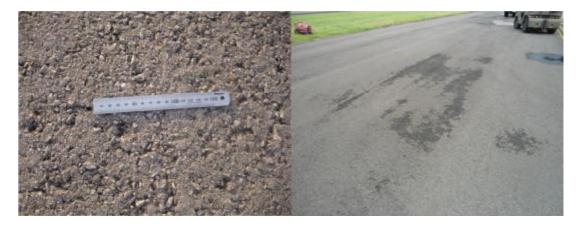
**Examples of Coarse Open Texture**

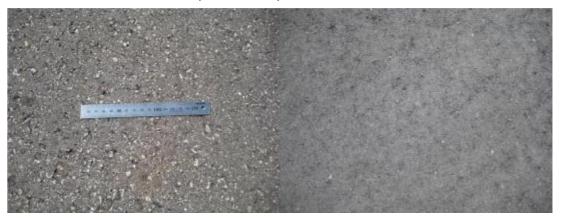
**Examples of Close Texture**

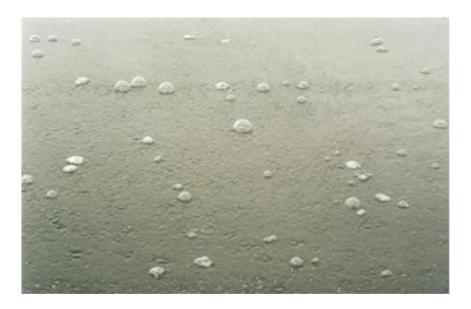
## 4.4.1 Blistering (Bubbling)

Blistering/bubbling is characterised by an upward, circular bulge in the bituminous surface (commonly a sprayed seal but may also occur in asphalt surfaces). The swelling may occur sharply over a small area or as a longer, gradual wave. Either type of swelling may be accompanied by surface cracking and spalling, possibly exposing the underlying material.

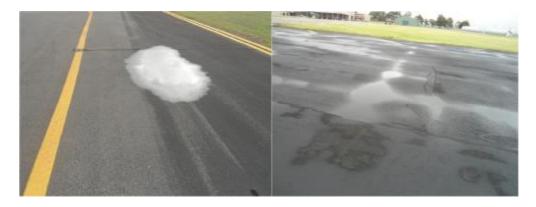
## 4.4.2 Depressions

Depressions are localised pavement surface areas having elevations slightly lower than those of the surrounding pavement surface plane. Depressions usually occur randomly, however they may also be load related, and hence occur within wheel paths. In many instances, shallow depressions are not noticeable until after a rainfall event, when ponding water creates "birdbath" areas. Depressions can sometimes also be identified from surface stains created by ponding.

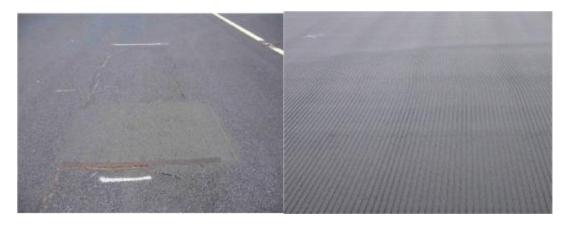
## 4.4.3 Heaving and Shoving

Heaving is usually associated with a shear failure and is characterised by bulging of the pavement surface parallel to the direction of traffic. Shoving is the result of horizontal pressures due to turning and braking and usually only affects the surfacing material (displacement) or the upper portion of the base course or asphalt layer – this can be readily seen where the asphalt surface is grooved.

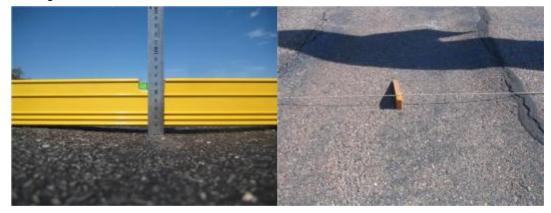
### 4.4.4 Rutting

Rutting comprises longitudinal deformation characterised by small/sharp radius of curvature within the wheel paths and trafficked areas of a pavement. Pavement uplift may occur along the sides of the rut. In many instances ruts are noticeable only after a rainfall event when the wheel paths hold water. For further details on surface

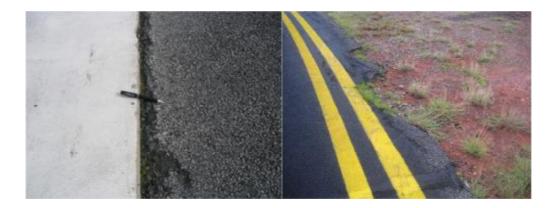
## 4.5.1 Edge Breaks

An edge break is where the edge of the bituminous surfacing is fretted, broken, irregular, cracked or spalled.

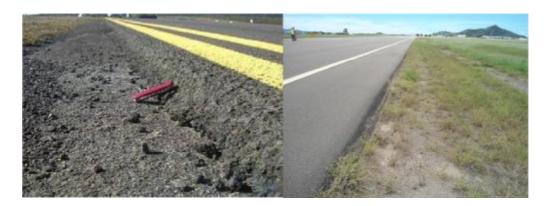
## 4.5.2 Edge Drop-Offs

An edge drop-off is an excessive (greater than 25mm) vertical height between the surface of the pavement edge and the surface of the shoulder or flank. CASA MOS Part 139 Chapter 6.2.12 has a maximum requirement of 25mm on runway edges.

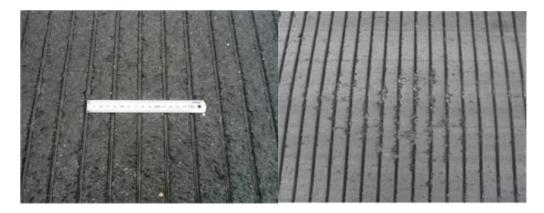
## 4.6 Groove Damage and Closure

Closure or breaking of the groove edges.

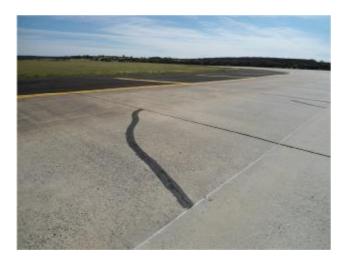
#### 5.2.1 Corner Cracks

A corner crack is a diagonal crack intersecting two (2) edges or joints of a concrete slab to form a triangular shape. There are two distinct situations. Larger triangles are likely to be corner 'breaks' in which case the diagonal crack extends through the full slab thickness. Smaller triangles are likely to be corner 'spalls' in which case the crack intersects the joint at an angle. The significance of the distinction is that corner spalls are more likely to dislodge and produce FOD.

Corner Crack. A diagonal crack intersecting two edges or joints of a concrete slab to form a triangular shaped spall in the corner of the slab.

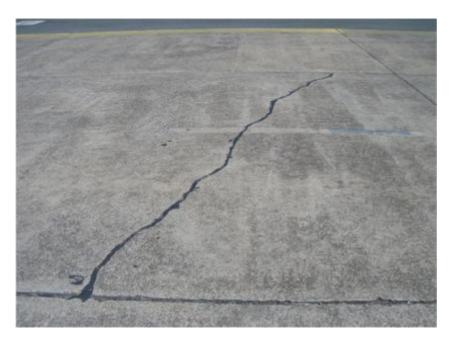
## 5.2.2 Diagonal Cracks

A diagonal crack is a crack or break approximately diagonally to the pavement centreline.

Diagonal Crack. A crack or break approximately diagonal to the pavement centreline.

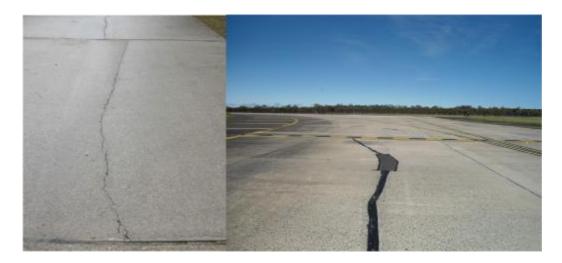
## 5.2.3 Longitudinal Cracks

A longitudinal crack is a crack or break approximately parallel to the direction of placing (commonly parallel to the pavement centreline and typically mid-slab).

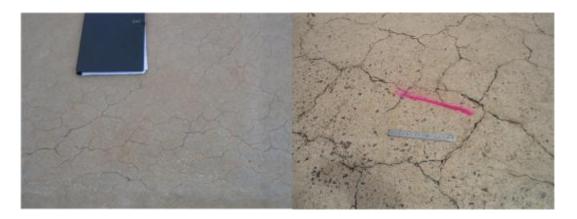
## 5.2.4 Plastic Shrinkage Cracks

Plastic shrinkage cracks are short, fine, generally shallow isolated cracks that form on the surface of freshly placed concrete. The severity of the cracking (and spalling) can vary.

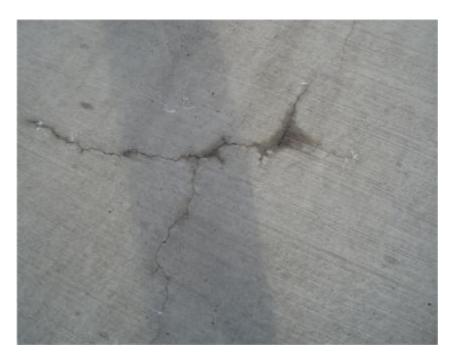
### 5.2.5 Random Cracks

A random crack is a crack or break that occurs in no particular orientation or pattern.

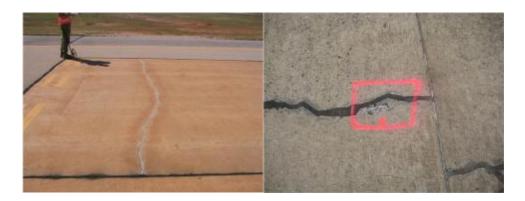
### 5.2.6 Transverse Cracks

A transverse crack is a crack or break approximately perpendicular to the direction of placing (commonly perpendicular to the pavement centreline).

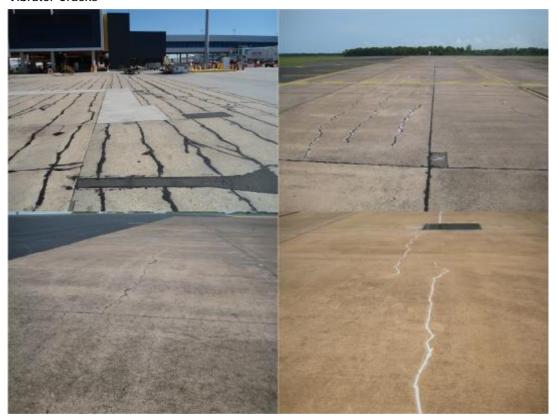
#### 5.2.7 Vibrator Cracks

Vibrator cracks are cracks formed in the pavement as a result of submerged needle (poker) vibrators being dragged through the concrete. The photo above results from dragging immersion vibrators mounted on the paving machine through the freshly placed concrete (this is no longer practiced).

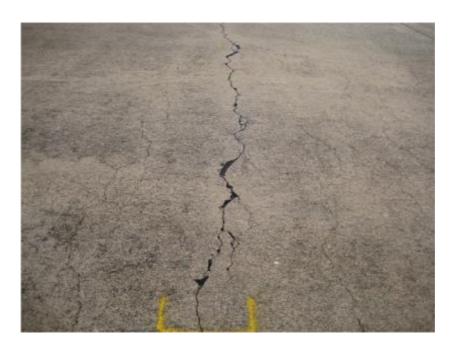
## 5.3.1 Spalling

Spalling is the break down, chipping or disintegration of concrete at joints, edges or cracks, usually resulting in the removal of material, and in the formation of an elongated cavity. Spalling commonly commences as crack formation adjacent to joints, cracks or edges and progresses as material is lost through trafficking.

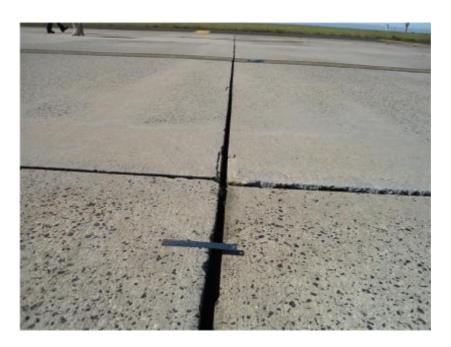
## 5.3.3 Faulting

Faulting is the differential residual vertical displacement across joints and cracks and at pavement edges, creating a step.

Faulting. Differential vertical displacement of abutting slabs at joints or at cracks creating a step in the pavement surface. Faulting indicates that the keying (load transfer) across the joint or crack has been lost. Consequently the stresses caused by traffic are significantly increased.

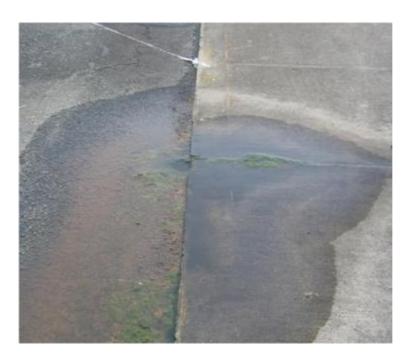
## 5.3.4 Pumping

Pumping is a dynamic phenomenon in which water or slurry from saturated base courses is ejected through joints or cracks under pressure due to traffic-induced slab deflection. Fines from the base course carried in the water are lost, ultimately resulting in the formation of voids and undermining at the joints or cracks.

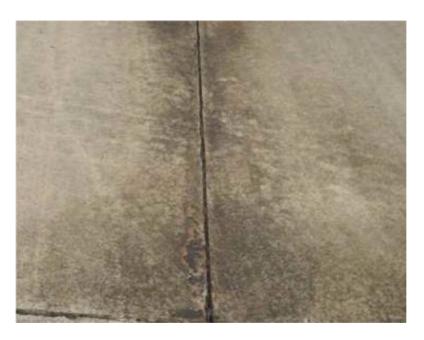
## 5.3.5 Staining

Staining of the pavement surface occurs when material is pumped from joints or cracks.

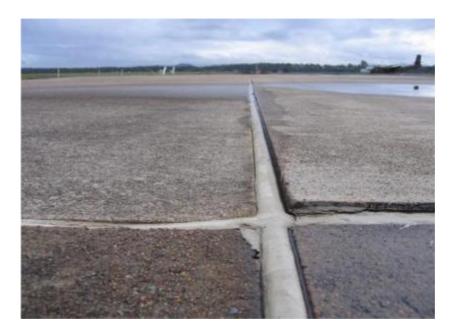
## 5.3.6 Warping

Warping (also known as curling) is slab bending due to temperature or moisture differentials. Warping of slabs is a dynamic phenomenon and is only considered as a pavement defect when its magnitude is such that it affects the ride quality of the pavement, or it leads to another form of defect (e.g. transverse cracking).

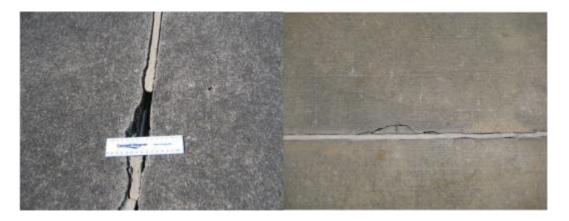
#### 5.4.1 Joint Sealant Failure – Adhesion

Joint sealant adhesion failures occur when the bond is lost between the joint sealant and the concrete joint face.

Joint Filler Failure – Adhesion. Loss of joint filler adhesion to the concrete surface.

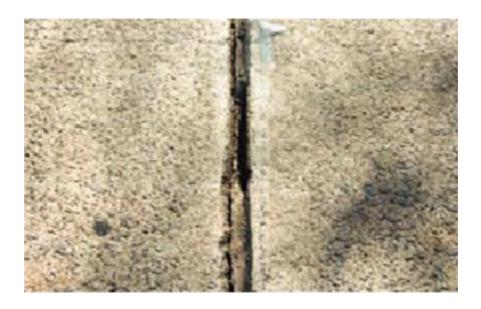
#### 5.4.3 Joint Sealant Failure – Chemical

Joint sealant chemical failures occur when the joint sealant is attacked by fuel, oil or other chemicals that have been spilt on the pavement.

**Joint Filler Failure – Chemical**. Loss of joint filler properties or loss of filler from the joint by chemical degradation.

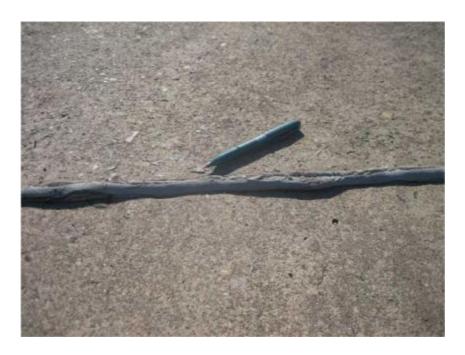
#### 5.4.4 Joint Sealant Failure – Extrusion

Joint sealant extrusion failures occur when the sealant is compressed to such an extent that it bulges up or protrudes above the pavement surface and under the action of wheel loads, is folded and flattened onto the pavement surface. It may also be a result of the initial overfilling of the joints.

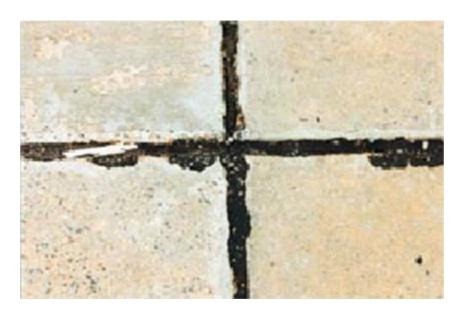
#### 5.4.5 Joint Sealant Failure – Intrusion

Joint sealant intrusion failures occur when aggregate particles or similar foreign materials are incorporated into the joint sealant and cause spalling when the concrete pavement expands and the joint width is reduced.

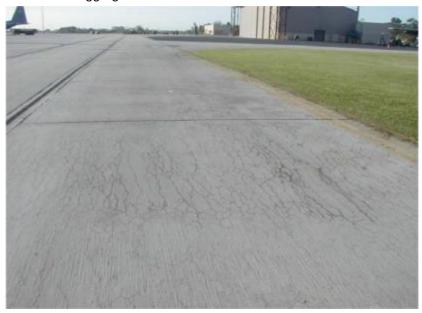
### 5.5.1 Alkali Silica Aggregate Reaction

A reaction between a form of silica present in some concrete aggregates and the alkalis present in some cements produces internal volume expansions that may cause a pattern of surface cracks (map cracking) that typically extends throughout a concrete slab, or may result in the closure of joints. Alkali-aggregate reaction is distinct from sulphate attack in that it involves large expansion without the softening that occurs with sulphate attack (also called alkali-silica reaction). The gradual expansive reaction may be expected to continue, and will eventually produce surface debris (spalls).

Alkali-Aggregate Reaction (Alkali-silica reaction). A reaction between a form of silica present in some concrete aggregates, and alkalis present in some cements. The reaction produces internal volume expansions that cause a pattern of cracks (map cracking) that typically extends throughout a concrete slab. Alkali-aggregate reaction is distinct from sulphate attack in that it involves large expansion without the softening that occurs with sulphate attack.

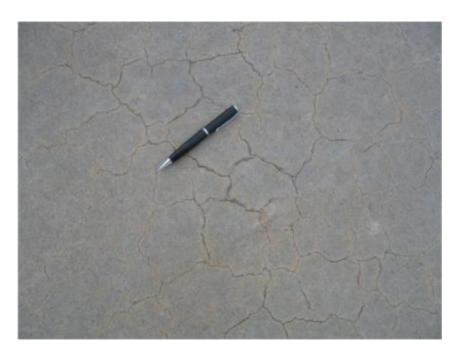
## 5.5.2 Crazing

Crazing comprises a pattern of shallow, hairline cracks on the concrete surface, tending to intersect at angles between 90° and 120° forming a chicken-wire pattern. Crazing is largely a cosmetic effect and it is very rare for this phenomenon to produce distress in concrete pavements. Even in the most severe cases, where cracks have opened and the edges have eroded, no significant spalling has occurred.

Crazing (also called map cracking). A fine pattern of hairline cracks in concrete pavements that extend only to shallow depth below the surface of a concrete slab. They are usually caused by over finishing and sometimes lead to scaling.

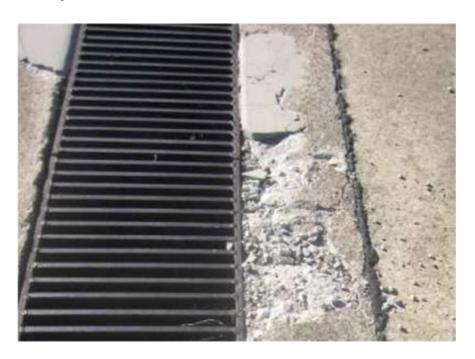
## 5.5.3 Disintegration

Disintegration is the deterioration of the concrete into small fragments or particles. This condition may result from neglected maintenance, from continued overloading, from the use of "poor" quality aggregates, or from degradation of the cement due to environmental factors.

**Disintegration**. Deterioration into small fragments or particles.

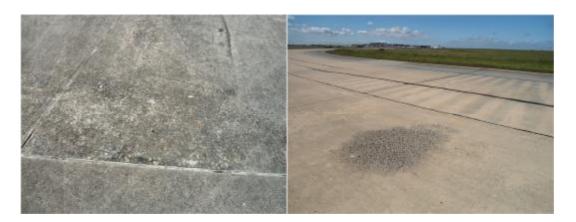
### 5.5.4 Pitting

Pitting is small surface cavities caused by loss of matrix and fine aggregates through weathering.

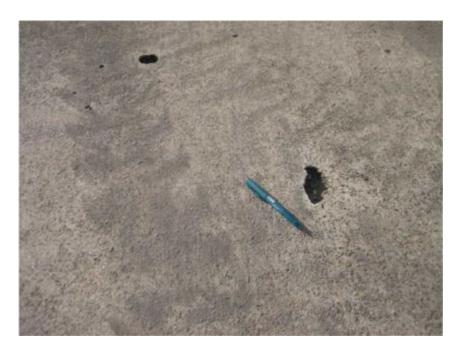
## 5.5.5 Pop Outs

Pop outs occur when a cavity is formed resulting from a small piece of concrete or a foreign object (typically 25mm to 100mm diameter) breaking loose from the pavement surface.

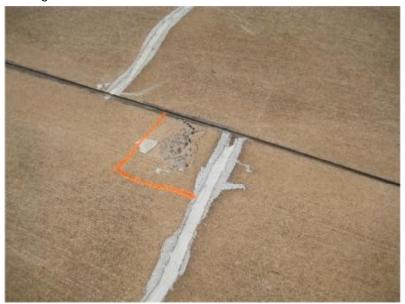
#### 5.5.6 Scaling

Scaling is the progressive disintegration and loss of concrete wearing surface, usually in shallow sections. A particular case is the loss of mortar resulting from a chemical reaction between cement and lubricants/hydraulic fluids leaking from parked aircraft.

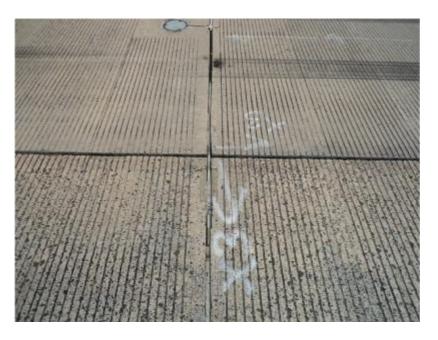
## 5.6 Groove Damage

Loss of groove edges and polishing of the concrete surface resulting in a loss of friction level.

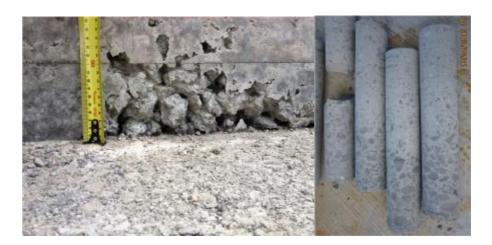
## 5.7 Poor Compaction and Honey Combing

Poorly distributed aggregate throughout the depth of the slab (in particular, coarse aggregate slump to the bottom of the slab). Inadequate compaction (particularly at slab edges) causing voids and possible low strength.

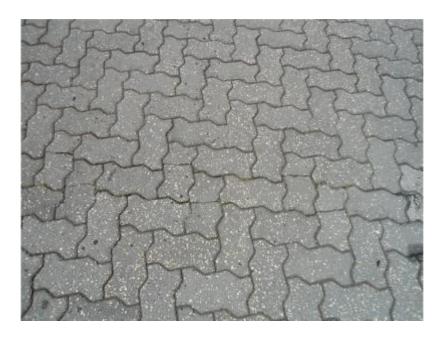
### 6.2 Broken Pavers

Broken pavers are characterised by either cracks through the units, or broken, chipped or spalled edges.

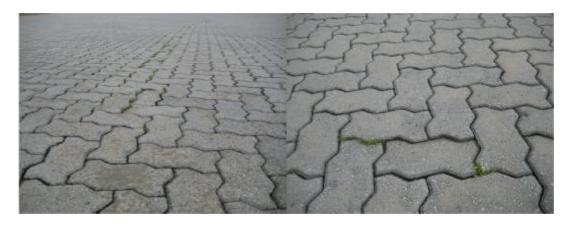
# 6.3 Lipping

Lipping is characterised by a change of level between one paving block and the adjoining paving block.

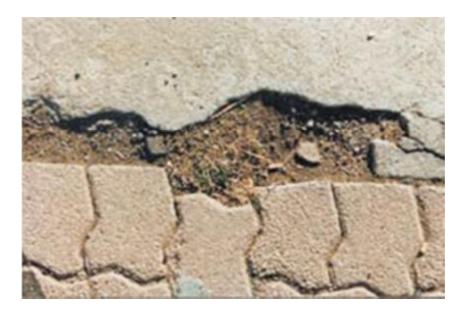
## 6.4 Loss of Edge Restraint

Interlocking concrete block paving requires edge restraints to prevent the lateral movement of the paving units, particularly at pavement edges. Lateral movement allows pavers to move under load, resulting in larger joints and an unstable surface.

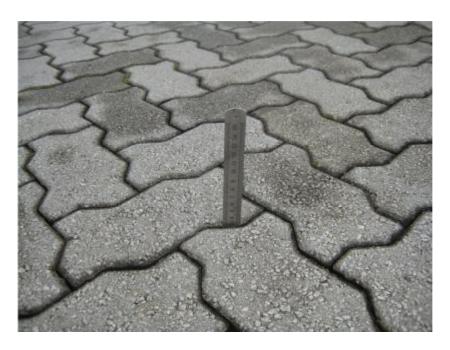
## 6.5 Loss of Joint Filling Sand

Erosion of the joint filling sand, either generally or localised, from the joints between the paving units may result in the units rotating, spalling or becoming loose.

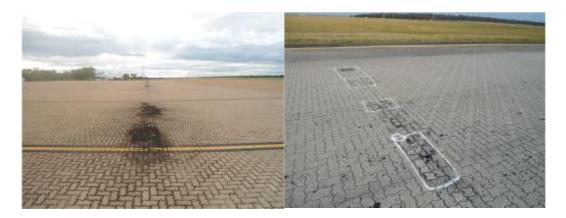
## 6.6 Surface Depressions

Localised depressions may occur due to subsidence in the subgrade, inadequacies in the compaction of underlying pavement and/or subgrade layers, loss of bedding sand, loss of interlock from cut AGL slots, or incorrect pavement design and/or construction. Shallow surface depressions hold water and silt and reduce the riding quality of the pavement surface, but should not affect the load carrying capacity.

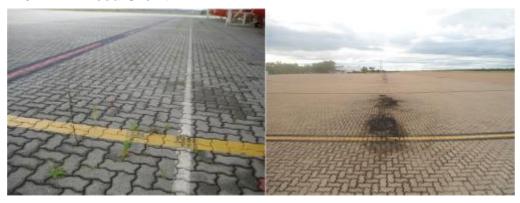
#### 6.7 Weed Growth

#### Description

Weed growth within the joints. Moss, mould and silt build up on the surface of the blocks which can be an OH&S issue.

Replace lost jointing sand ('top-up') with new joint filling sand complying with the particle size distribution specified in Section 12.3 and seal. Alternatively, proprietary stabilised sands such as 'SuperSand', 'Pave-Lok' or 'Gap Sand' may be used. Liquid applications such as ACM Pavseel and Resiblok 22 can also be used to seal the filling sand.

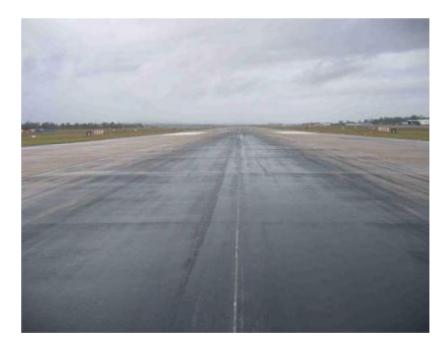
There are two (2) methods currently in use for the removal of tyre rubber deposits on all types of runway surfaces.

The first method employs chemicals combined with high/medium pressure water jetting. This is currently Defence's least preferred option due to the potential environmental risks.

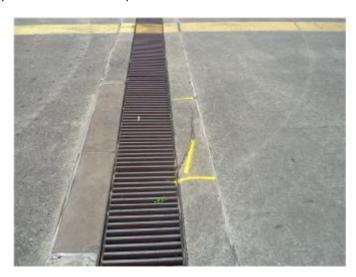
By far the most common problem associated with drains and pits is opening of the interface between the structure itself and the adjacent pavement. As drains and pits are located in low points, such openings can allow the entry of water. In pavements constructed over clean sand, this may not be an issue. However, in pavements constructed over clay or silt materials, the change in moisture content can lead to softening of the subgrade with associated pavement strength and level problems. In highly expansive clays, the entry of water can lead to significant heaving. There have been examples where such heaving has resulted in the trench drain or pit not being at the lowest point in the pavement.

Sealing of the interface between the drain or pit and the adjacent pavement should be a high priority maintenance item. In concrete pavements, this interface should be sealed as for a crack or joint (ie: using a flexible joint sealant). In flexible pavements, the opening should be sealed as for a crack, or alternatively, the interface should be subjected to RBB (over banding).

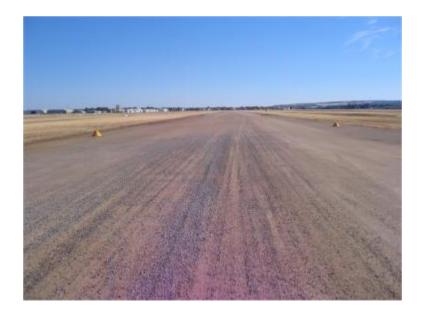
Common defects include corrugations, potholes, rutting, slippery surface, scouring, softening, ravelling and loose particles. Where the functionality of an unsealed pavement is affected by these defects, the same material or a material with similar properties to the parent material should be added. The pavement should then be re-shaped and re-compacted as appropriate in layers not greater than 100mm in thickness.

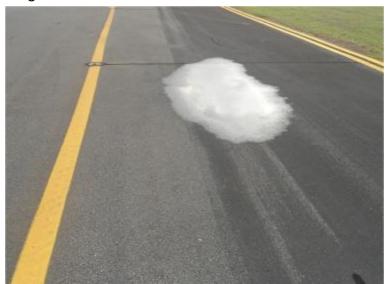
## 7.13 Surface Irregularities

CASA MoS 139 (2012) Chapter 10.15.4. notes that aerodrome operators must maintain the surface of paved runways in a condition such as to preclude excessive bouncing, pitching, vibration or other difficulties with control of aircraft and further notes that paved runway surfaces should be maintained so that standing water is neither formed nor retained. Birdbath depressions should be repaired at the earliest opportunity.

CASA MoS 139 (2012) Chapter 6.2.9.1 also provides limits of surface regularity on runways and notes "the finish of the surface of a runway should be such that, when tested with a 3m straight-edge placed anywhere on the surface, there is no deviation greater than 3mm between the bottom of the straight-edge and the surface of the runway pavement anywhere along the straight-edge".

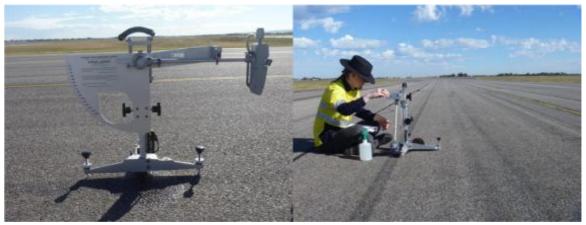
**British Pendulum Swing Test**

The test is undertaken to AS/NZS 4663 (2004) (both BS7976 and NSW RTA Test Method T130.2) to measure the British Pendulum Number (BPN) (and in turn, an approximate Coefficient of Friction).

Since 2011, Defence having been using the British Pendulum Swing Test to measure the relative BPN before and after application of PME surface treatments on a number of runways and taxiways.

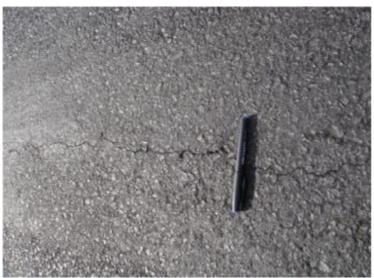
**Example of Low Severity Cracking**

Low severity cracks are cracks of hairline width or barely visible (typically less than1mm wide) with or without associated spalling, but little or no potential for dislodgement of particles (typically with a spall width less than 25mm).

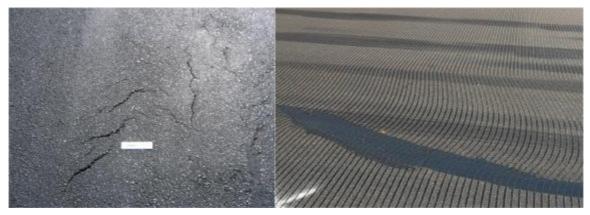
### 10.2.5 Slippage Cracks

Slippage cracks are half-moon or crescent shaped cracks, commonly associated with the slippage and deformation of the wearing course under horizontal wheel loads (braking and/or turning of aircraft). Cracks occur in a closely spaced parallel group, confined within the slipped asphalt layer.

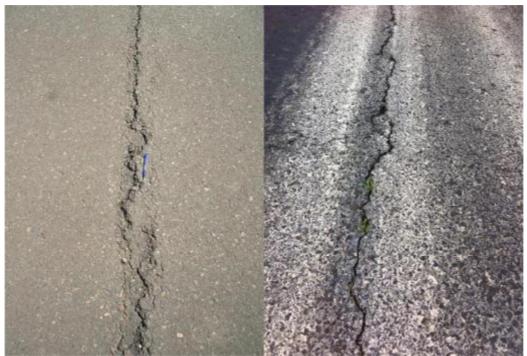
Reflection cracks are caused by movement at joints or cracks in the underlying concrete slab, cement stabilised layer or previous asphalt surface.

**Examples of Severe Reflection Cracking in Asphalt Pavements**

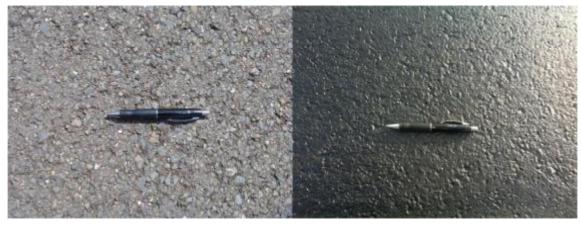
Example of PME Surface Treatment (Before and After)

In recent years, the use of PMEs have been favoured over SESTs. This has been due to OHS issues associated with Coal Tar SESTs and also OHS issues around the use of powerful solvents (such as Shell A1 solvent) in cut back SESTs. These powerful solvents often have dangerously low flash points and are governed by strict legislation regarding their storage and handling. SESTs cut back with kerosene can have excessive curing times (often in excess of seven (7) days) meaning they are often impractical for operational aircraft pavements. These issues have led to the development of various emulsion based materials that are being increasingly used in SEST style rejuvenate applications.

Larger sized asphalt mixes can usually accept more residual binder than finer mixes due to a greater surface texture depth.

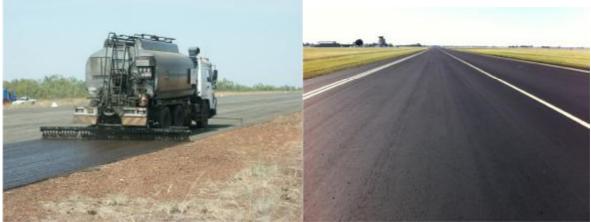
PME Application to Chip Seal Surface (Mount Bundey - August 2012) - Aged Asphalt - Pavement Treated with PME

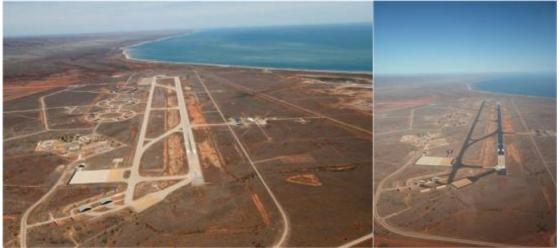
RAAF Base Learmonth - Before and After PME Surface Treatment in November 2011

The PME must be applied to a clean and dry surface and all rubber deposits removed. On large projects, the use of specialist spray trucks is recommended. Trials are required to determine the application rate for each asphalt surface and the rate will depend on the texture of the surface. Some very coarse areas may require a pre-treatment of PME.

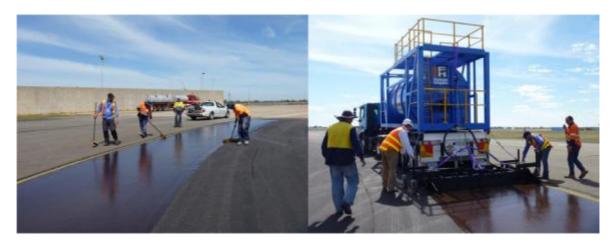
PME Application at RAAF Base Edinburgh in 2012

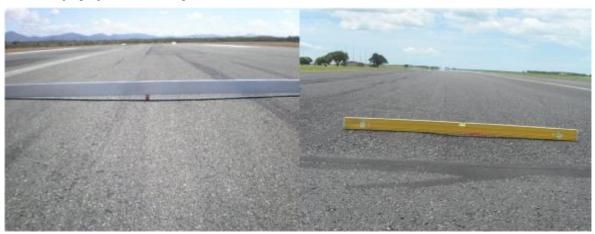
**Examples of Deformation in an Aircraft Wheel Path**

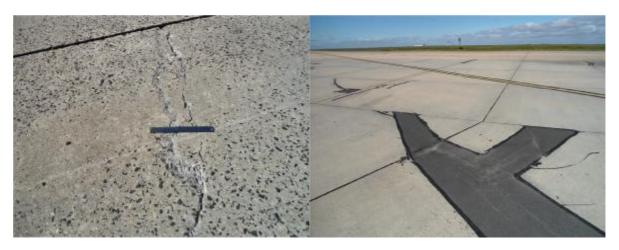
Examples of Cracked Concrete Pavements and Repaired Pavement Requiring Repair

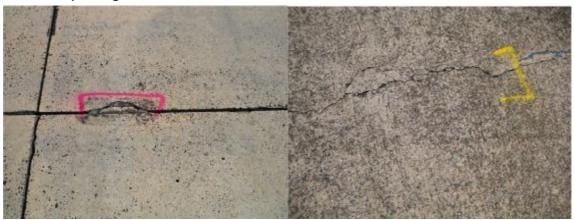
### 11.4 Spalling

The objective of repairing spalling adjacent to joints and cracks in concrete pavements is to:

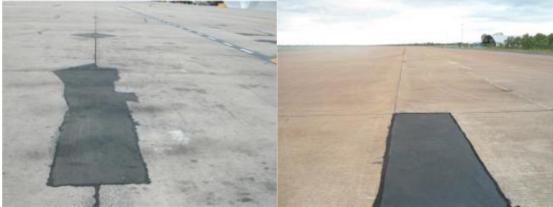
Examples of asphalt patches constructed in concrete pavements are shown in the photographs below.

Examples of Hot Asphalt Joint and Corner Spall Repairs in Concrete Pavements

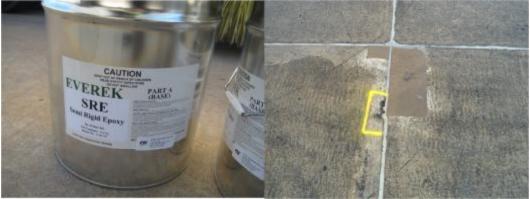
SRE(S) Repairs in Concrete Pavements

The procedure for installing the SRE(S) is as follows:

- (a) Remove loose spalls and adjacent jointing material (if any) from cavity;
- (b) Prepare the surface of the spall cavity as detailed in Section 11.4.3.1 (d) (i);
- (c) Reduce the level of the spalled area by use of hand tools, scabbler or cold planer to a roughly horizontal surface at generally the same level as the deepest level of the spall or saw cut whichever is the lower, but not less than 50mm;
- (d) Blow the repair clean of dust debris and standing water using oil-free compressed air; and
- (e) Install the SRE(S) strictly in accordance with the manufacturer's instructions.

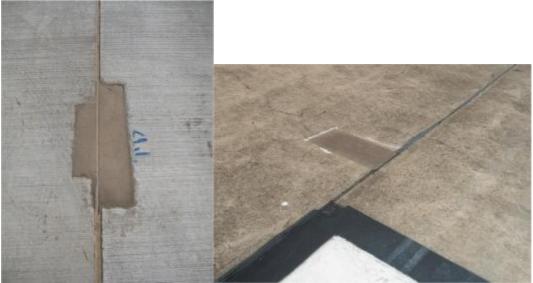
Examples of Semi Rigid Epoxy (SRE(S)) Repairs in Concrete Pavements
