CALIBRATION AND LAG OF A FRIEZ TYPE CUP ANEMOMETER

TECHNICAL NOTE NO. 341.

CALIBRATION AND LAG OF A FRIEZ TYPE CUP ANEMOMETER.

By Robert M. Pinkerton,

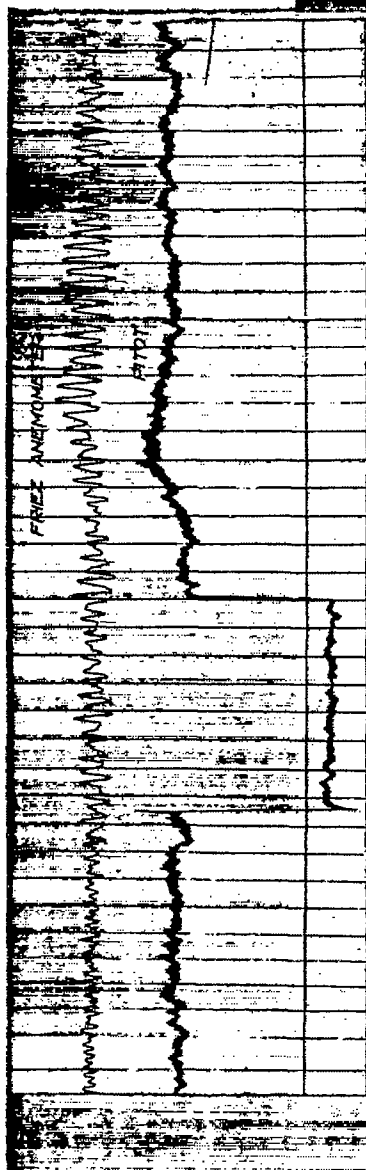
Fig. 4 Copy of photographic record of airspeed indications as an obstruction is suddenly placed in front of Pitot and then suddenly removed. (Timing lines are at 1/2 second intervals).

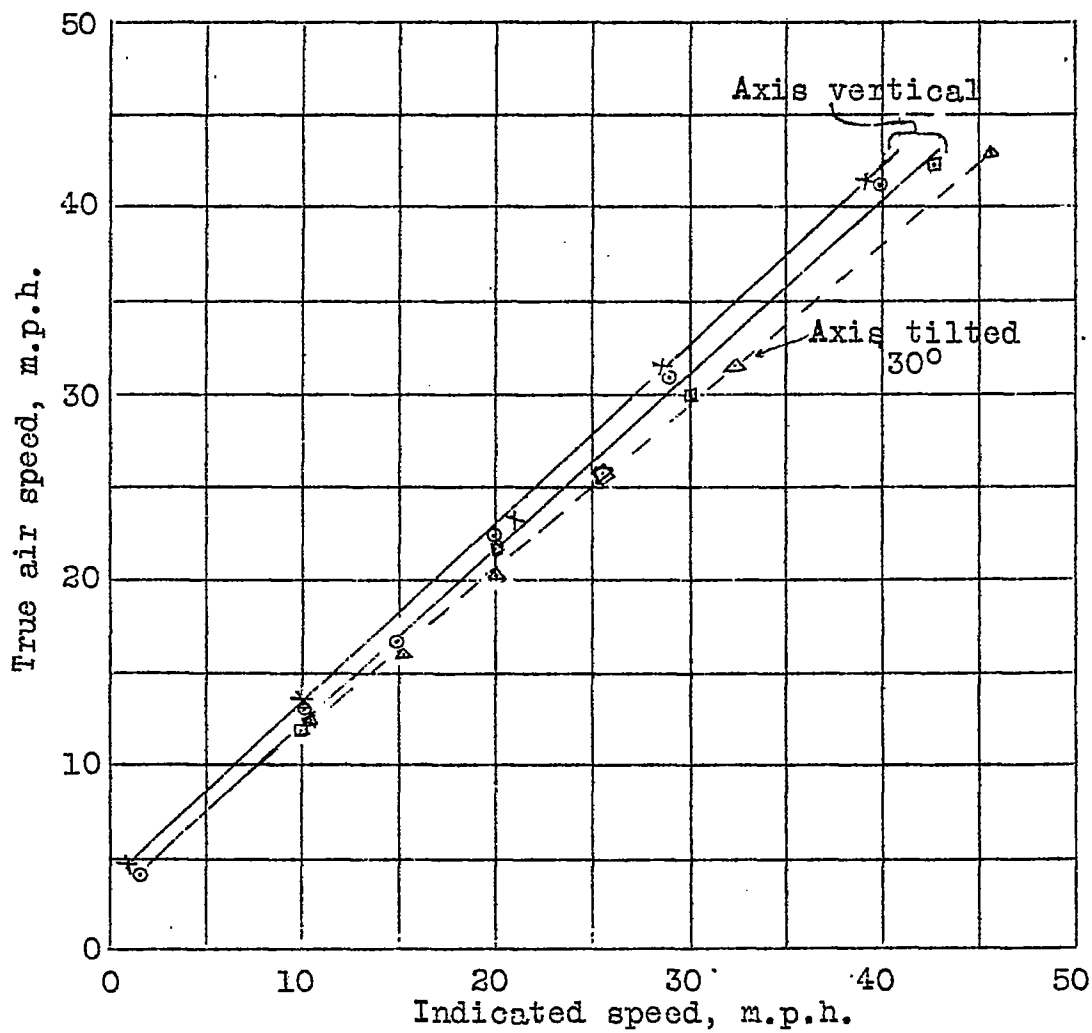
Fig.2 Calibration curves of Friez type cup anemometer.

The results are presented as calibration curves (Fig. 2), lag curves (Figs. 5 to 10), and friction data (Table I). The calibration curves are obtained by plotting the true air speed, as measured by the Pitot-static tube, against the speed indicated by the anemometer. The lag was determined by comparing curves of air speed versus time in seconds from the Pitot-static

Because of the proximity of the Pitot-static tube to the rotating cups of the anemometer, it was thought that the interference of the anemometer upon the air flow about the Pitot might be appreciable. Hence, to determine the amount of this interference the velocity of the air stream was calculated from the static pressure obtained by means of a static-pressure orifice, located in the return passage of the tunnel and calibrated against a Pitot-static tube placed in the center of the air stream, the anemometer being removed. This velocity was compared with that calculated from the Pitot-static tube with the anemometer in place, and the results indicated that there was no appreciable interference between the anemometer and the Pitot-static tube. Figure 2 indicates two factors which affected the instrument calibration, namely, the attitude of the anemometer with respect to the air stream, and the density of the air. With the axis inclined forward 30 degrees the indicated velocity was approximately 6 per cent higher than it was with the axis vertical. At the reduced pressure, the indicated velocity was approximately 6 per cent lower than it was at atmospheric pressure, indicating that an altitude factor should be applied to the latter calibration. Another factor which may have affected the calibration is that the instrument was

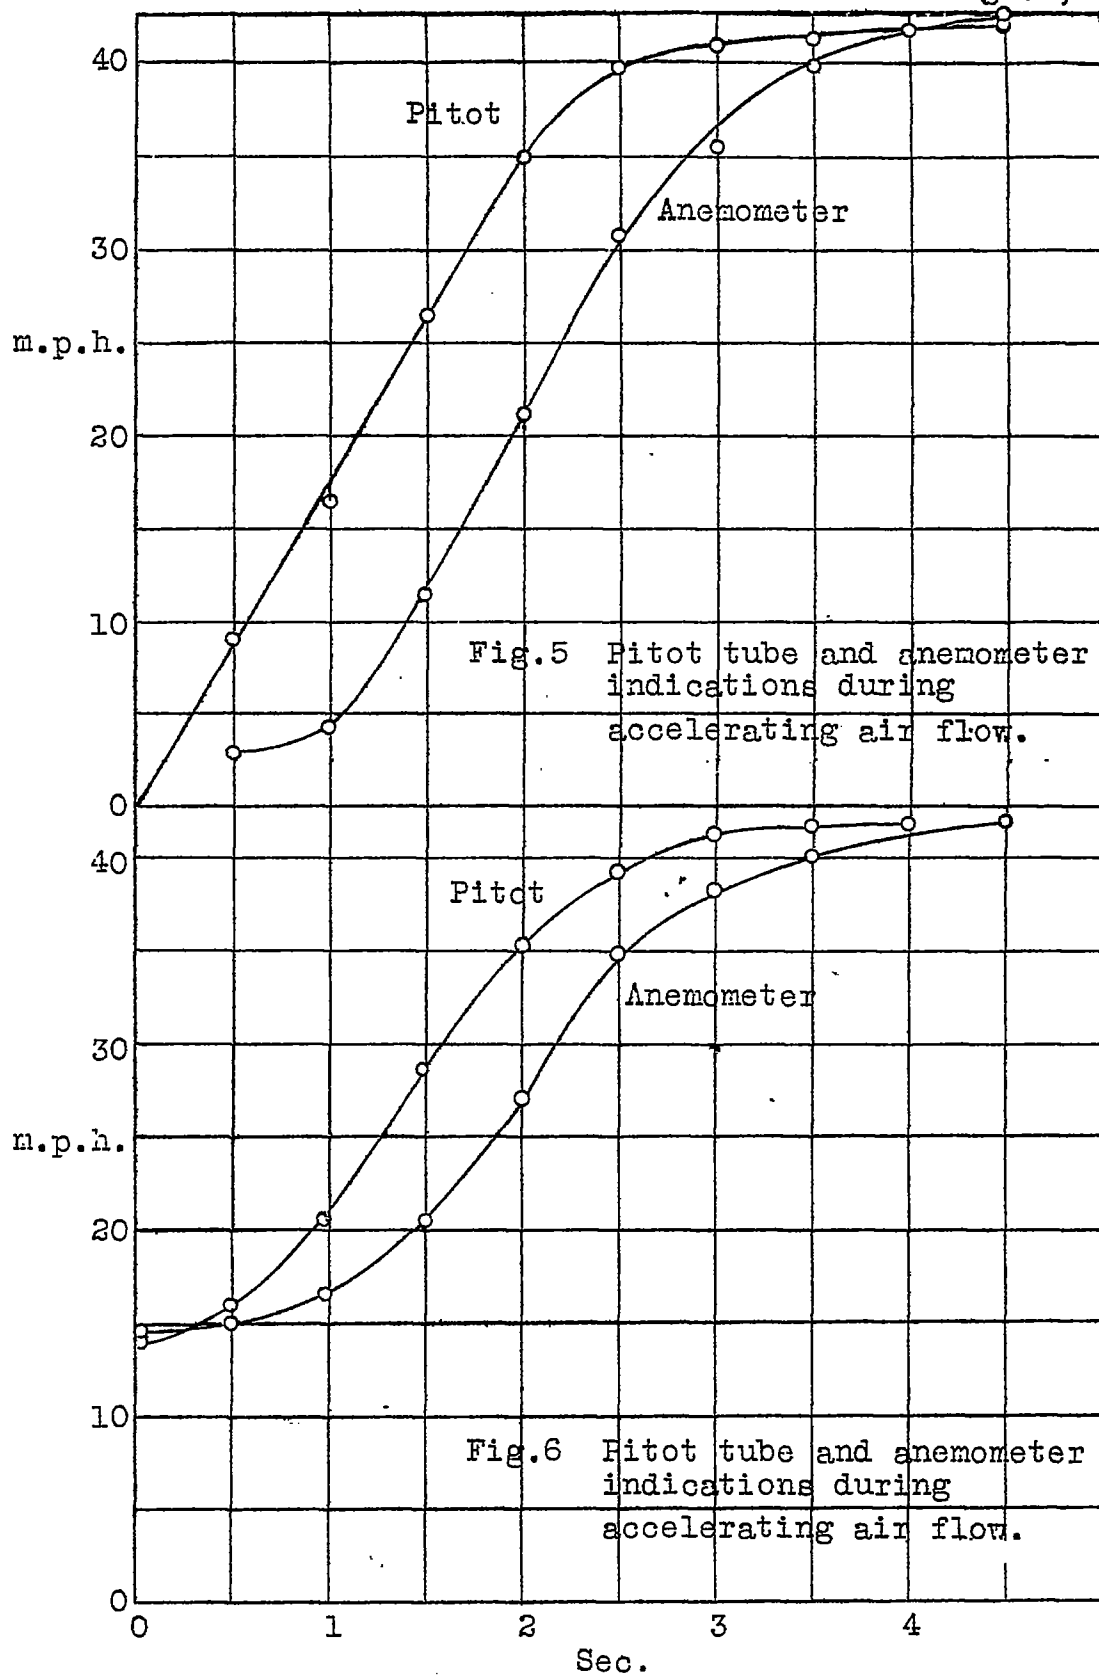
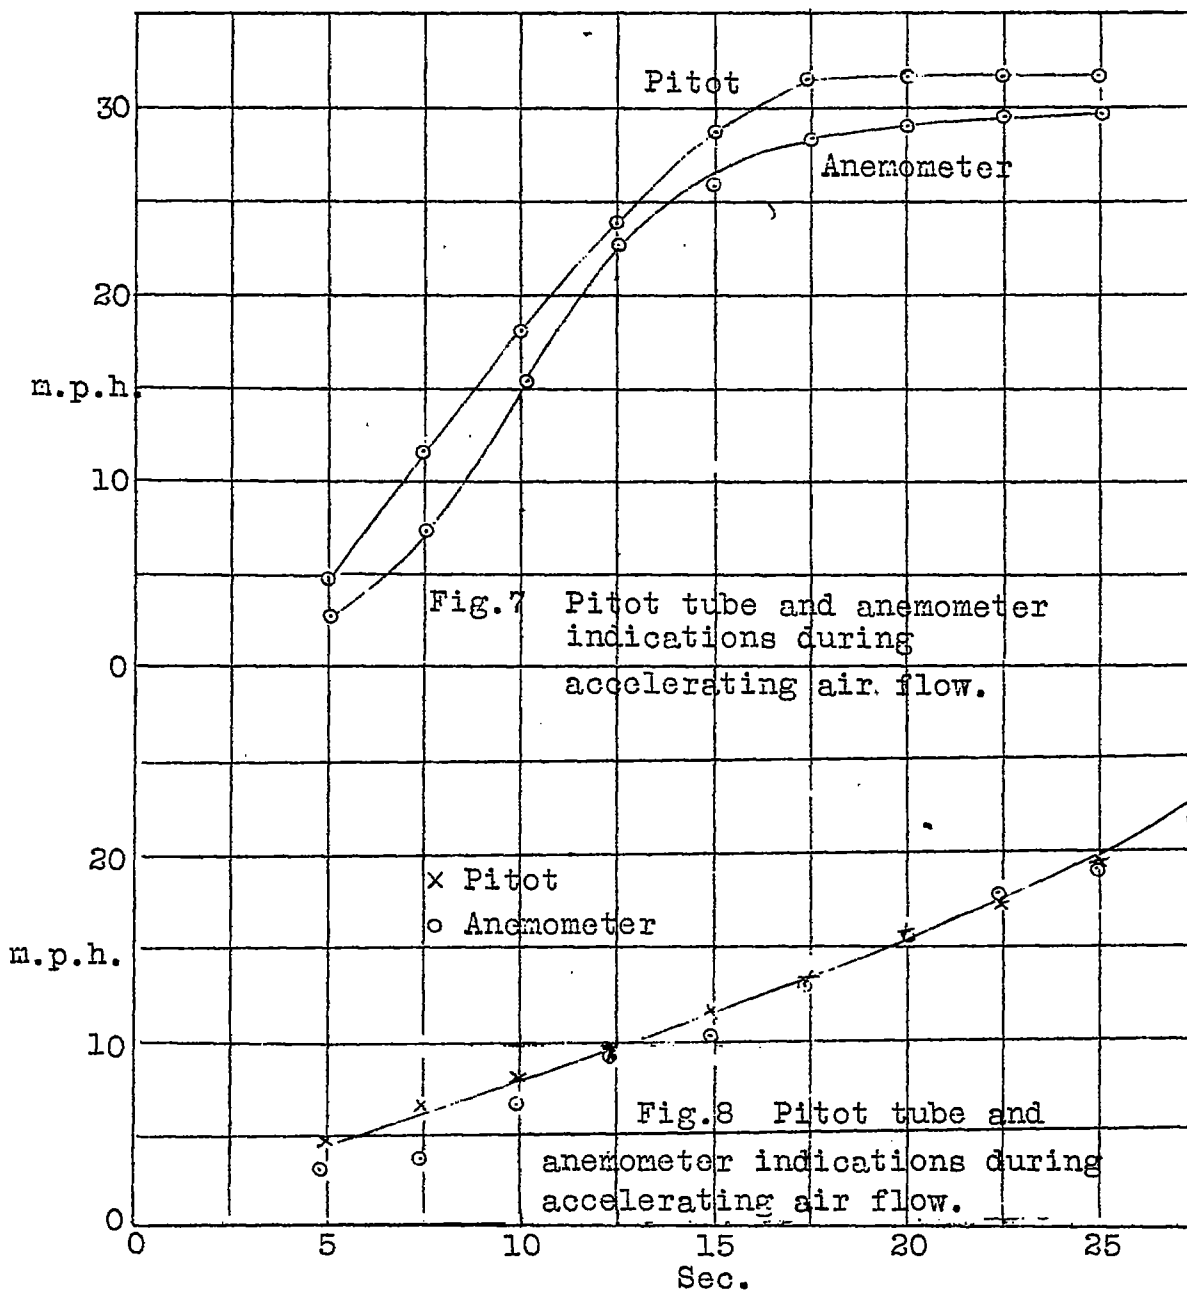
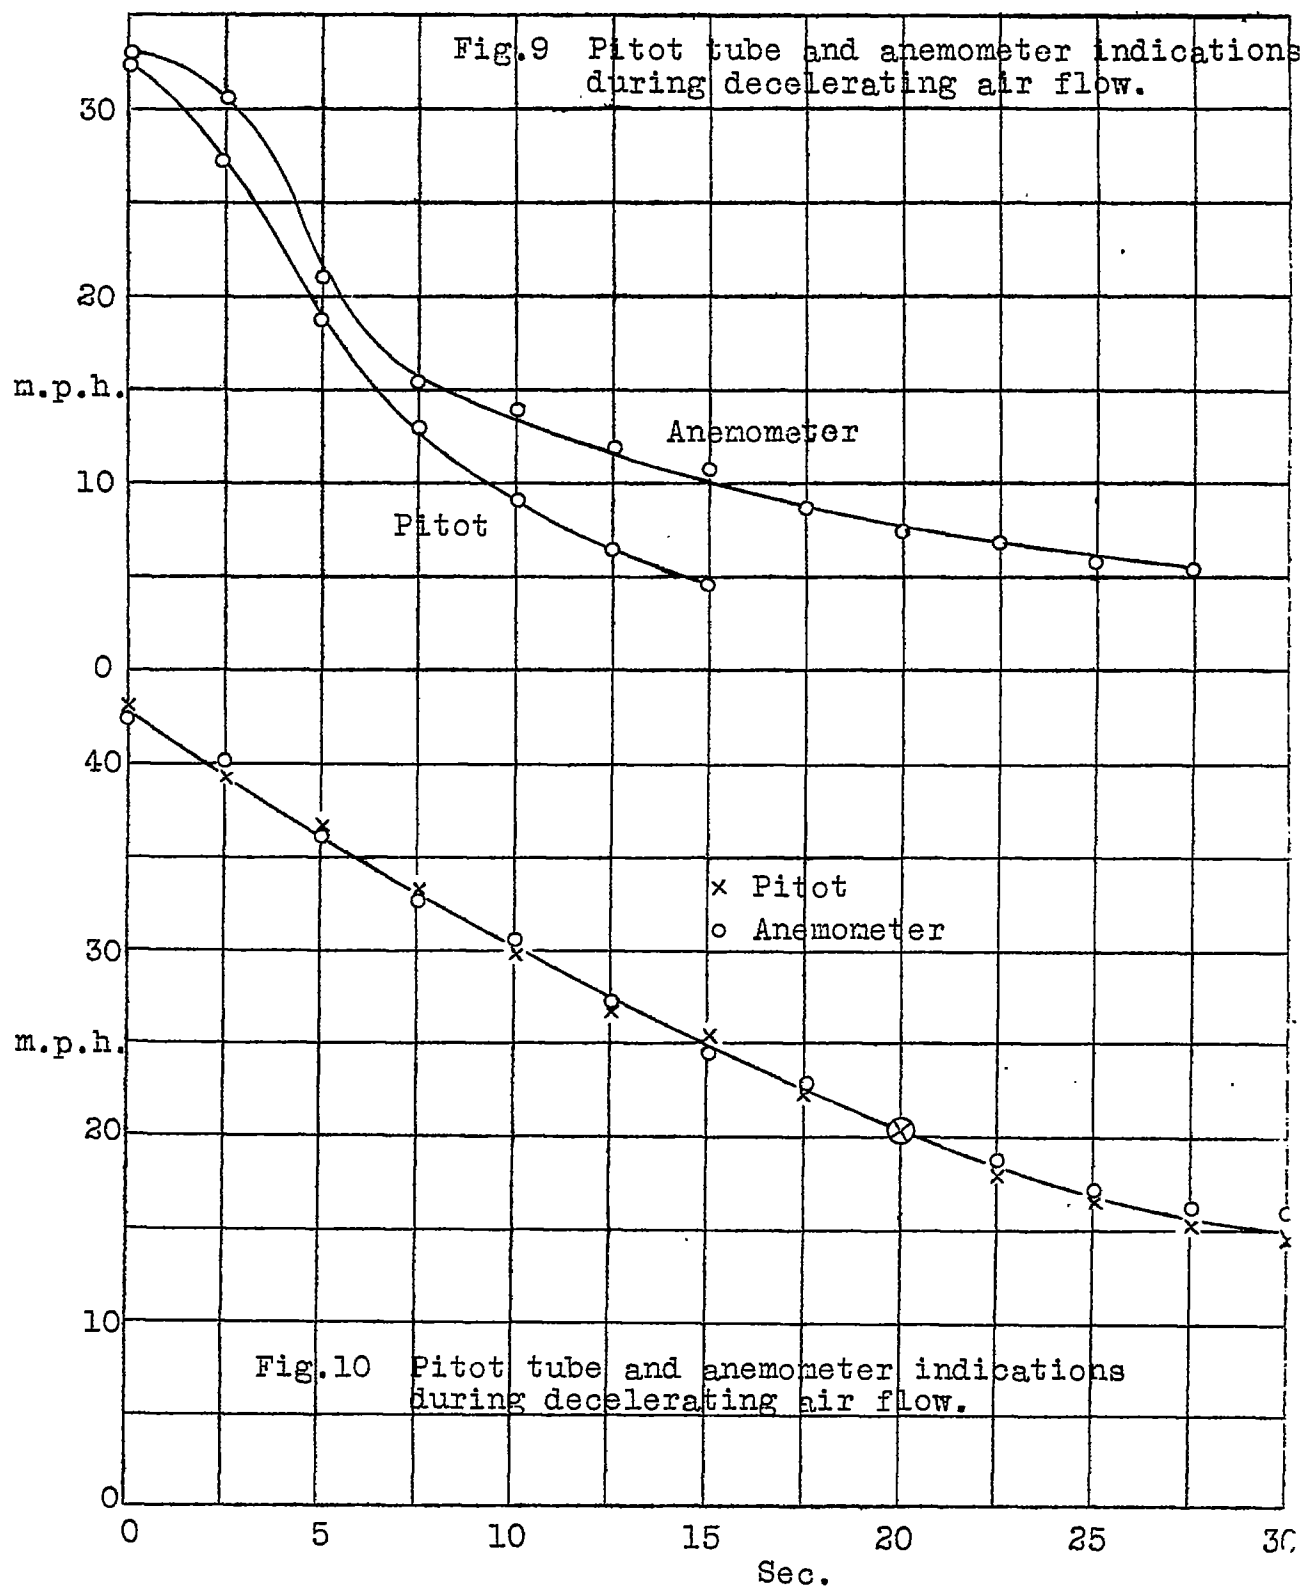
Figs.5,6

Unpublished data on wind velocities obtained by the flight research section of the Langley Memorial Aeronautical Laboratory reveal that wind accelerations of 64 m.p.h. per second are sometimes reached and accelerations of 7.5 m.p.h. per second are common. Figure 6 shows that for accelerations of approximately 9 m.p.h. per second the anemometer experiences a lag of about  $1/2$  second. In the light of these data it is con-
