DOT/FAA/AR-02/121

Guidelines for Analysis, Testing, and Nondestructive Inspection of Impact- Damaged Composite Sandwich Structures

March 2003

Final Report

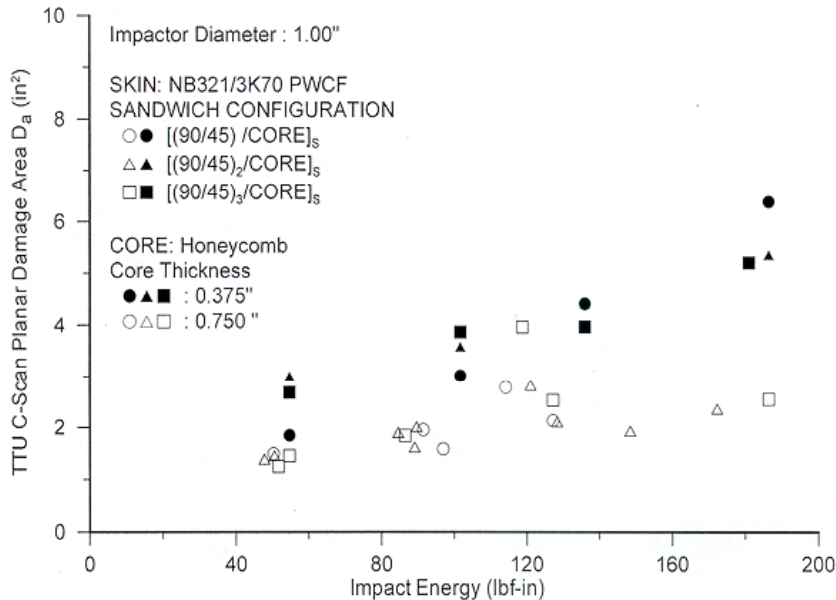
FIGURE 2-8. PLANAR DAMAGE RELATIONSHIP AS A FUNCTION OF IMPACT ENERGY FOR THE RELATIVELY SHARP (1") IMPACTOR

structure may experience during its service life. Figures 2-8 and 2-9 show the relationship between planar damage area and impact energy for a small (relatively sharp) (1") impactor and a blunt (3") impactor, respectively. As seen from these figures, the impact diameter plays a large role in the resulting planar damage area. It is also interesting to note the role that the core thickness plays with respect to planar damage area (particularly for high-energy impacts).

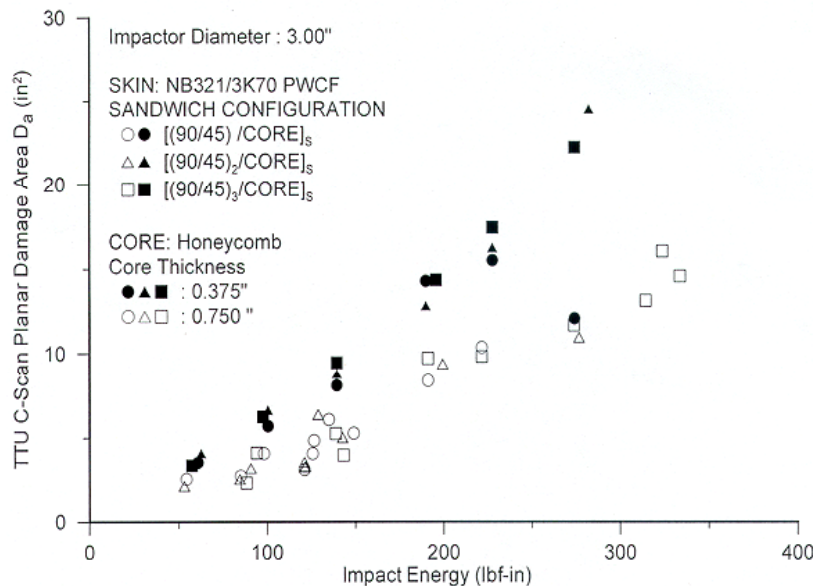
FIGURE 2-9. PLANAR DAMAGE RELATIONSHIP AS A FUNCTION OF IMPACT ENERGY FOR THE BLUNT (3") IMPACTOR

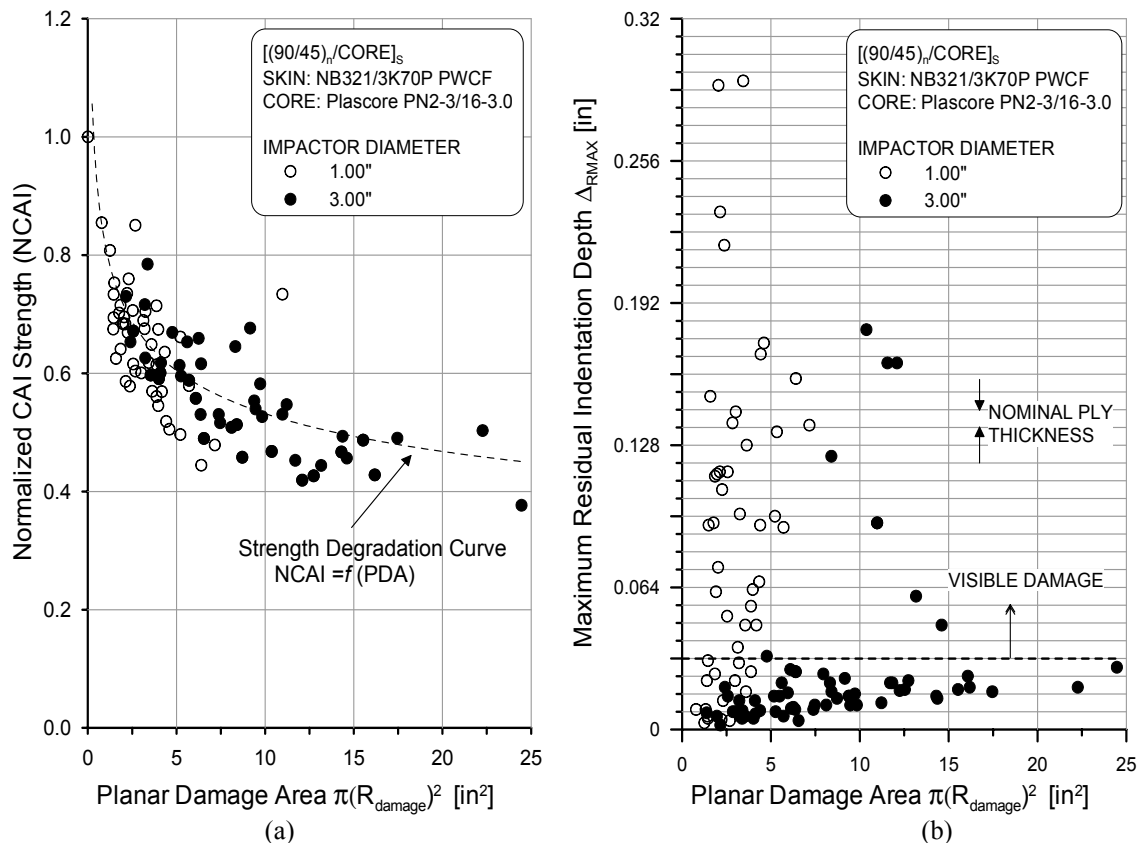
FIGURE 2-10. (a) NORMALIZED RESIDUAL STRENGTH FOR [(90/45)_n/CORE]_s (n=1,2,3)* SANDWICH PANELS WITH HONEYCOMB CORE (3/8" AND 3/4" THICK) AND (b) VARIATION OF MAXIMUM RESIDUAL INDENTATION DEPTH WITH PLANAR DAMAGE AREA FOR THE SANDWICH PANELS

The normalized (to undamaged strength) residual strengths of sandwich panels impacted with 1" and 3" diameter impactors are plotted as a function of planar damage area in figure 2-10(a). It can be observed that the data is scattered around a hypothetical degradation curve irrespective of the impactor diameter. However, the data points corresponding to the smaller diameter impactor are spread over the initial portion of the curve, while those of the larger impactor fall over the asymptotic region of the curve. The impact damage states in practice will only undergo a posteriori analysis based on the damage metrics, without any knowledge of the associated impact energies. The maximum residual indentation has been typically used as a measure of the severity of impact damage. The threshold of detectability based on the residual indentation is known as Barely Visible Impact Damage. There is no consensus on a standard value for the BVID, even though it has been assumed that the strength degradation is proportional to the residual indentation depth. It has been shown in the previous study [3] that the maximum residual indentation depth does not necessarily correlate well with the CAI strength. It can be seen from figure 2-10(b) that large planar damage areas can exist while the maximum residual indentation is on the order of a few ply thicknesses (0.008" in this case). Thus, it was concluded that residual indentation depth is not a reliable indicator of impact damage; rather, the planar damage size better reflects the residual strength degradation in sandwich panels. To quantify the planar damage, damage state, or the structure's residual strength capability, it becomes necessary to identify damage detection techniques and their effectiveness in light of this observation.

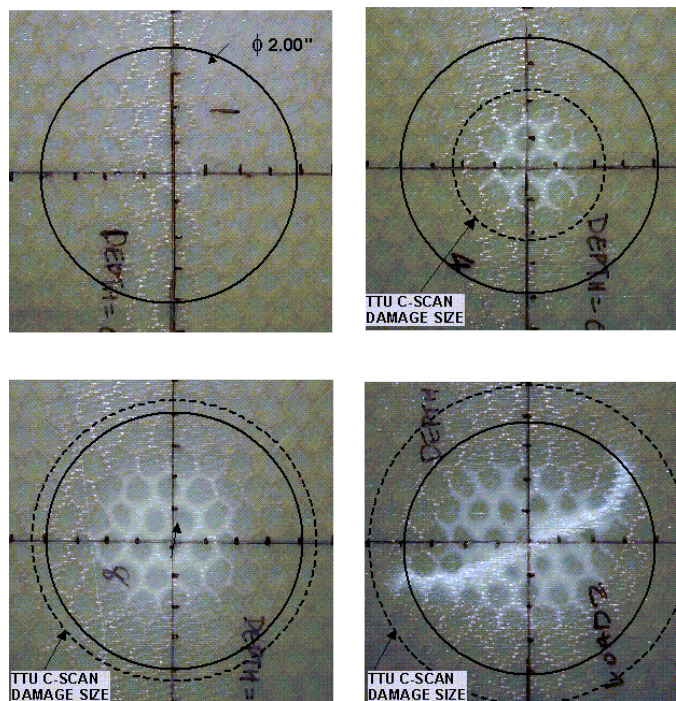
FIGURE 2-11. TYPICAL NETWORK OF DELAMINATIONS OBSERVED IN $[(90/45)_2/\text{CORE}]_s$ SANDWICH PANELS WITH FIBERGLASS FACESHEETS AND HONEYCOMB CORES, IMPACTED WITH A 3.00" DIAMETER IMPACTOR

The facesheet damage was observed to initiate in the form of delaminations between the plies adjacent to the facesheet-core interface, and these delaminations occurred above the honeycomb cell walls [9]. A network of delaminations was observed at higher-impact energy levels. The area over which delamination networks occurred was found to increase with impact energy up to the point when facesheet fracture was initiated. The typical delamination network in sandwich panels impacted with the 3.00" diameter impactor are illustrated in figure 2-11. It was observed that the damage area measured by the TTU C-scan method was consistently higher than the area corresponding to the facesheet delaminations. This implies that, in practice, the facesheet damage may go undetected in the absence of a conspicuous facesheet fracture. Further, the presence of a layer of paint or a nontranslucent facesheet will make it difficult to detect these facesheet damage states.

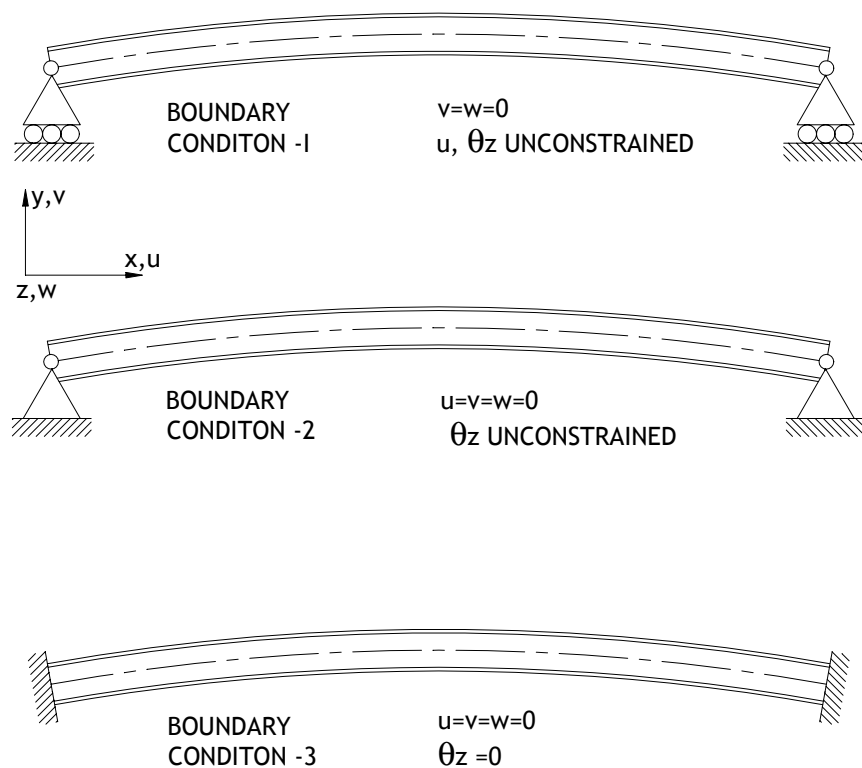
FIGURE 2-15. BOUNDARY SUPPORT CONDITIONS USED DURING IMPACT TESTING OF CYLINDRICAL SANDWICH PANELS

The cylindrical sandwich specimens were impacted on the convex side at their respective geometric centers. The specimens were supported along their longitudinal edges using three different boundary supports with varying degrees of end fixity. The boundary conditions investigated in this study are illustrated in figure 2-15.

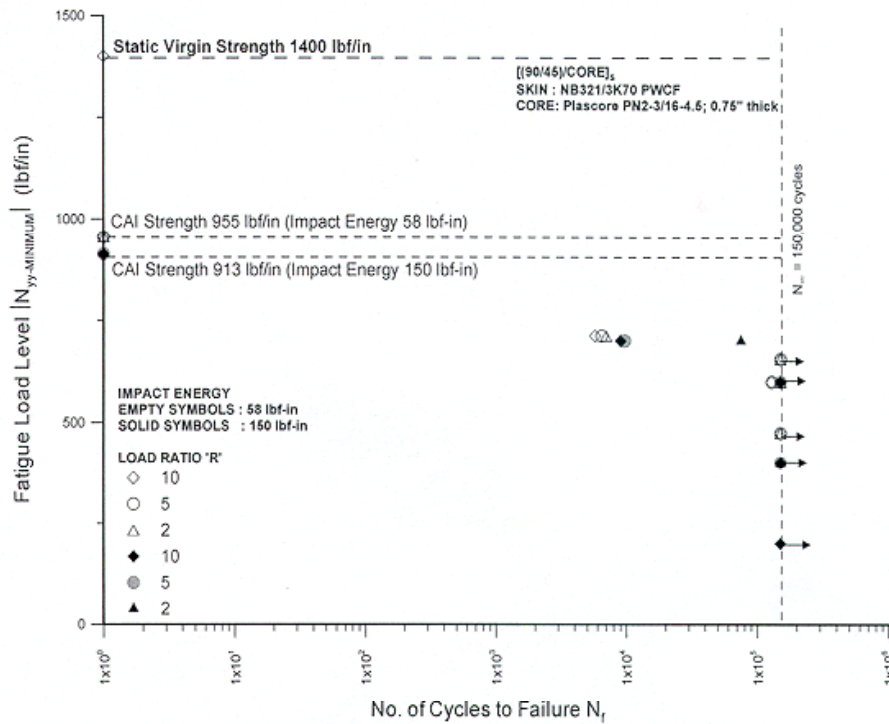
FIGURE 2-21. FATIGUE LIFE DATA FOR [(90/45)/CORE]_s SANDWICH PANELS WITH HONEYCOMB CORE

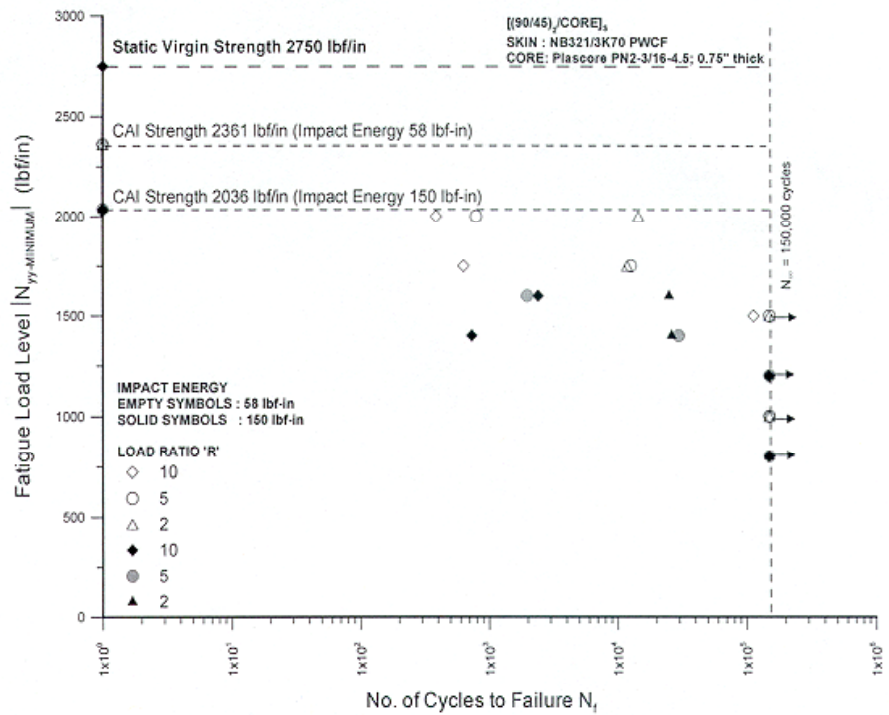
FIGURE 2-22. FATIGUE LIFE DATA FOR [(90/45)₂/CORE]_s SANDWICH PANELS WITH HONEYCOMB CORE

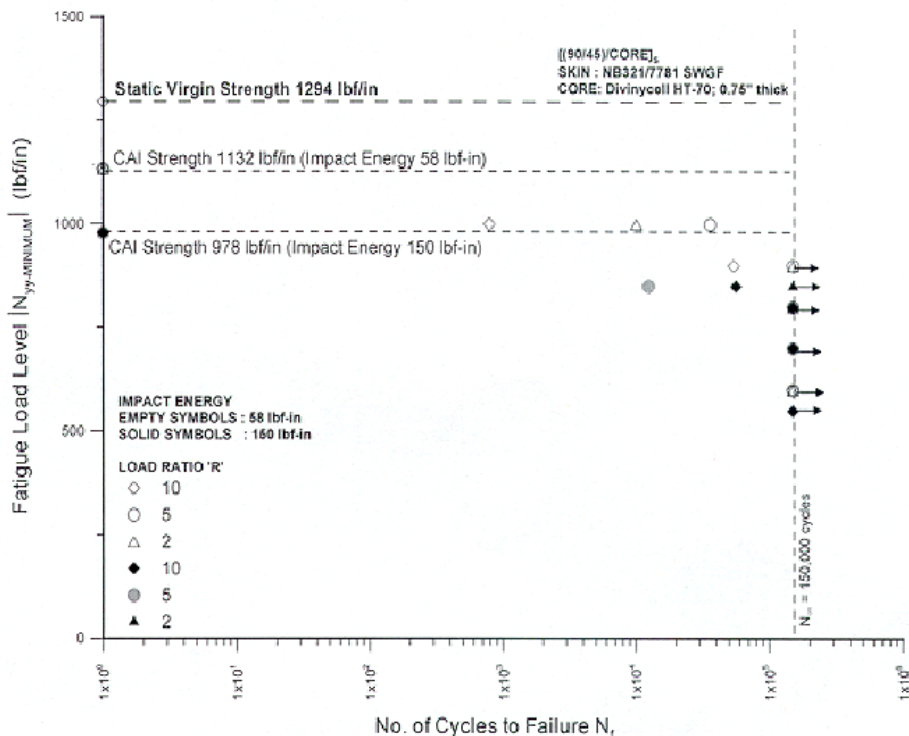
FIGURE 2-23. FATIGUE LIFE DATA FOR [(90/45)/CORE]_s SANDWICH PANELS WITH FOAM CORE

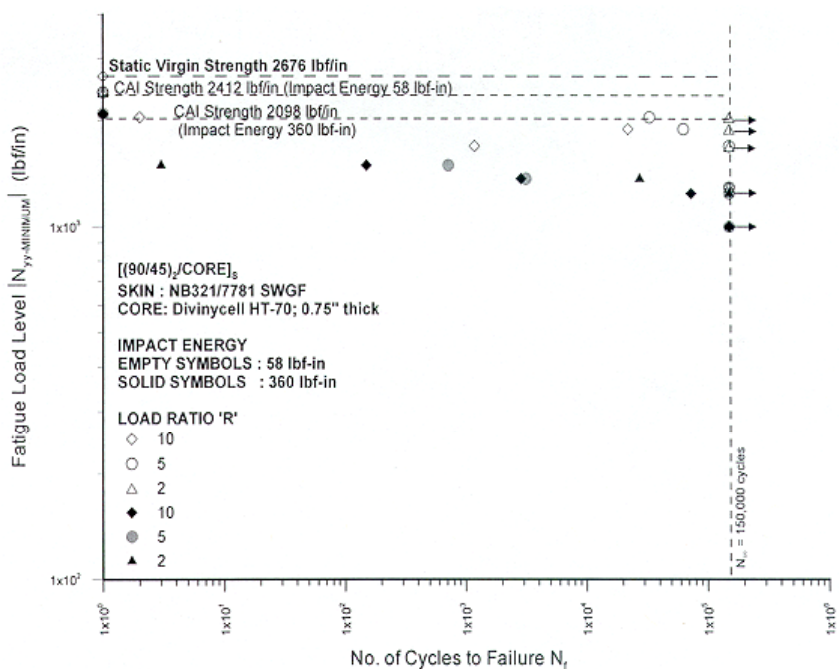
FIGURE 2-24. FATIGUE LIFE DATA FOR [(90/45)₂/CORE]_s SANDWICH PANELS WITH FOAM CORE

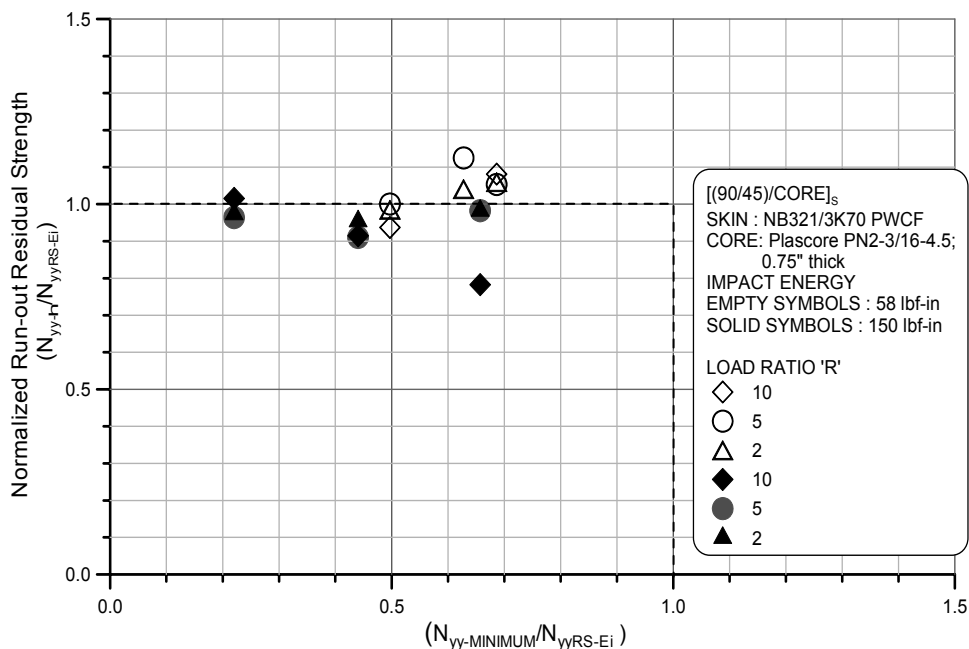
FIGURE 2-25. RESIDUAL STRENGTH DEGRADATION FOR $[(90/45)/CORE]_s$ SANDWICH PANELS WITH HONEYCOMB CORE

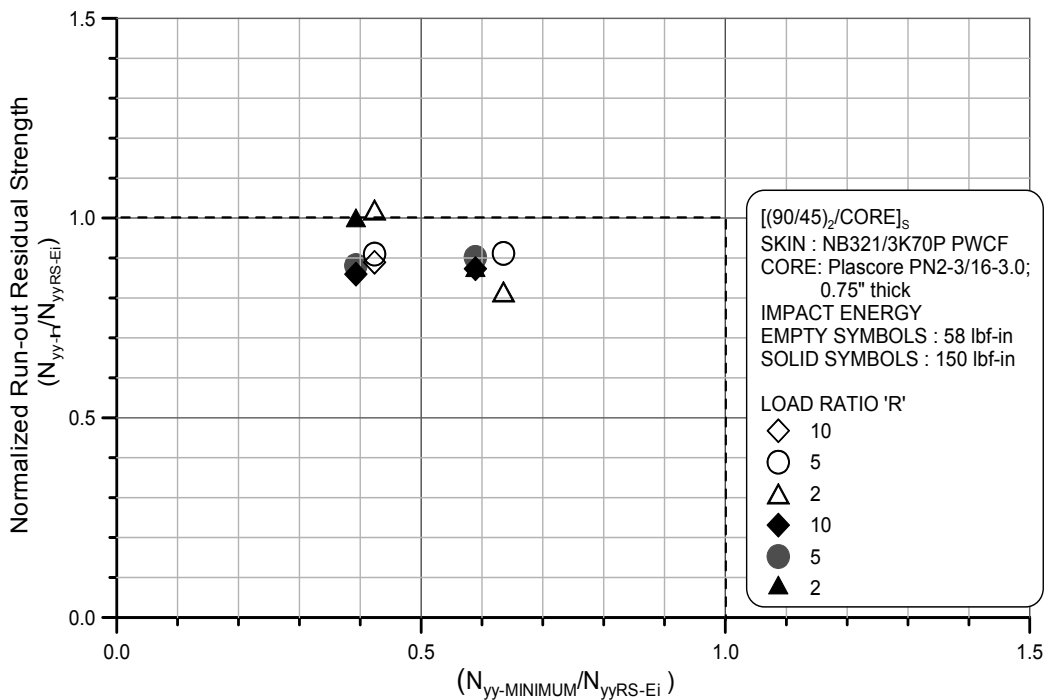
FIGURE 2-26. RESIDUAL STRENGTH DEGRADATION FOR [(90/45)₂/CORE]_s SANDWICH PANELS WITH HONEYCOMB CORE

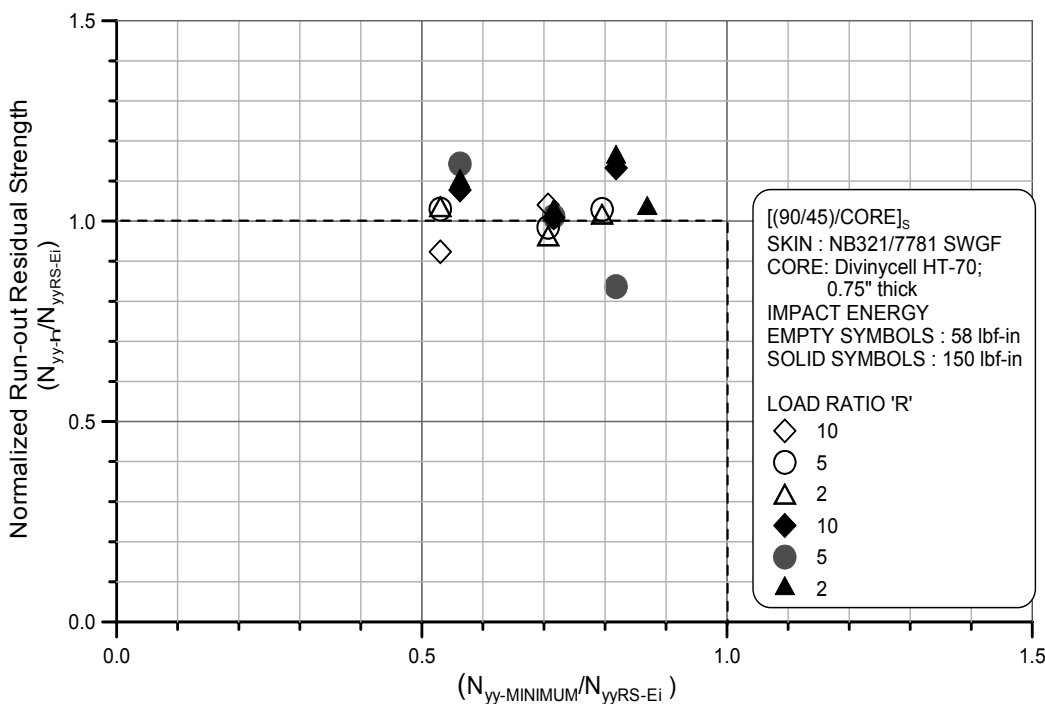
FIGURE 2-27. RESIDUAL STRENGTH DEGRADATION FOR [(90/45)/CORE]_s SANDWICH PANELS WITH FOAM CORE

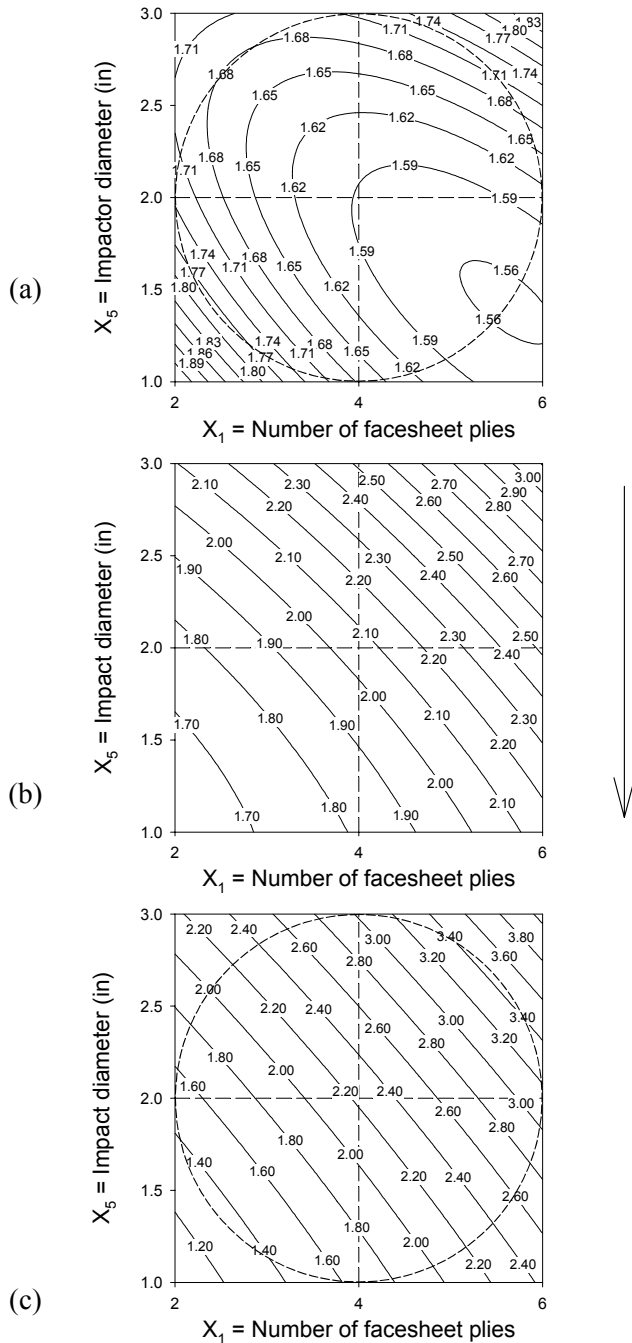
FIGURE 3-1. PREDICTED DAMAGE DIAMETER (in.): (a) $X_4 = 90.0$ in-lb, (b) $X_4 = 120$ in-lb, AND (c) $X_4 = 150$ in-lb

These response surface estimates of the size of the planar damage region typically associated with core crushing suggest that the damage development is somewhat sensitive to the velocity of the impactor. Midrange values of impact velocity resulted in damage estimates that were a relative minimum. Similar to earlier results, an increase in the number of facesheet plies and/or impact energy tended to result in an increase in the estimated planar damage dimension for a given set of impact parameters. Response surface results show that the residual facesheet indentation due to impact is also impact velocity dependent. However, as the response surface was constructed on the basis of 3.0-in.-diameter impactor (shallow indents), the validity of this response surface is questionable.

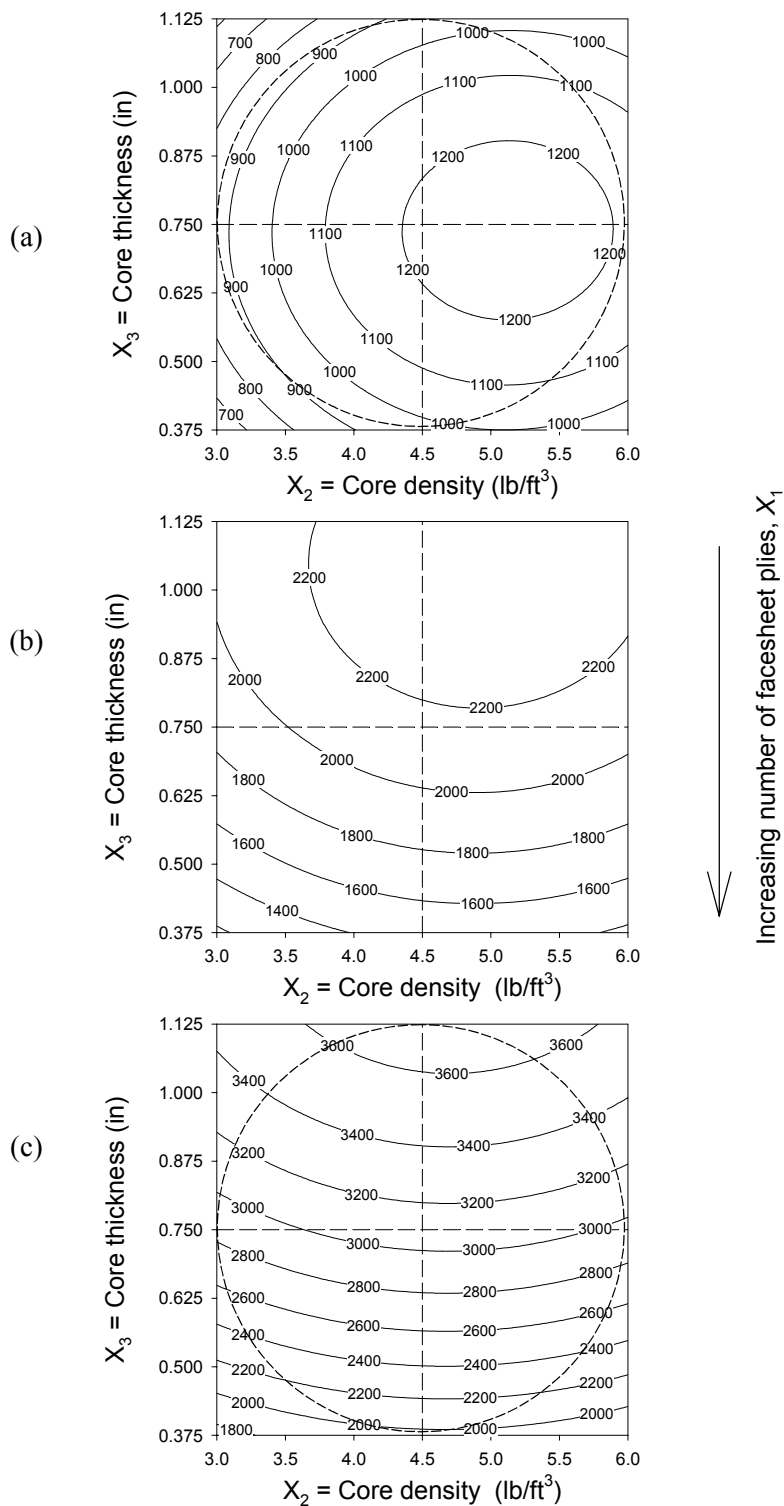
FIGURE 3-2. PREDICTED RESIDUAL STRENGTH (lbs/in): (a) $X_1 = 2$ PLIES $[90/45]_1$, (b) $X_1 = 4$ PLIES $[90/45]_2$, AND (c) $X_1 = 6$ PLIES $[90/45]_3$

For the relatively blunt object impacts considered here, enhanced penetration resistance associated with an increase in the number of facesheet plies often results in CAI failure processes characterized by facesheet dimple propagation across the width of the test specimen [3]. The applied load level (e.g., strength) at which this process initiates apparently is influenced by core thickness (e.g., increasing the core thickness may provide enhanced bending rigidity that serves to delay the onset of facesheet dimple propagation). The peak predicted CAI strength occurs in the vicinity of $X_2 = 6.0 \text{ lb/ft}^3$ and $X_3 = 9/8 \text{ in.}$; the strength is a relative minimum for $X_2 = 3.0 \text{ lb/ft}^3$ and $X_3 = 3/8 \text{ in.}$, corresponding to the extreme ranges of the tested values.

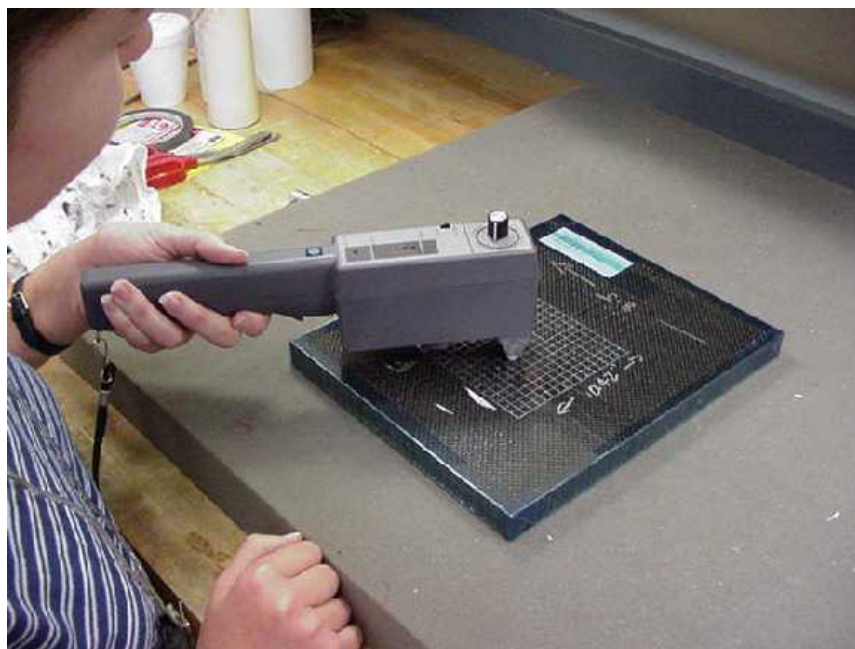
FIGURE 4-1. MITSUI WOODPECKER AUTOMATED TAP TESTER

In the acoustical tap testing, the characteristic resonant sound emanating from the tap test is analyzed by the human ear. The audible resonant sound will depend on the sandwich local impedance and tap mass/hammer characteristics. The damaged region is characterized by a dull (dead) sound, which can be attributed to the decreased participation of the higher frequency modes. The manual tap test hammer (Airbus design) is shown in figure 4-2.

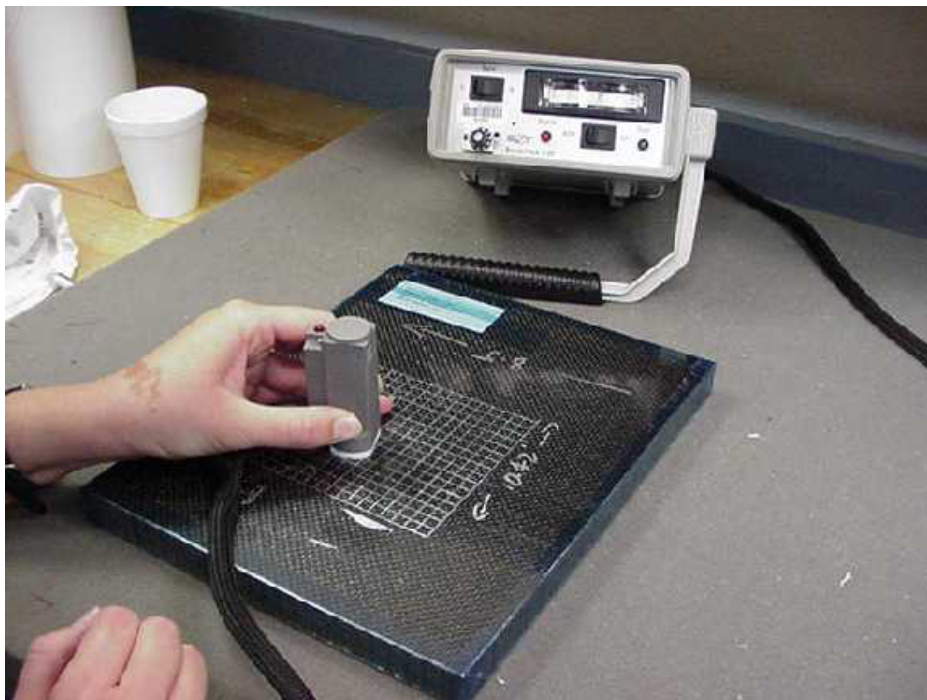
FIGURE 4-3. V-95 BOND TESTER USED FOR MECHANICAL IMPEDANCE ANALYSIS

impedance of the sandwich structure and can result in a phase or amplitude change to the displayed signal, depending on the frequency of the probe. The probe consists of two piezoelectric crystals with the driver positioned behind the receiver within the same holder. The driver converts electrical energy into sonic vibrations; the receiver, in direct contact with the test surface, converts the modified vibrations into electrical signals for processing by the instrument. The V95 low-frequency bond tester is illustrated in figure 4-3.

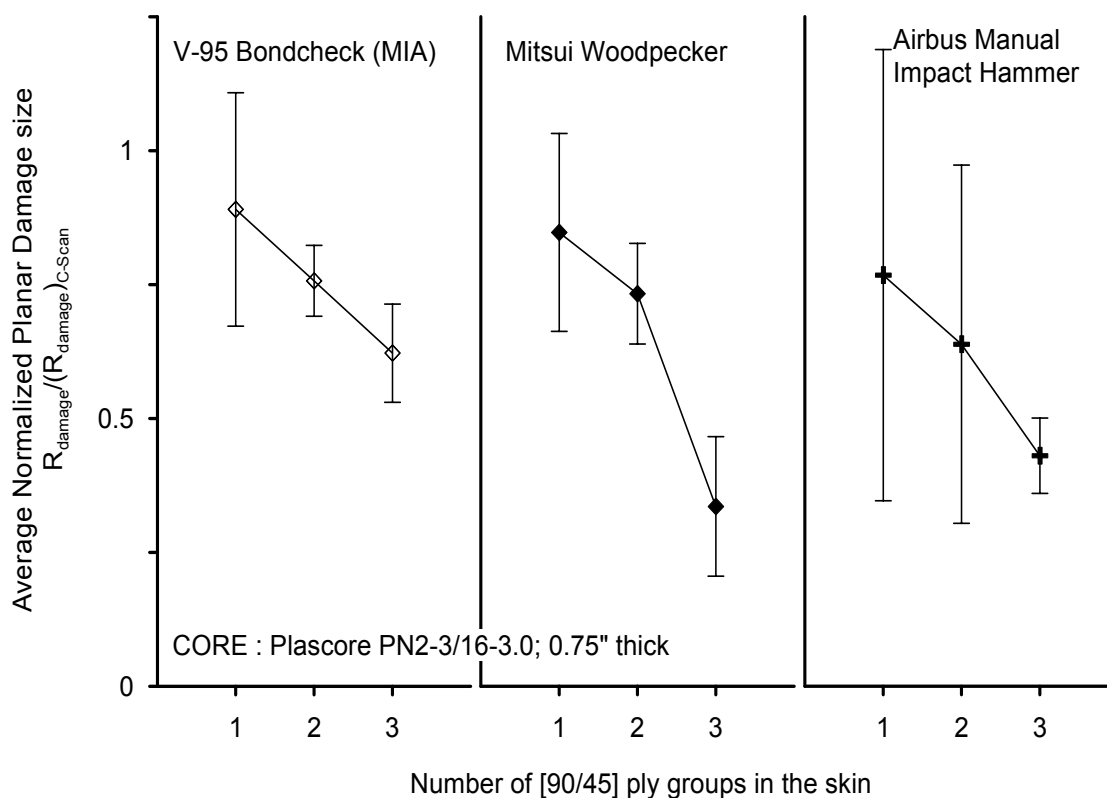
FIGURE 4-4. AVERAGE NORMALIZED DAMAGE SIZE FOR SANDWICH PANELS WITH DIFFERENT FACESHEET CONFIGURATIONS, WITH 0.75" THICK, 3.0 lb/ft³ CORES ONLY

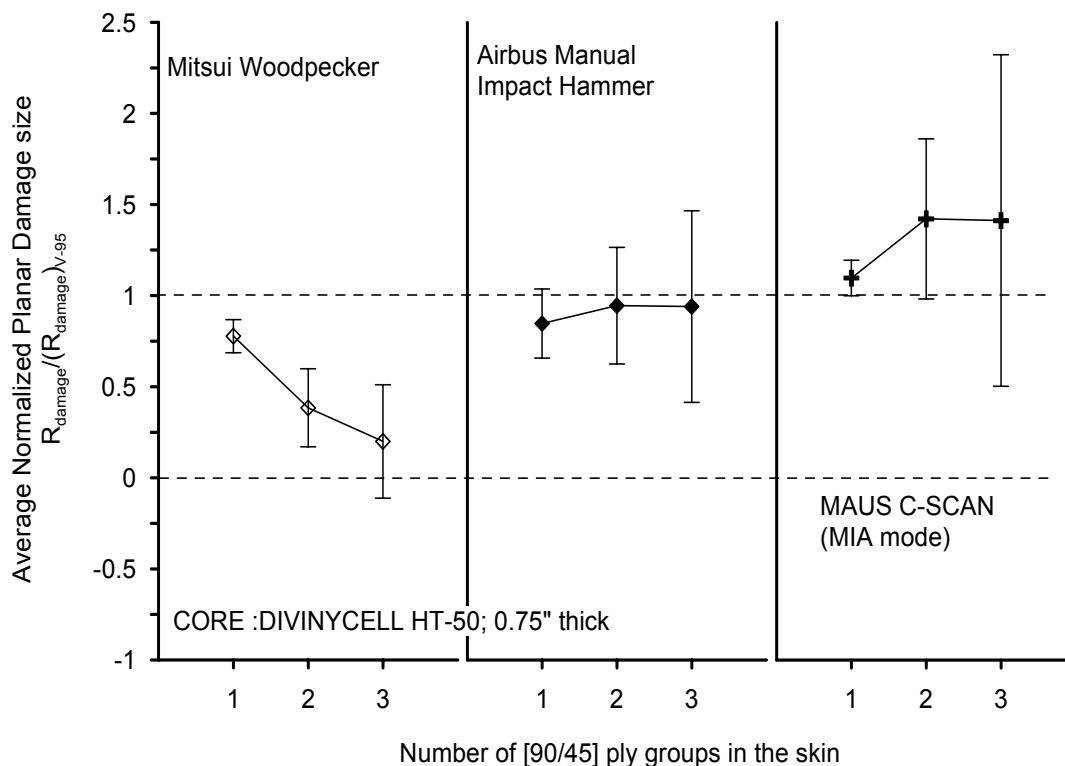
FIGURE 4-5. AVERAGE NORMALIZED DAMAGE SIZE FOR SANDWICH PANELS WITH DIFFERENT FACESHEET CONFIGURATIONS, WITH 0.75" THICK, 2.6 lb/ft³ CORES ONLY

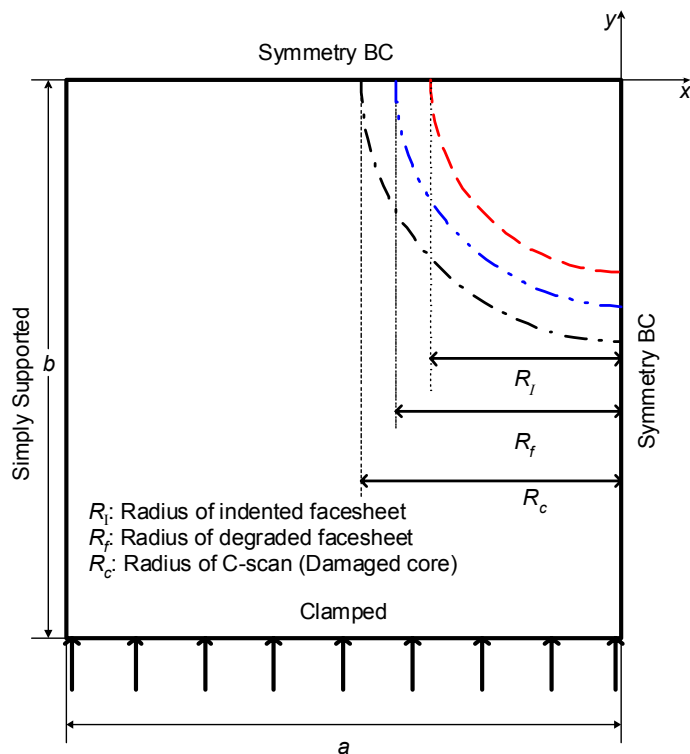
FIGURE 5-2. PLAN VIEW SCHEMATIC OF FINITE ELEMENT MODEL

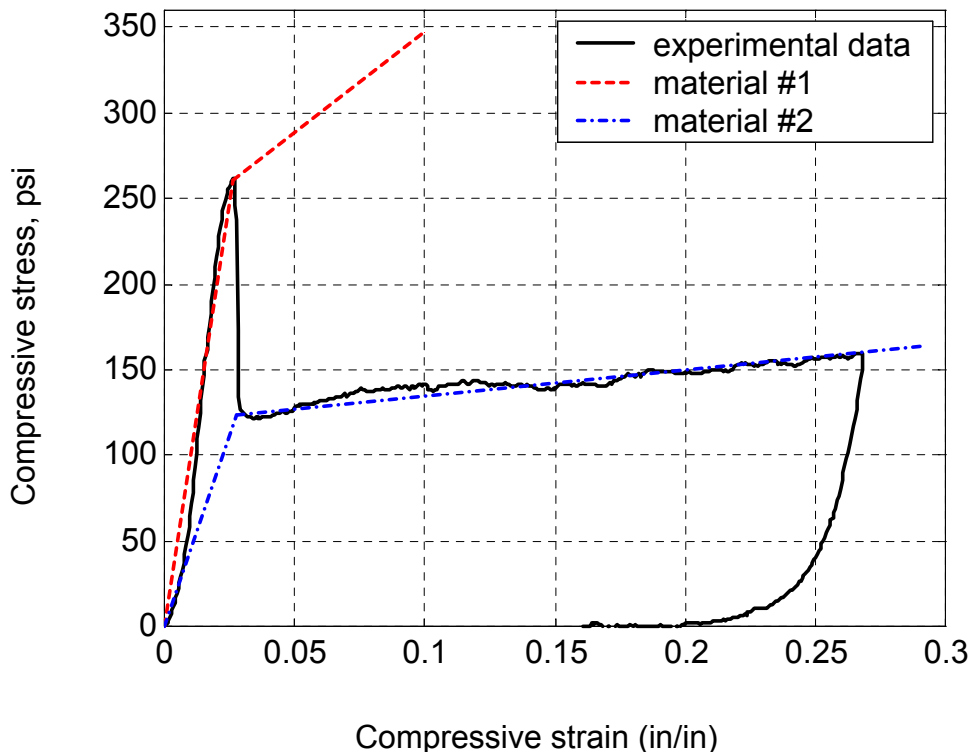
FIGURE 5-5. NONLINEAR CORE MATERIAL PROPERTIES

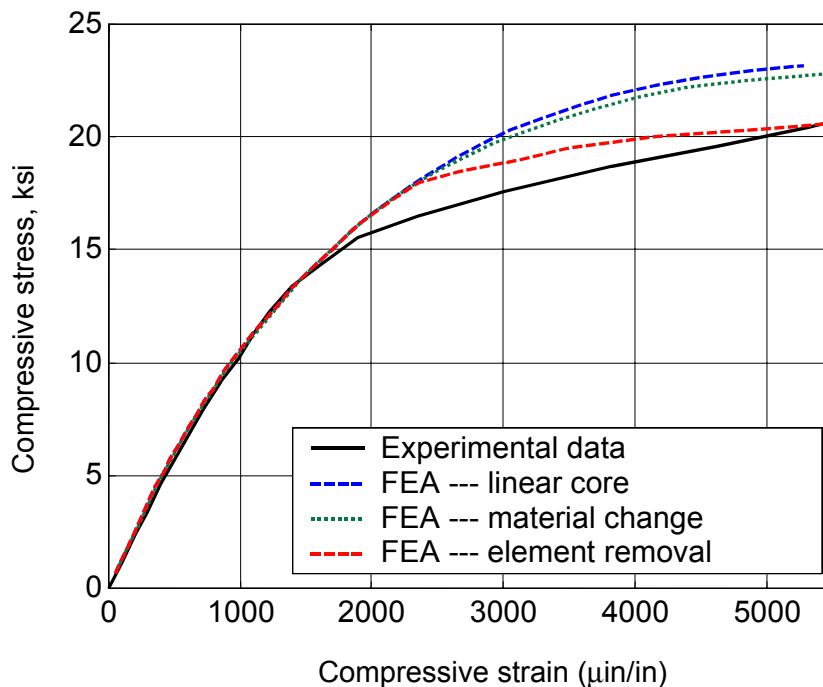
FIGURE 5-6. CORRELATION BETWEEN ANALYSIS WITH DIFFERENT CORE PROPERTIES AND EXPERIMENT

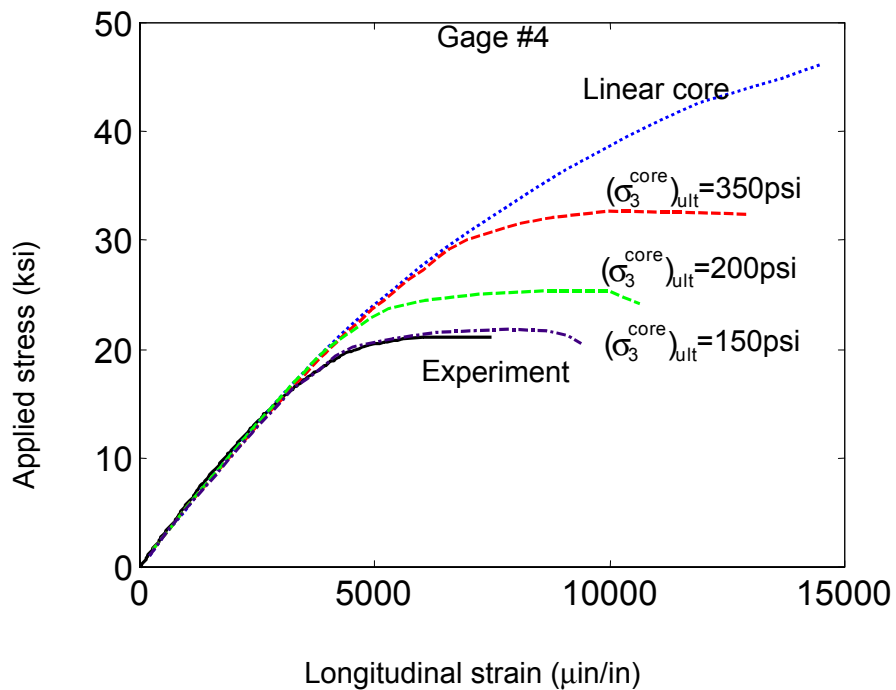
FIGURE 5-12. FAR-FIELD STRESS VERSUS STRAIN FOR GAGE NO. 4 LOCATION

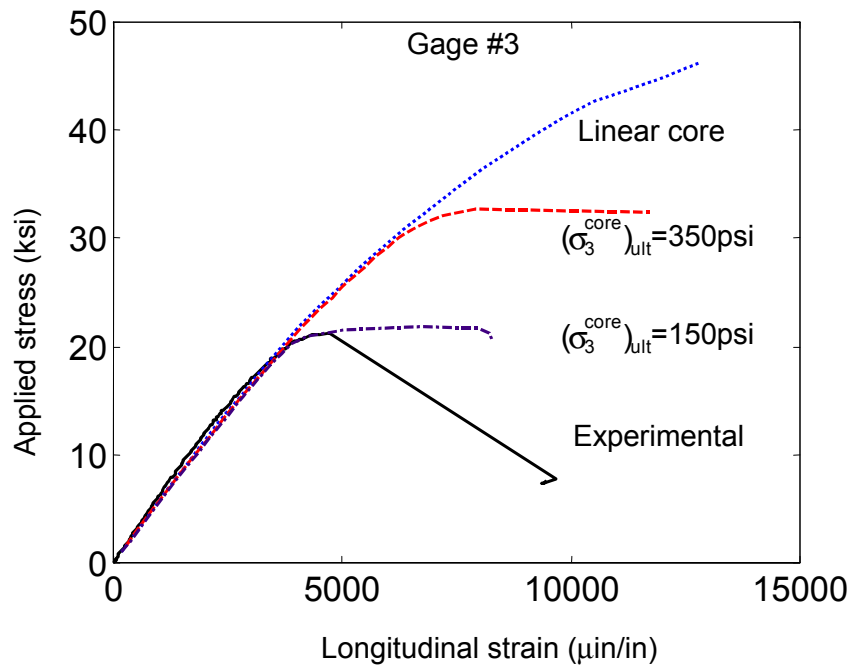
FIGURE 5-13. FAR-FIELD STRESS VERSUS STRAIN FOR GAGE NO. 3 LOCATION

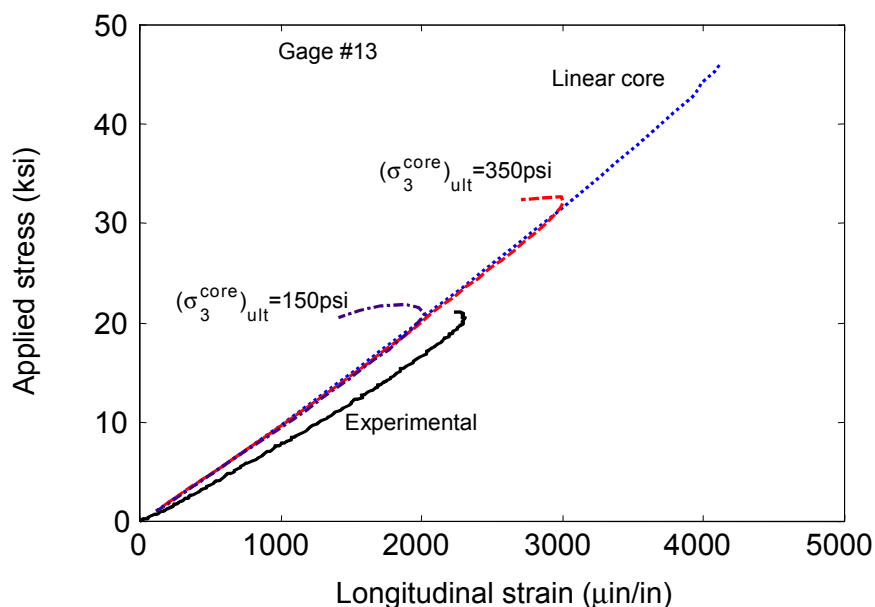
FIGURE 5-14. FAR-FIELD STRESS VERSUS LOCAL STRAINS FOR GAGE NO. 13 LOCATION

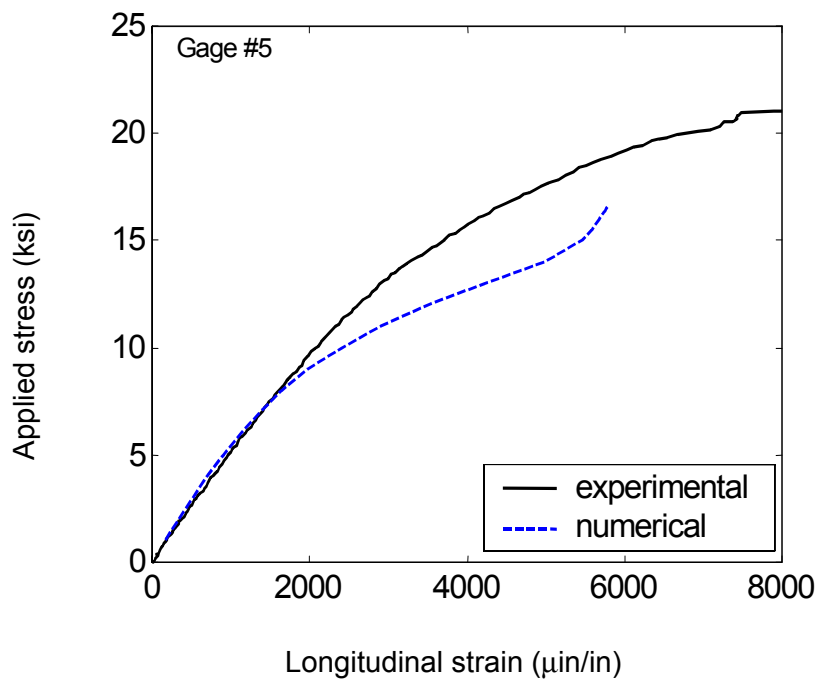
FIGURE 5-18. COMPARISON OF STRAINS AT GAGE NO. 5

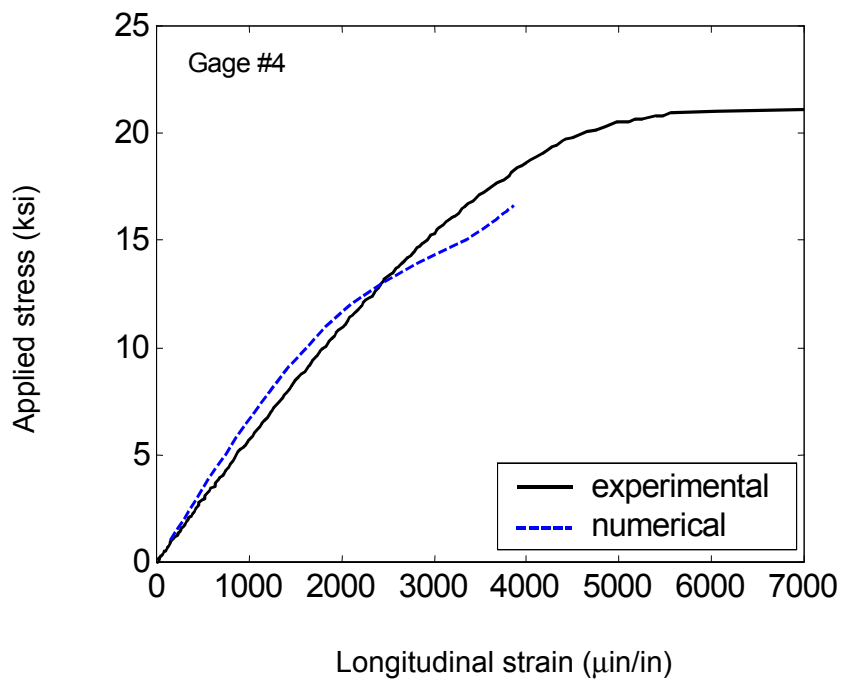
FIGURE 5-19. COMPARISON OF STRAINS AT GAGE NO. 4

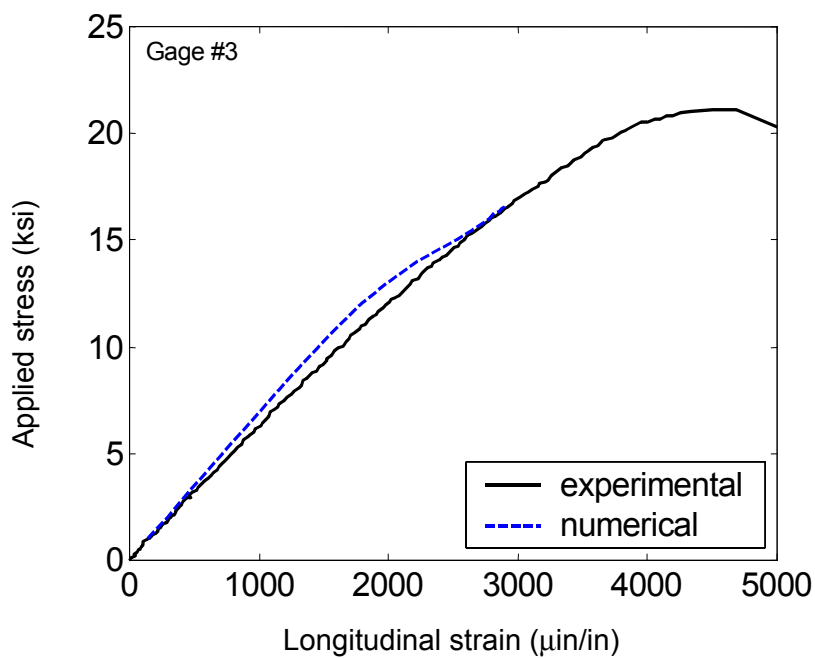
FIGURE 5-20. COMPARISON OF STRAINS AT GAGE NO. 3

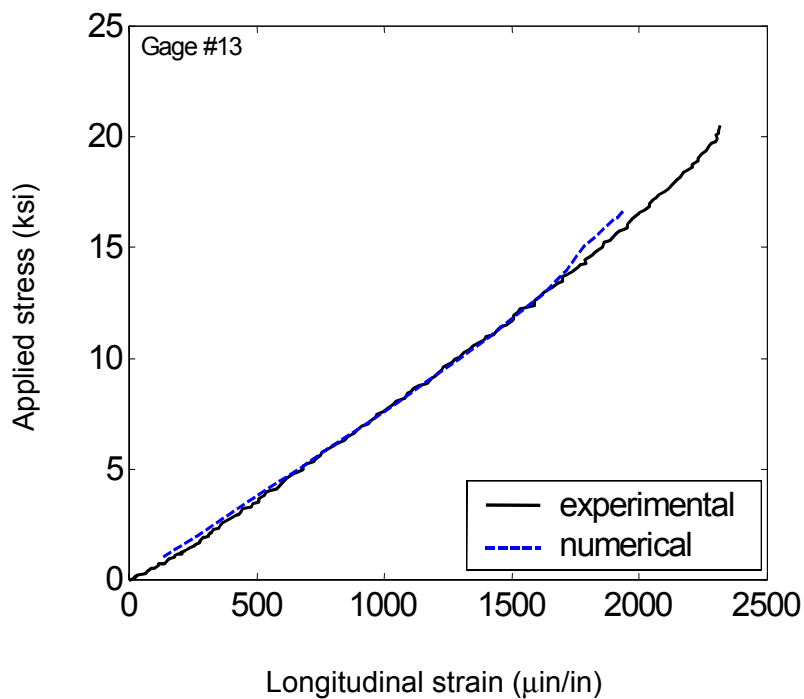
FIGURE 5-21. COMPARISON OF STRAINS AT GAGE NO. 13

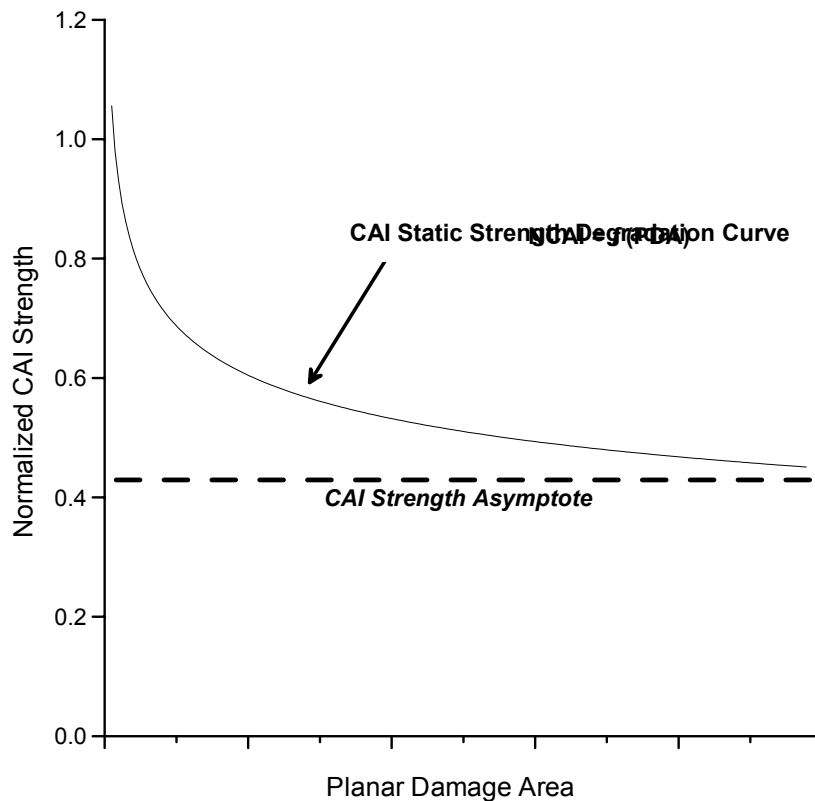
FIGURE 6-2. CAI STATIC STRENGTH DEGRADATION CURVE
