TECHNICAL NOTE 2212

THE EFFECT OF ICE FORMATIONS ON
PROPELLER PERFORMANCE

By Carr B. Neel, Jr., and Loren G. Bright

Ames Aeronautical Laboratory
Moffett Field, Calif.

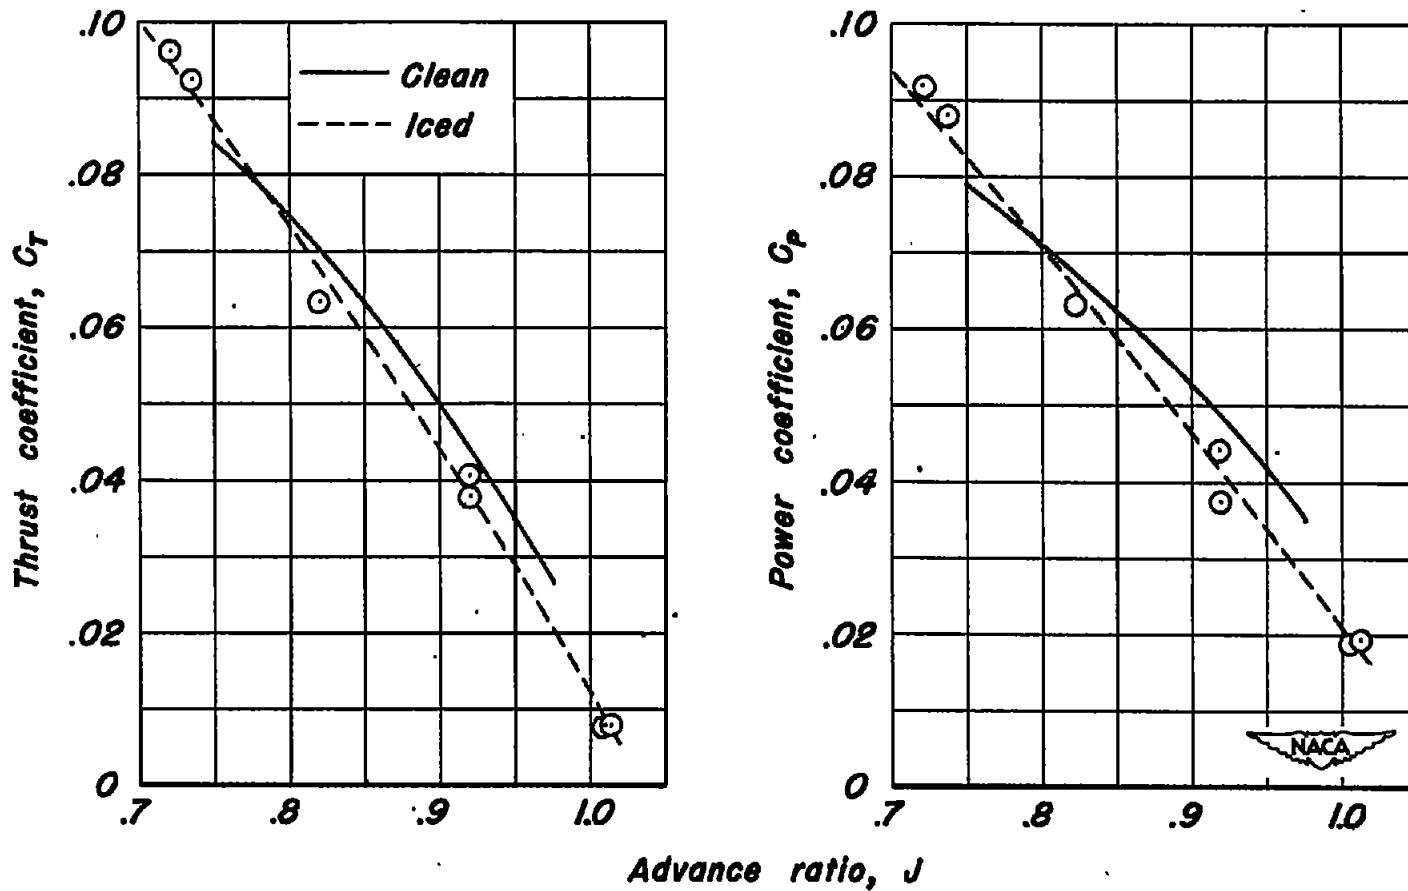
(b) Encounter 3a. $\beta_0 = 20.7^\circ$.

Figure 9. - Continued.

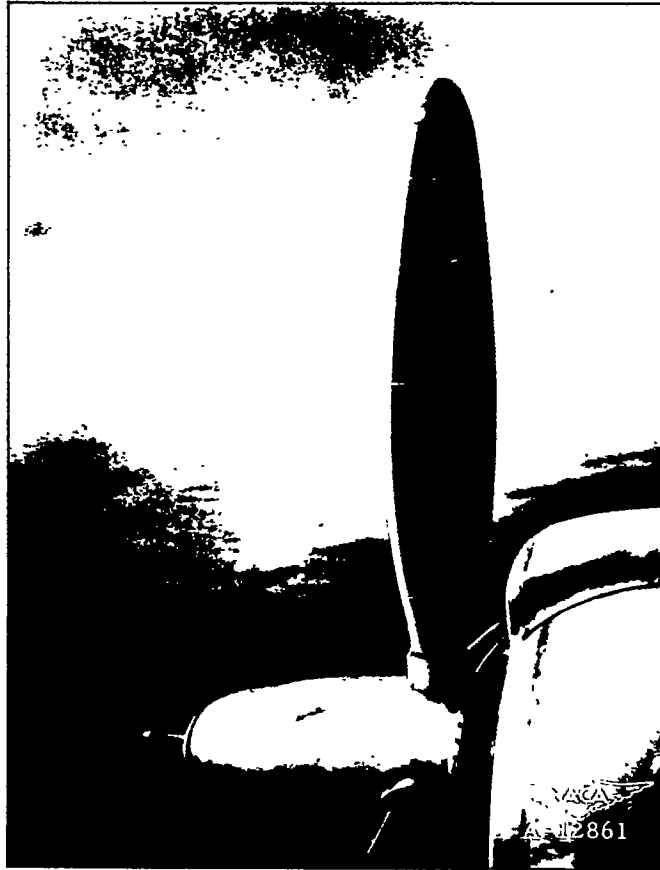
Figure 31.— Ice formation of encounter 12. Camber face. Efficiency loss, 5 percent.
