## TECHNICAL NOTE NO. 400

## ADVANTAGES OF OXIDE FILMS AS BASES FOR ALUMINUM

## PIGMENTED SURFACE COATINGS FOR ALUMINUM ALLOYS

By R. W. Buzzard and W. H. Mutchler

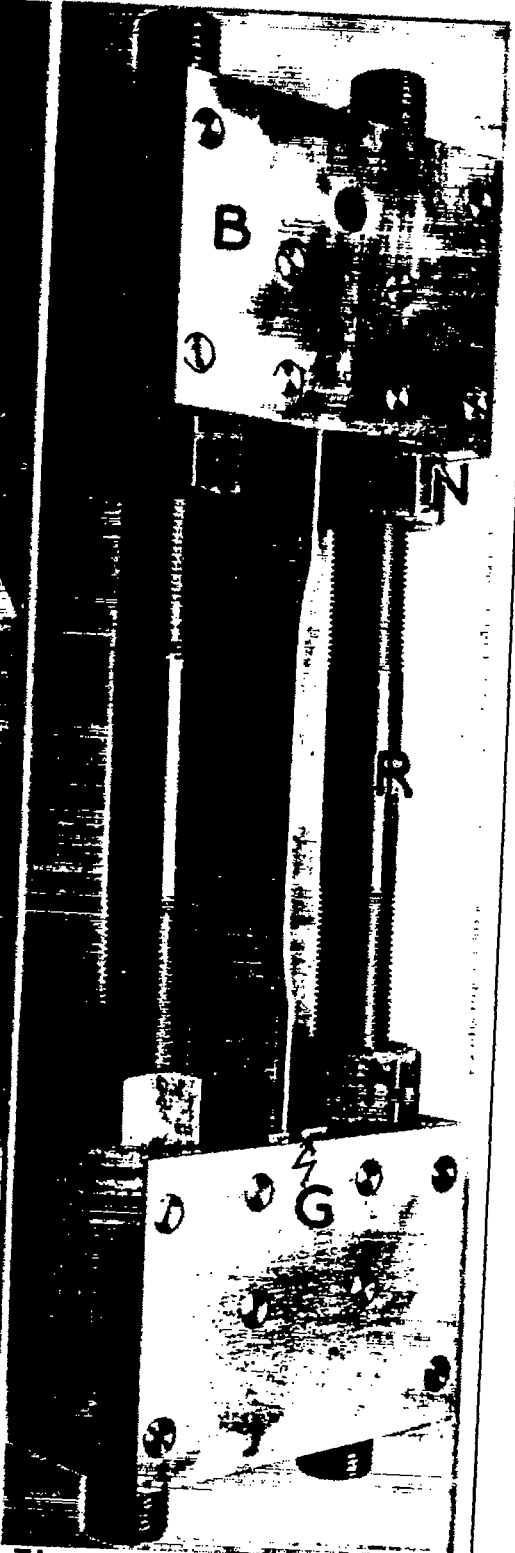
Fig. 3 Specially designed  
static stress grips for securing  
specimens  
during corrosion tests

No fundamental changes in the intermittent immersion method were necessary in order to corrode specimens under static tension, except that the apparatus sustaining the static load was substituted for the glass racks which ordinarily supported the specimens. The static tension apparatus was constructed of steel and was heavily coated with paraffin prior to corroding the specimen which it held. Reference to the photograph, (fig. 3), will serve to illustrate its operation. The load was applied to the specimen in an Amsler testing machine through the end blocks B-B' and the grips G-G', the four nuts N not being in contact with the end blocks. When the desired load was recorded on the Amsler machine the nuts N were tightened until the load on the Amsler registered zero, the rods R-R' then sustaining the load.
