## MATIONAL ADVISORY COMMITTEE FOR AERONAUTICS

No. 409

## EFFECT OF AGING ON TAUT RUBBER DIAPHRAGMS

By D. H. Strother and H. B. Henrickson Bureau of Standards

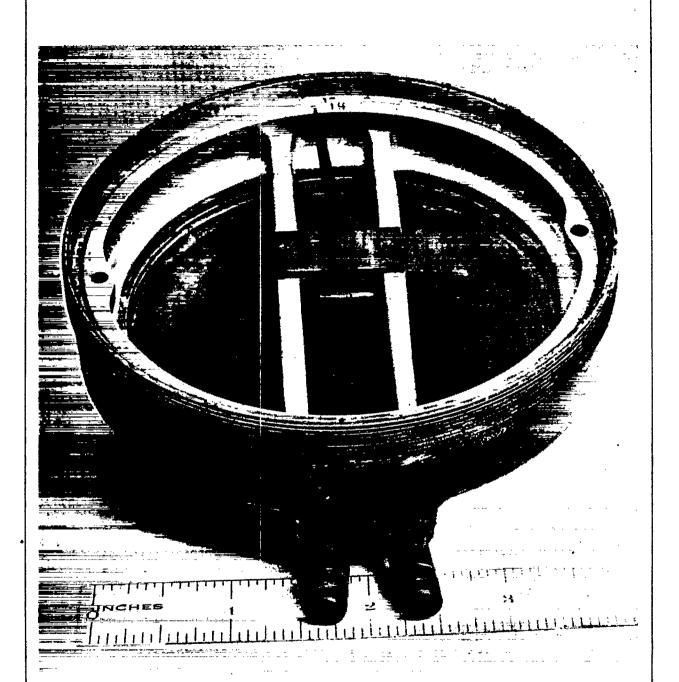
Fig. 1 View of rubber diaphragm mounted in an instrument. Note the simple arrangement for multiplying the motion of the diaphragm.

The samples were attached while taut to mounting rings in the manner described by Eaton and Buckingham. (Reference 1.) Each mounting ring and diaphragm was then installed in the case of an Ogilvie air-speed indicator. A view of a diaphragm in one of the instruments is shown in Figure 1.

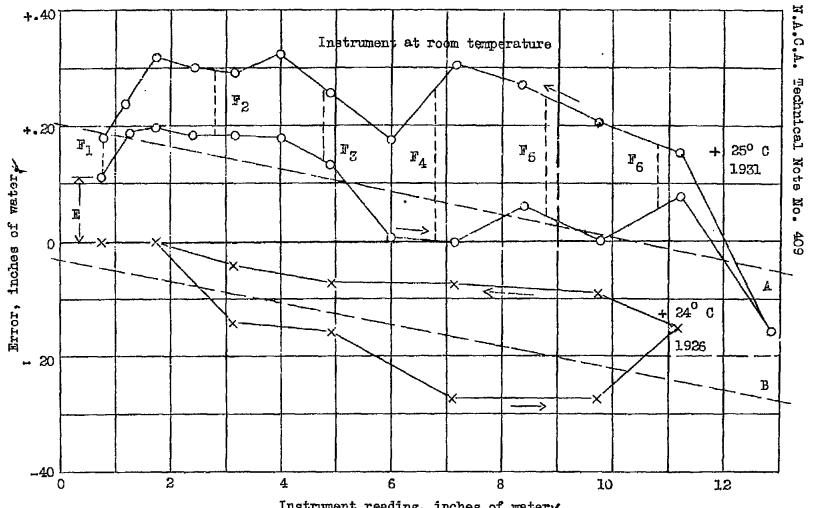
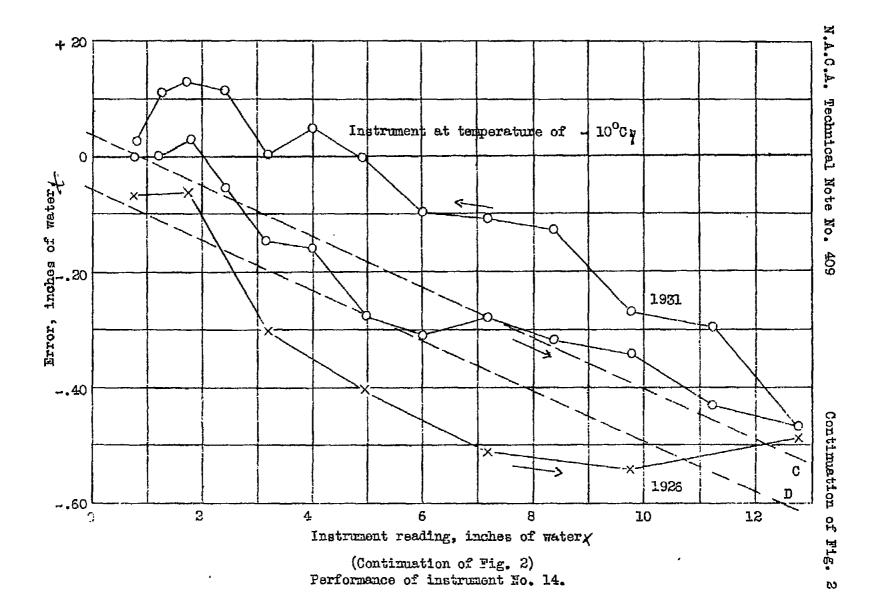
Fig. 2 (Continued on next page) Performance of instrument No. 14.

The curve showing the errors for instrument No. 14 given in Figure 2, is typical of the curves obtained.

The average increase in stiffness due to the lapse of time given in Table III is the difference in the slopes of the curves for increasing pressures obtained at the beginning and the end of the time interval. Thus, for instrument No. 14, the value at room temperature is the difference in slope of lines A and B in Figure 2.

The average increase in stiffness with decrease in temperature was determined similarly. For instrument No. 14 the value for 1931 is the difference in slope of lines A and C in Figure 2 and for 1926, the difference in slope of lines B and D.

The zero shift with the lapse of time is given in terms of pointer motion in degrees of arc. The prefix. H means that the reading increased with time and L, that it decreased. In Figure 2, the ordinate E gives the

zero shift in units of pressure, which has been converted into degrees of pointer motion using the data of Table II and on the assumption of a straight line relation between diaphragm deflection and differential pressure.

The hysteresis is the difference in the errors at a given reading of the instrument obtained first when the pressure was increased to the maximum and then when decreased to zero again. Thus in Figure 2,  $F_1$ ,  $F_2$ , etc. are values of the hysteresis. The average hysteresis in per cent of range is the average of the hysteresis at equal intervals of the reading between the first and maximum reading divided by the maximum reading. Thus in Figure 2, the average hysteresis in the upper curve is
