TECHNICAL NOTE 4157

CORROSION RESISTANCE OF NICKEL ALLOYS IN  
MOLTEN SODIUM HYDROXIDE

By H. B. Probst, C. E. May, and Howard T. McHenry

Lewis Flight Propulsion Laboratory  
Cleveland, Ohio

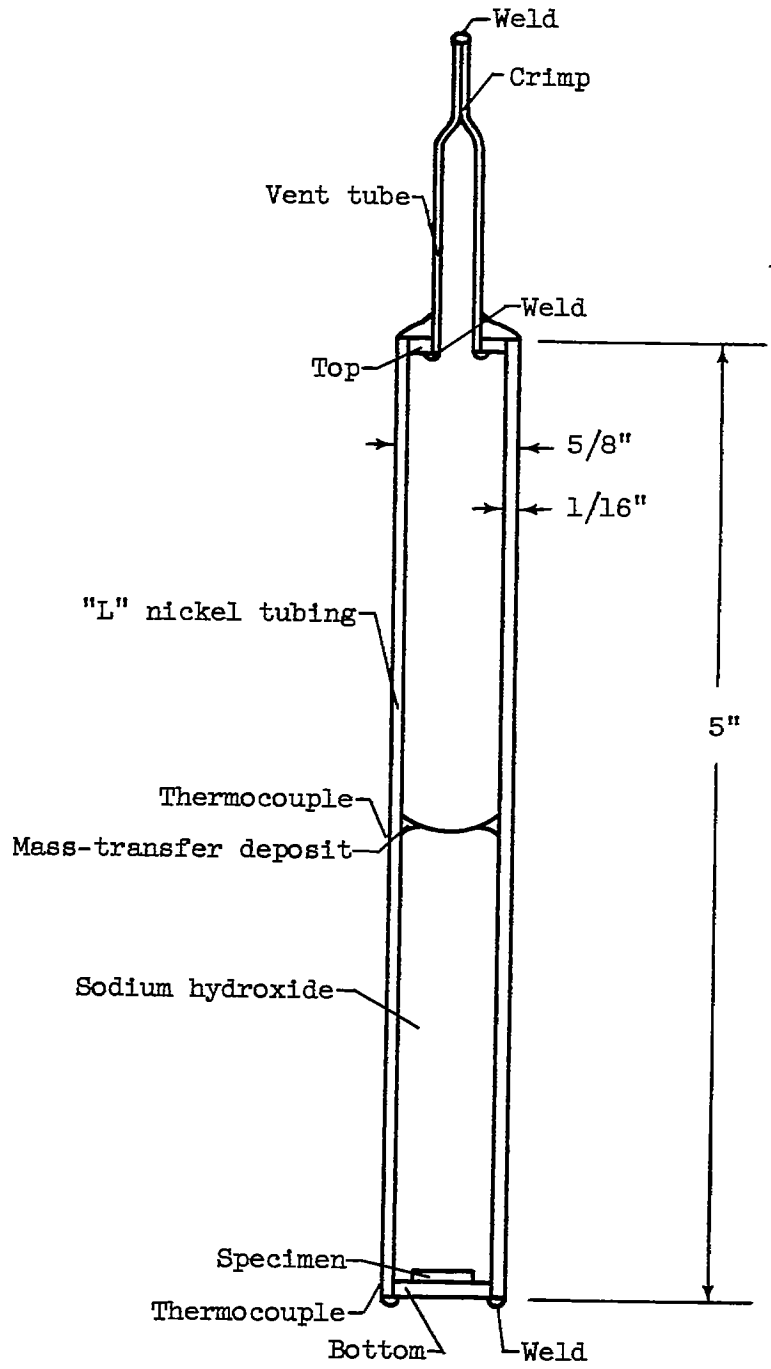
Figure 2. - Corrosion test capsule assembly.

The corrosion tests were run in "L" nickel capsules of the geometry shown in figure 2. A specimen was placed at the bottom of each capsule. The components of each capsule assembly, that is, tube, top, bottom, and vent tube, were cleaned in modified aqua regia (ref. 12) before assembly for 2 minutes.

After the bottom was welded in place, the weighed test specimen was placed in the capsule and sodium hydroxide ( $13.0 \pm 0.1$  g) was then added to the capsule in a helium dry box. The top and vent tube were then welded in place by means of a modified heliarc welding process. A welding atmosphere of helium plus 15 percent hydrogen was maintained while argon flowed through the assembly during welding.

Moisture and air were removed by evacuating to a pressure of 5 microns of mercury at 580° F (below the melting point of NaOH) and then evacuating to a pressure of 5 microns of mercury at 720° F (above the melting point of NaOH). The approximate times required for the two evacuations were 16 hours and 4 hours, respectively. Following the evacuation and cooling process, a cover gas of helium at a pressure of 2 pounds per square inch gage was admitted and the assembly sealed by crimping and welding the vent tube. Thermocouples were spotwelded to the capsules 1/8 inch from the bottom and also at the liquid level,  $2\frac{1}{2}$  inches from the bottom.

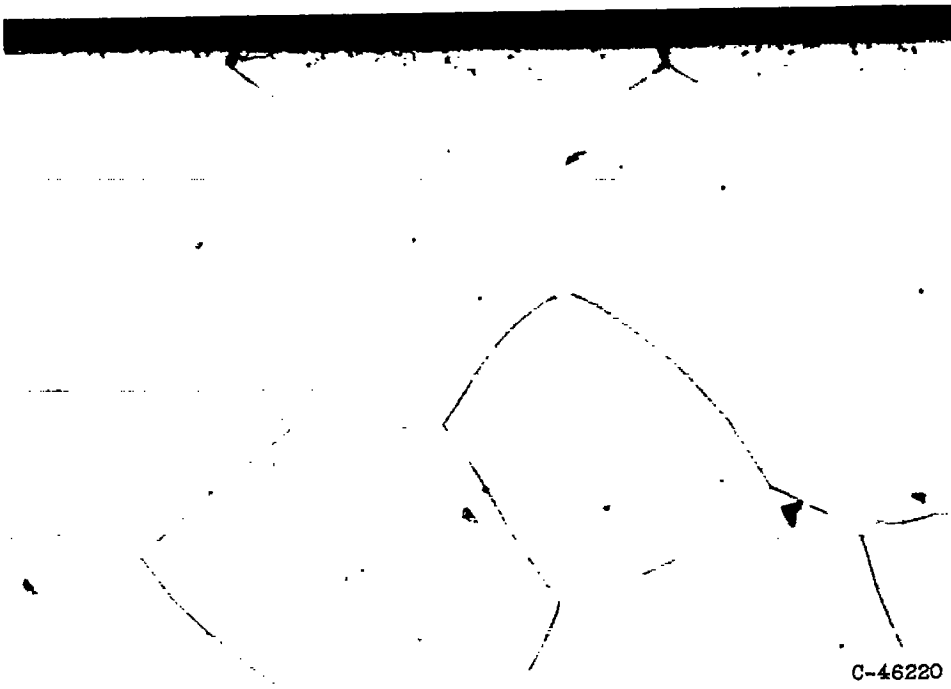
Figure 3. - Nickel plus 5 percent molybdenum after corrosion test at 1700° F. Etched; X250.

Nickel plus molybdenum. - No change was noted in the microstructure of the nickel plus 5 percent molybdenum composition after testing at 1500° F; however, slight intergranular attack resulted at 1700° F, as shown in figure 3. Leaching of molybdenum from the solid solution was slight at both temperatures, as measured by analysis of the sodium hydroxide.

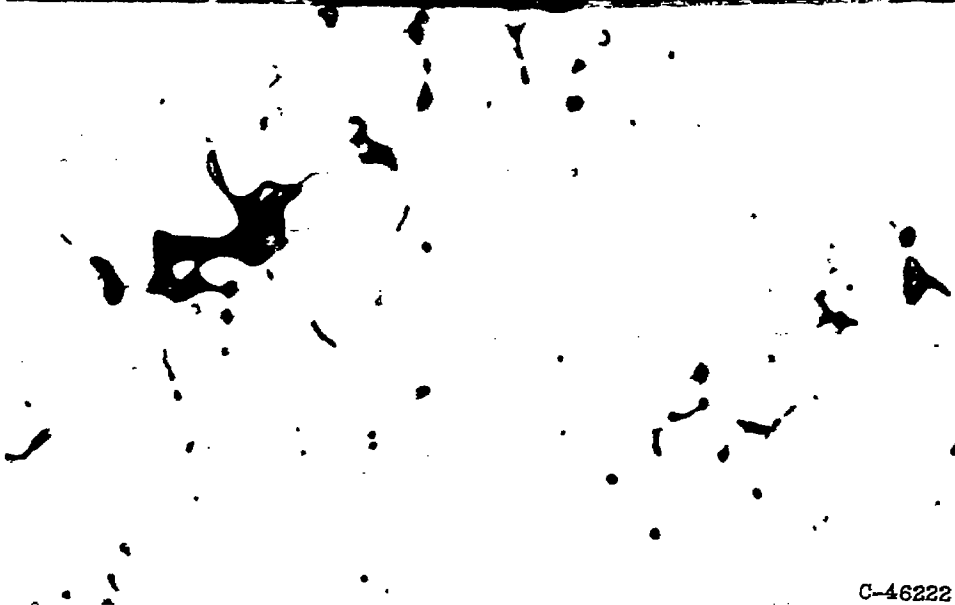
C-46222

Figure 5. - Nickel plus 5 percent tin after corrosion test at 1700° F. Etched; X250.

Nickel plus tin. - No change in microstructure was noted for the nickel plus 5 percent tin alloy after testing at 1500° F. Some intergranular attack was observed after the 1700° F test. A foreign phase was present in the grain boundary regions as shown in figure 5. Since the leaching appeared to be slight at 1700° F, according to chemical analysis, it was assumed to be slight at 1500° F as well. However, chemical analysis was lacking for the lower temperature sample. X-ray diffraction data showed similar changes in the lattice parameter after the tests at both temperatures, indicating at least surface leaching.

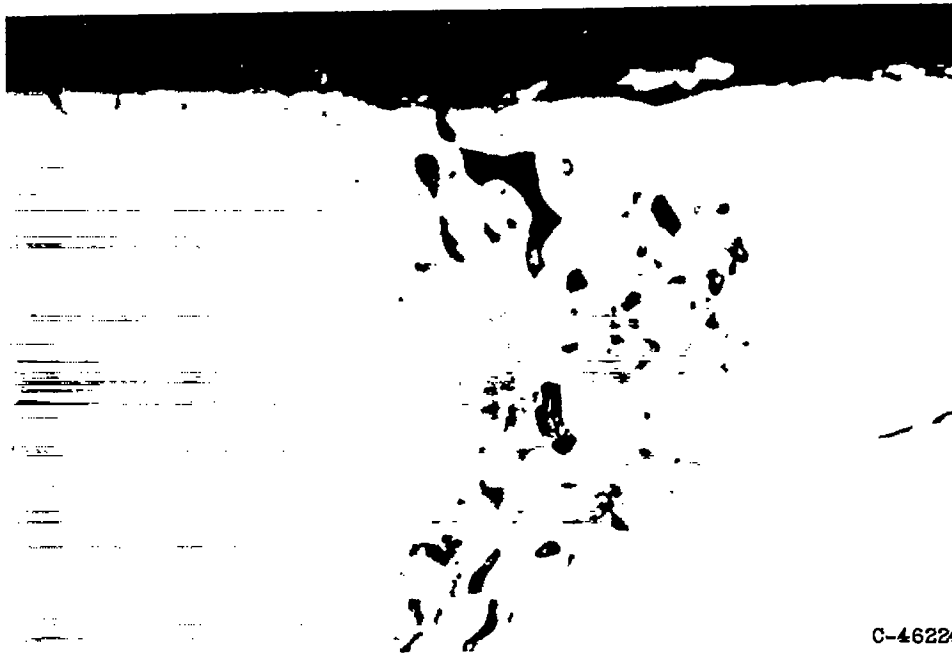
(c) Microstructure. Temperature, 1700° F. Unetched; X500.

Figure 6. - Concluded. Nickel plus 15 percent columbium after corrosion test.

Nickel plus columbium. - The nickel plus 15 percent columbium alloy showed an unusual reaction to sodium hydroxide. The swelling that occurred on the surface at 1500° F and the microstructure of this swelling are shown in figures 6(a) and (b), respectively. The surface of the swell is a single phase, while the body of the swell contains a foreign phase. The microstructure of this composition after the 1700° F test is shown in figure 6(c). Grain boundary attack is evident with a foreign phase present in the grain boundary regions. While it is not evident in the photomicrograph, a slight surface swelling was present after the test at 1700° F. Both X-ray and chemical analysis data indicated that considerable leaching of columbium had taken place at both test temperatures.

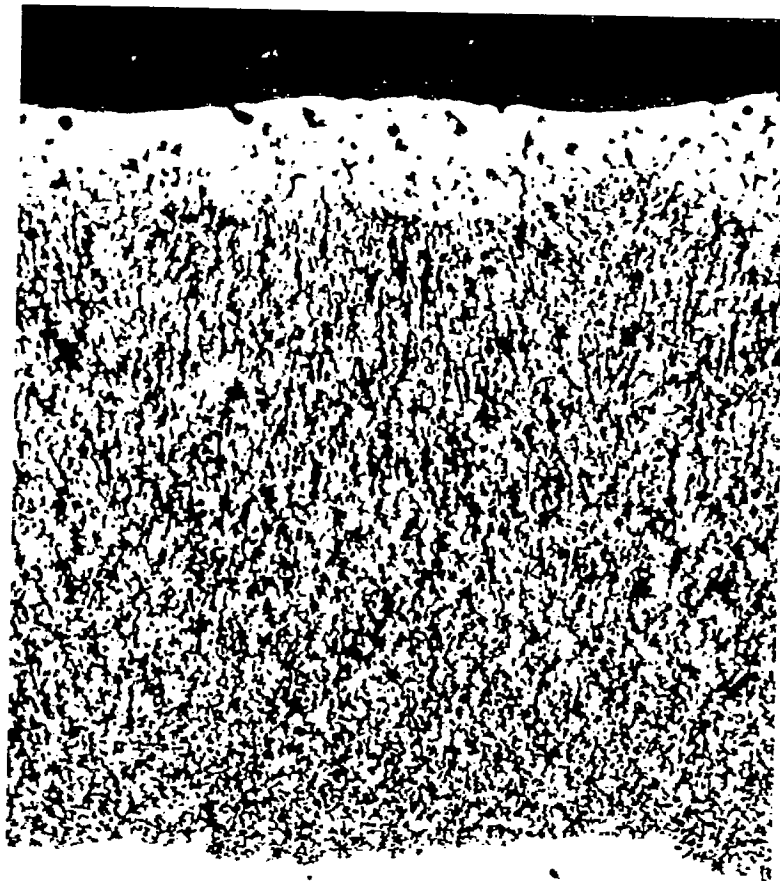
C-46225

(a) Temperature, 1500° F. Unetched; X250.

Figure 7. - Nickel plus 15 percent manganese after corrosion test.

Nickel plus manganese. - Another material showing abundant formation of a foreign phase at 1500° F was nickel plus 15 percent manganese. In this case, however, the foreign phase was not localized and appeared to have formed with no volume change (fig. 7(a)). The surface of the sample was pure nickel as shown by X-ray diffraction data. This region may have been depleted of manganese rather than being plated as there is no evidence of any interface. Localized formation of the foreign phase with some surface swelling resulted after the 1700° F test, as shown in figure 7(b). Chemical analysis showed only minor leaching at both temperatures.

Metallographically, the foreign phases contained in the various materials appeared to be similar, that is, they had a dark gray to black appearance resembling the oxide. Of the materials containing the foreign phase, the sample shown in figure 7(a) (Ni + 15 percent Mn) was the best suited to identify the foreign phase by X-ray diffraction. The surface of the sample was ground to various depths that were within the region containing the foreign phase. X-ray patterns obtained from these newly ground surfaces gave only nickel lines. However, it was noted that after the specimen was left standing in air for 24 hours, the ground surface of

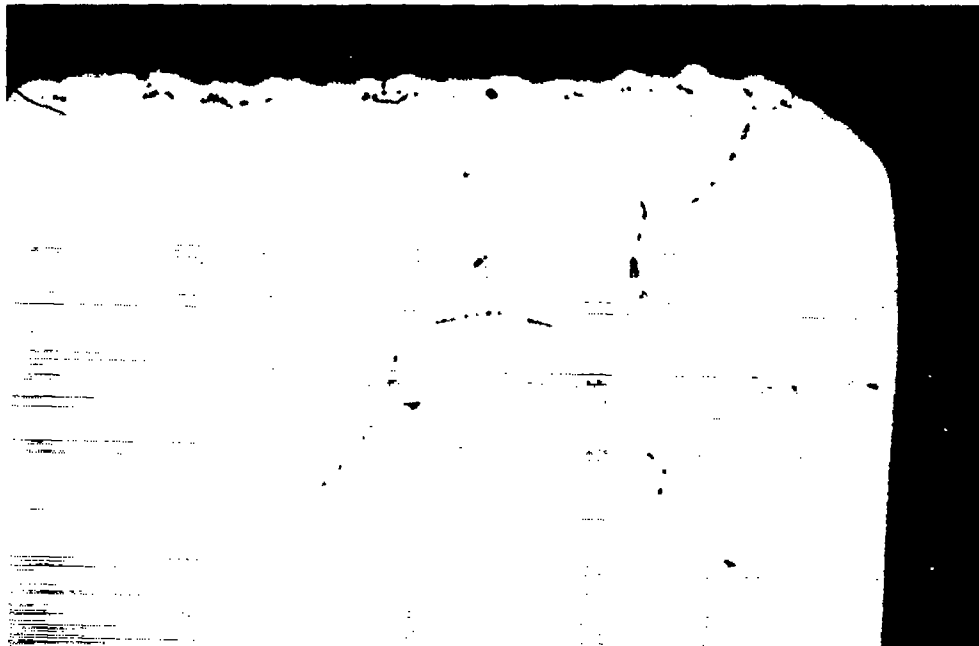
C-46227

Figure 8. - Nickel plus 1 percent silicon after corrosion test at 1700° F. Etched; X100.

Nickel plus silicon. - There was no change in the appearance of the microstructure of the nickel plus 1 percent silicon alloy after testing at 1500° F, but slight intergranular attack resulted at 1700° F as shown in figure 8. This composition showed the greatest leaching effect of all the compositions studied. At both 1500° and 1700° F, virtually all the solute was leached by the sodium hydroxide. Thus, this alloy has no advantage over pure nickel, since the alloy is essentially changed to pure nickel when exposed to molten sodium hydroxide.

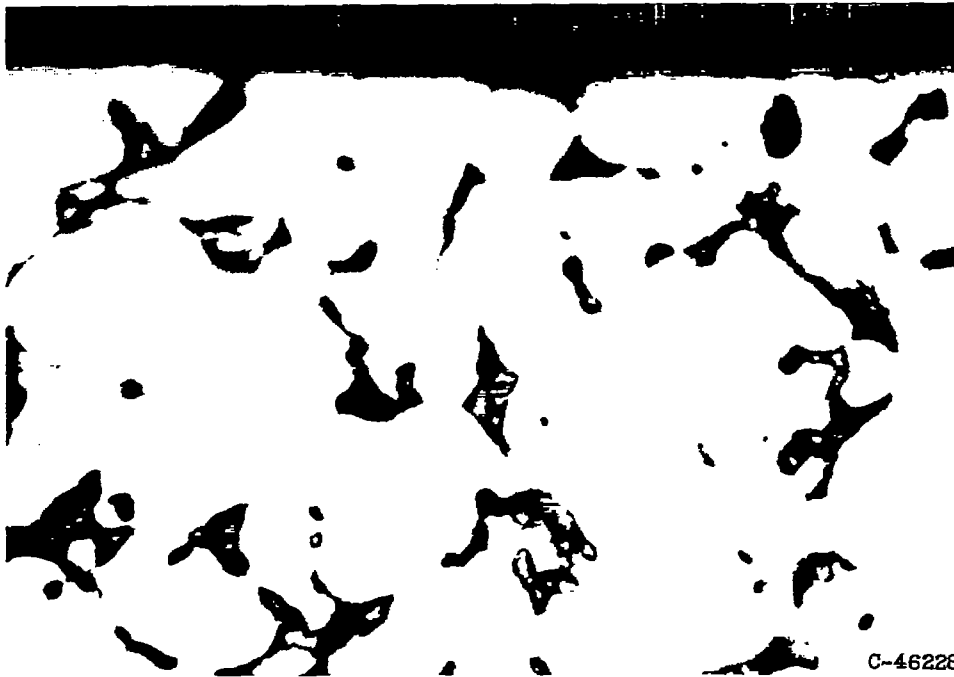
Figure 9. - Nickel plus 4.3 percent magnesium oxide after corrosion test at 1700° F. Etched; X500.

The group of materials with mechanically dispersed second phases possessed generally good corrosion resistance. There was no intergranular attack at either 1500° or 1700° F. Contrary to expectation, however, the attack of refractory particles was not confined to the particles exposed at the surface. Microscopic examination showed that particles below the surface had been removed, leaving voids. Figure 9 is a photomicrograph of the nickel plus magnesium oxide material after corrosion test at 1700° F. The nickel plus titanium carbide compositions showed a similar removal of titanium carbide particles. In addition to voids, the nickel plus 8.2 percent titanium carbide specimen tested at 1700° F contained a dark foreign phase near the surface similar to that noted in a number of the solid-solution alloys.

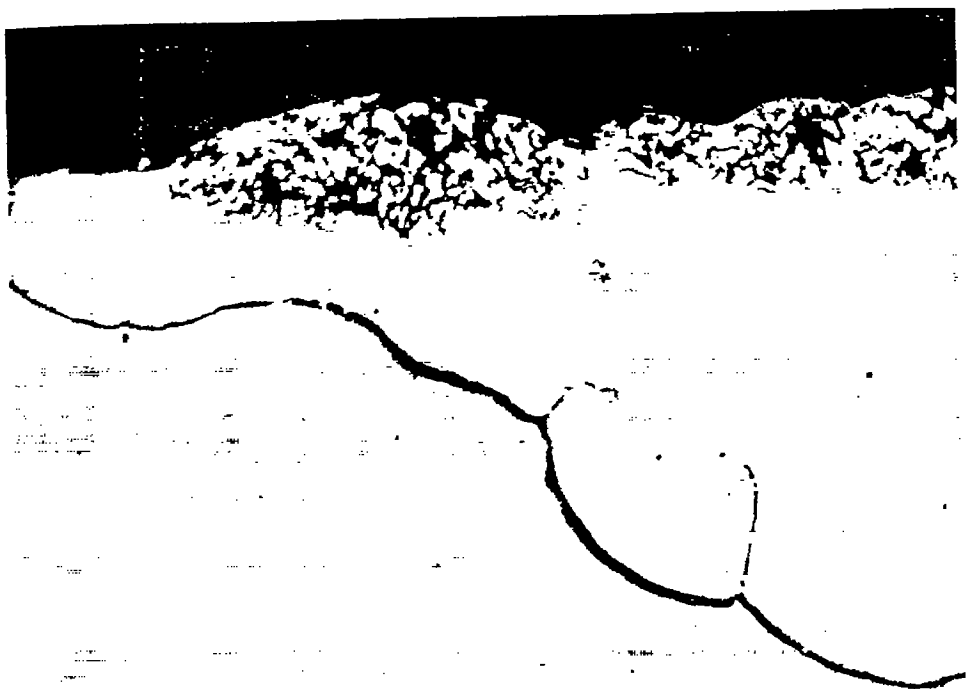
(b) Temperature, 1700° F. Unetched; X200.

The nickel plus 11 percent titanium alloy was severely attacked by molten sodium hydroxide both at 1500° and 1700° F. As shown in figure 10, attack was predominantly intergranular. The grain boundary regions were depleted of titanium and showed the presence of a foreign phase. In addition, specimens tested at both temperatures also showed localized surface swelling with a foreign phase in the swells.

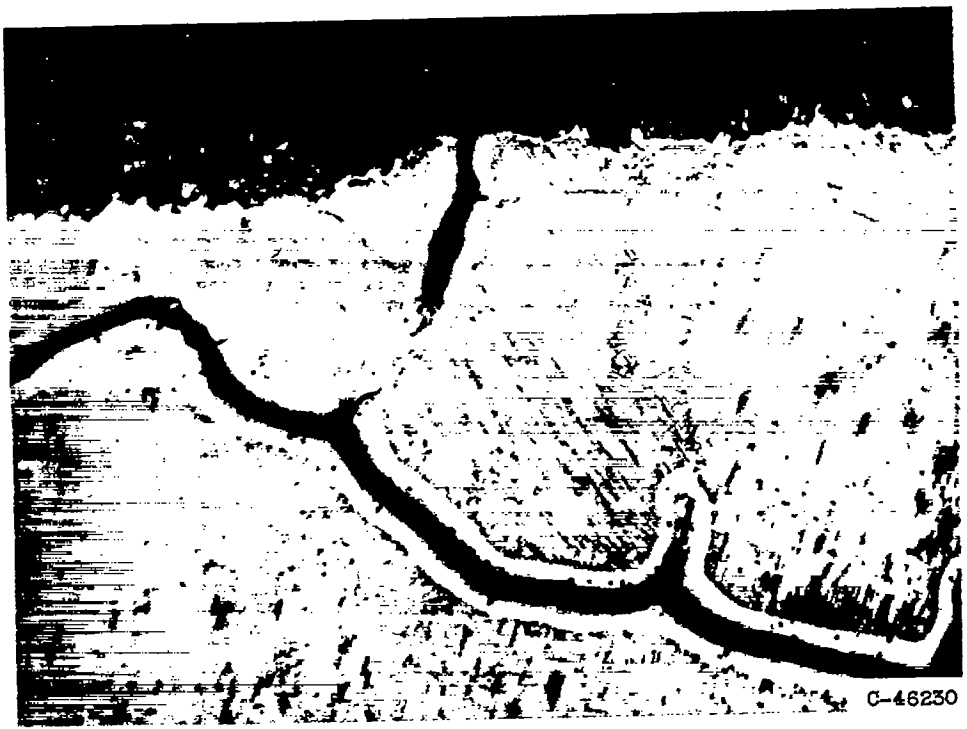
(c) Temperature, 1700° F. Etched; X250.

Figure 10. - Concluded. Nickel plus 11 percent titanium after corrosion test.

During the test at 1500° F, a nickel plate formed on the specimen (fig. 10(a)); this presumably came from the nickel capsule. In figure 10(a), the surface swells containing the foreign phase appear to have been formed after the deposition of the nickel plate. An accompanying positive volume change is suggested by the ruptured plate. The internal boundary regions of the swells in figure 10(c) appear to be depleted of Ni<sub>3</sub>Ti.
