TECHNICAL NOTE 4163

EFFECT OF TEMPERATURE ON ROLLING-CONTACT FATIGUE
LIFE WITH LIQUID AND DRY POWDER LUBRICANTS

By Thomas L. Carter

Lewis Flight Propulsion Laboratory
Cleveland, Ohio

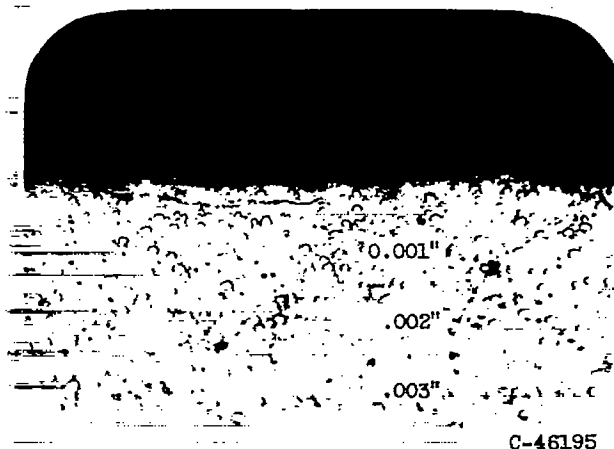
(e) Longitudinal section; X500;
 330×10^6 stress cycles.

(f) Track surface;
 330×10^6 stress cycles.

(g) Longitudinal section; X500;
 53×10^6 stress cycles (unetched).

Figure 8. - Concluded. Typical specimens. Lubricant, 0.2-percent molybdenum disulfide suspension in polyalkylene glycol; M-1 tool steel; test temperature, 100° F; maximum Hertz compressive stress, 725,000 pounds per square inch.

A strong tendency for formation of surface cracking was observed in these specimens (figs. 8(b), (d), and (f)). This condition is not typical of fluid lubricant fatigue failures. This cracking had a characteristic pattern that bore a definite relation to the relative sliding always encountered in rolling contact of a ball with a race. Since the radius of rotation is at a maximum at the running track center and is progressively less toward the outside while the angular rotation is the same, the surface speed must vary in the transverse direction. This causes relative sliding of the surfaces. To maintain an over-all rolling of the ball, the sum of the friction forces generated at the contact zone must be zero. Otherwise the ball would skid. Thus, the sliding is opposite the rolling direction at the center of the ball and in the same direction at the track edges. At some point in between, the relative sliding of the two surfaces is zero. Thus, there are two bands of pure rolling on the track. The cracking in figures 8(b), (d), and (f) has an abrupt change in direction at these bands of pure rolling. Thus, it has a characteristic pattern relative to surface sliding.

local stresses causing cracking, would facilitate corrosion, and a corrosion pit would provide the stress concentration for fatigue cracking. Figures 8(a) and (c) present a cross section of the ball subsurface showing the penetration of corrosion cracking into the subsurface. The increase in depth with longer test time is apparent. These corrosion cracks generate secondary cracking parallel to the surface, which is the normal cause of fatigue spalling. A typical spall is shown in figure 8(e).
