TECHNICAL NOTES

No. 753

MEASUREMENT OF THE FORCES ACTING ON GLIDERS IN TOWED FLIGHT

By W. B. Klenperer
The Soaring Society of America, Inc.

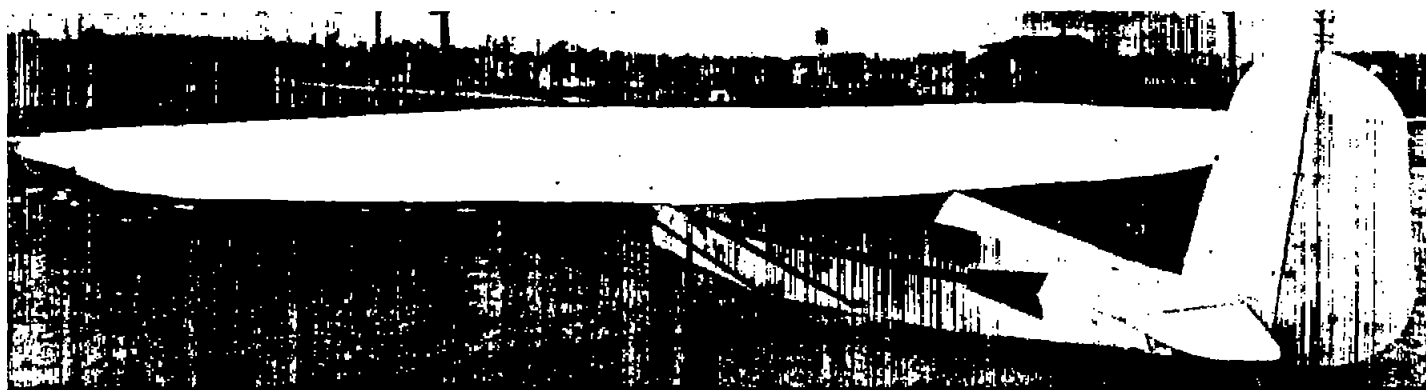
Figure 1.- Utility cadet type of glider used for group I of glider tow tests.

The glider used in the first group of tests was a Cadet of the Secondary Training or General Utility type, a high-wing monoplane, license No. G10265, owned by Richard Randolph of Akron, Ohio. It was constructed as shown on the attached photograph (fig. 1) except that jury struts and additional tail-bracing wires were provided (as authorized by the Bureau of Air Commerce). The wing span of the glider was 37 feet 10 inches; length, 18 feet 9 inches; wing area, 160 square feet. The weights were as follows:
